Inspection Report

433 SE Lake Circle Drive
Stuart FL 34994

Professional View Home Inspection Services

Date: 11/6/2023	Time: 10:30:00 AM	Report ID: 110623JH1
Property: 433 SE Lake Circle Drive Stuart FL 34994	Customer: Rosi Shepard	Real Estate Professional:

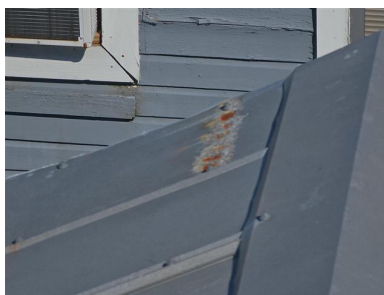
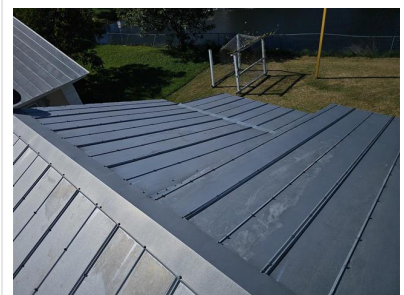
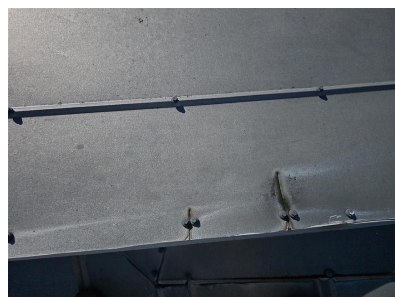
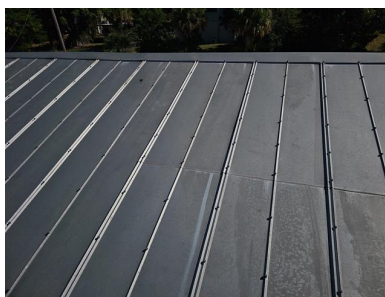
(3) The roof covering has corrosion and rust in areas. This can allow moisture intrusion. Multiple metal roof panels are installed improperly. This cause wind to uplift certain areas of the covering. Multiple attachment screws were backing out of position.

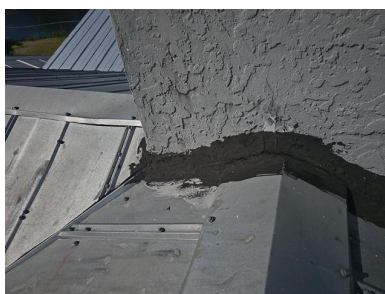
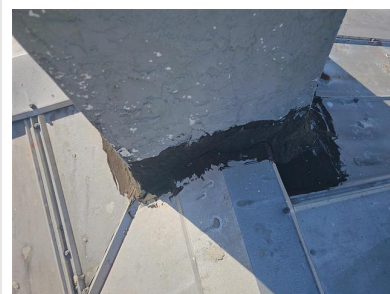
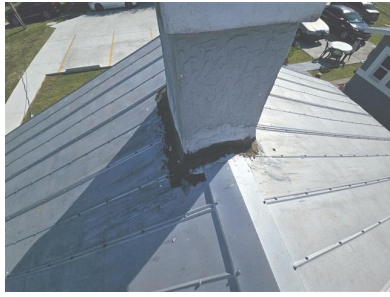
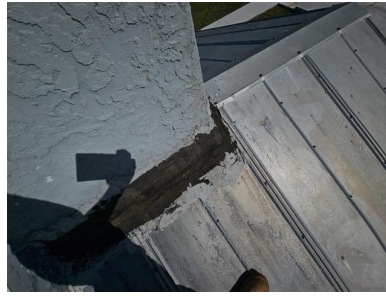
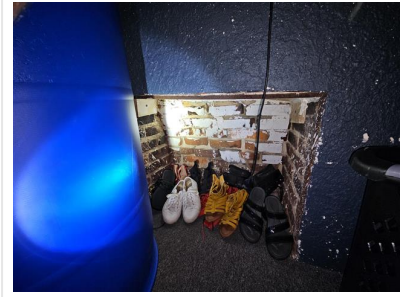
The tar seals around the chimney are considered temporary repairs. I recommend further evaluation. This can allow moisture intrusion. The chimney have been capped off. There not in use anymore.

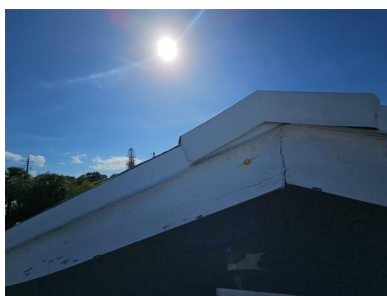
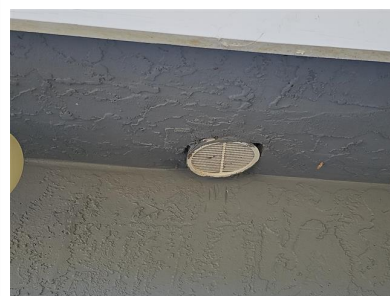
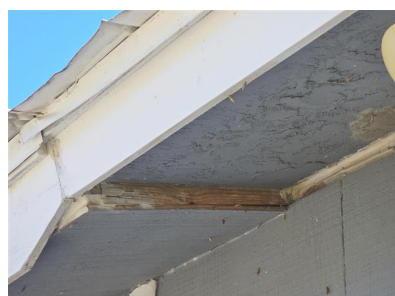
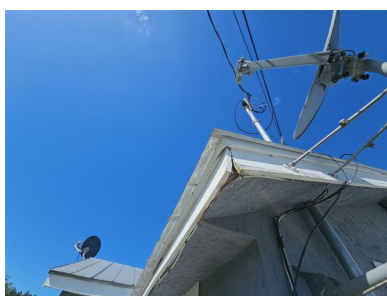
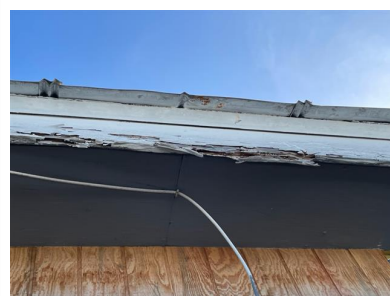
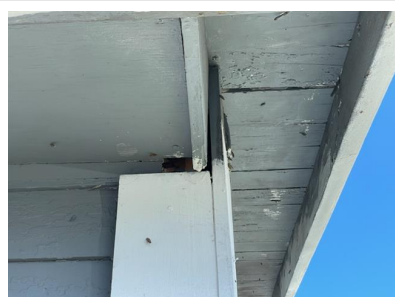
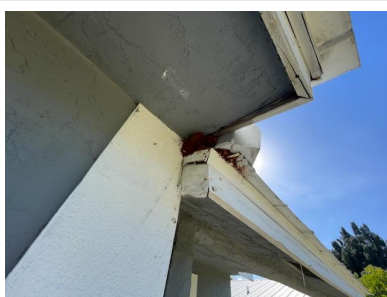
The fascia at the left and right side duplexes have deterioration of the wood in multiple locations. Multiple soffit vents were not fully secured at the time of the inspection. This can allow insects and rodents access to the attic. The soffits have gaps in areas.

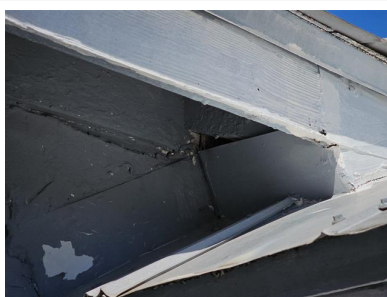
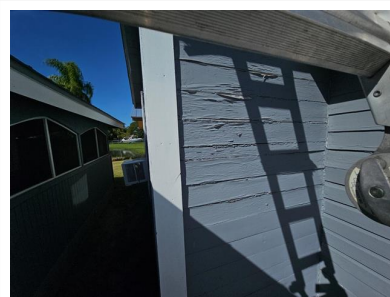
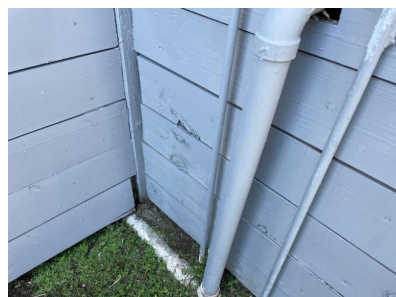
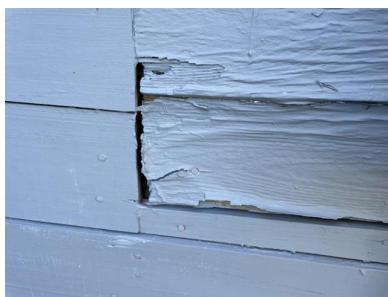
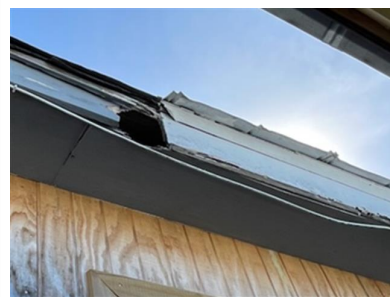
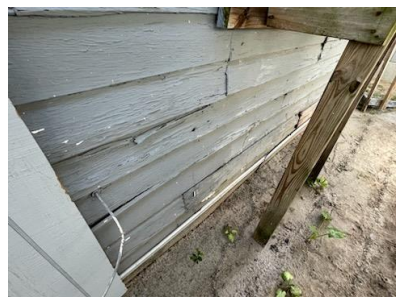
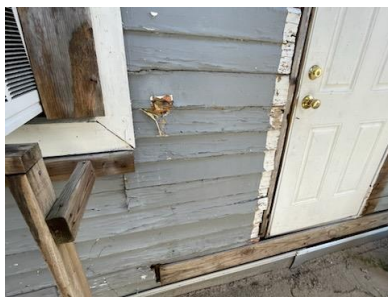
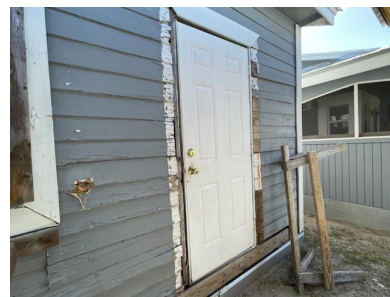
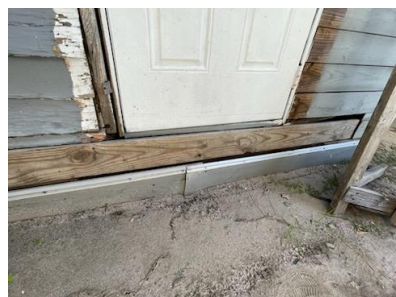
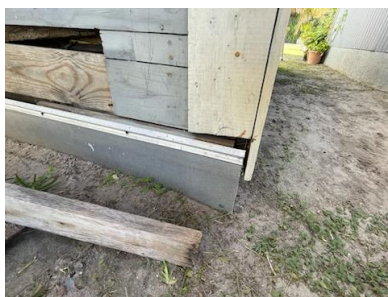
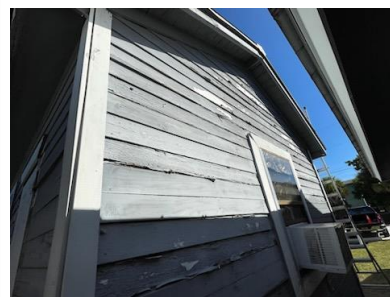
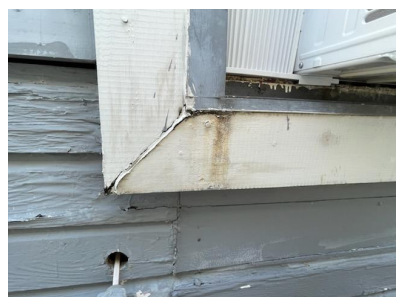
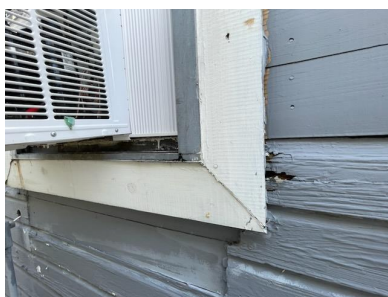
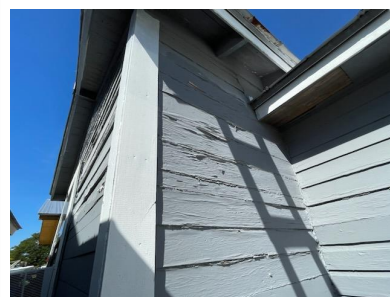
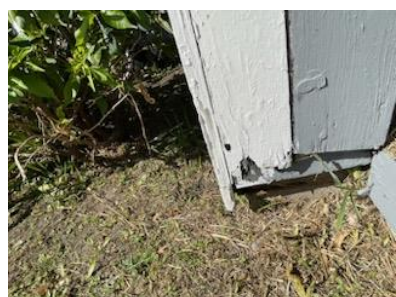
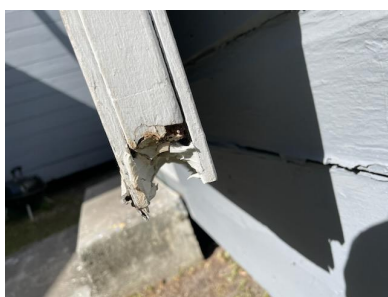
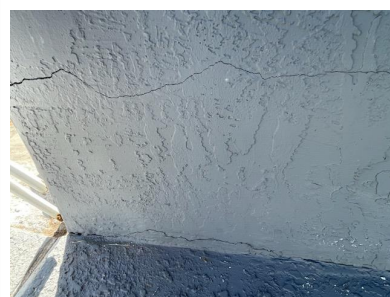
The exterior siding has deterioration of the wood in multiple locations at the right side building. This is allowing insects rodents access to the attic. The siding has staining in areas. The siding has settlement cracking in areas.

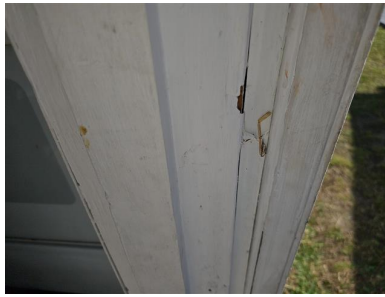
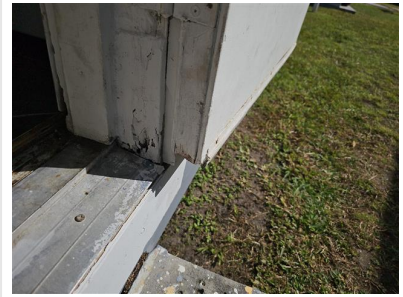
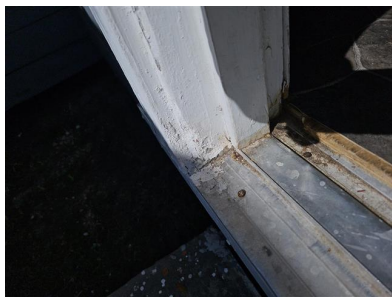
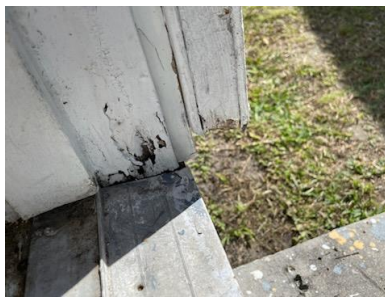
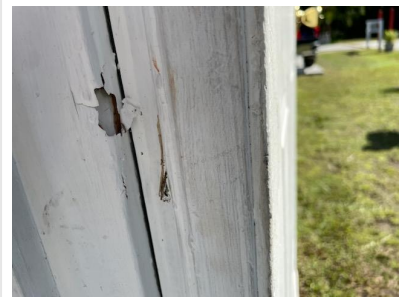
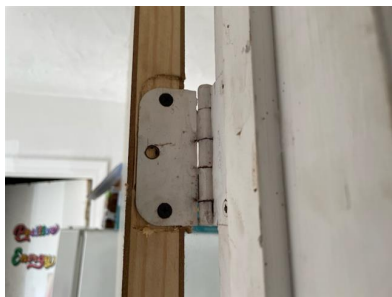
(1) The front right building left side unit front door frame has insect related damage. The door has deterioration of the wood. Multiple interior door were missing attachment screws in both duplexes.

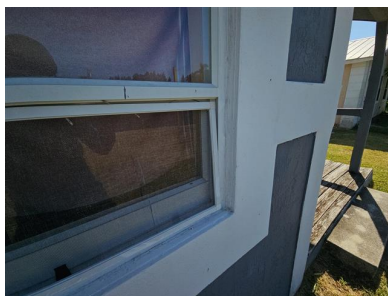
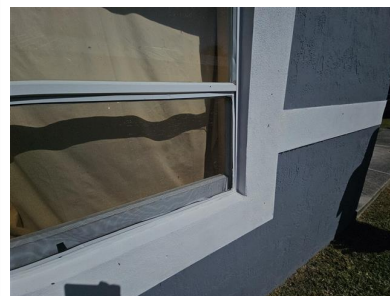
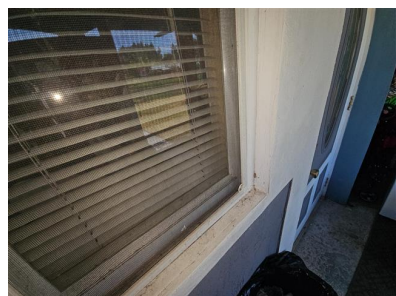
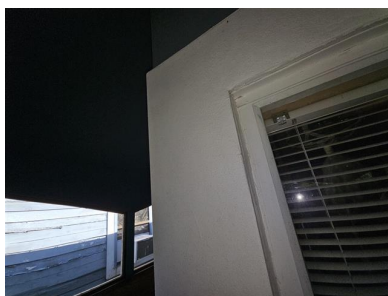
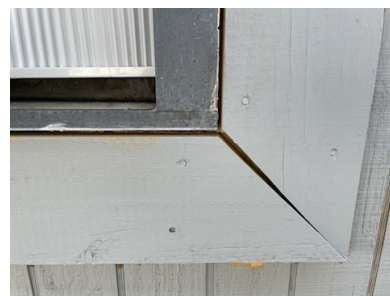
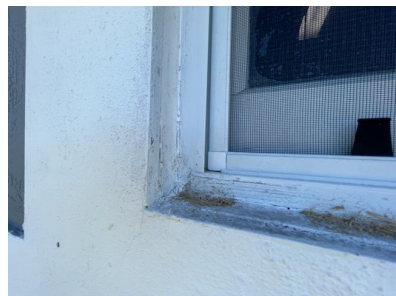
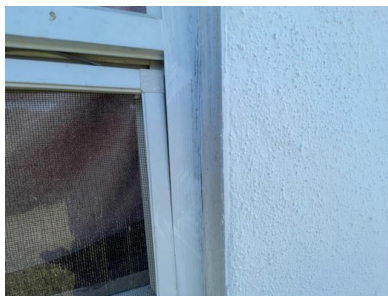
(1) The caulking around multiple exterior windows is missing in areas including but not limited too right and left side buildings. I recommend re-sealing to prevent moisture intrusion.

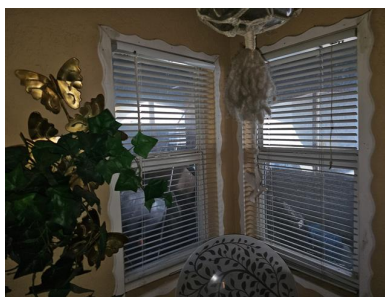
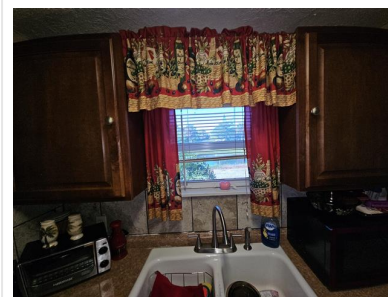
(2) Multiple exterior and interior windows were damaged at the time of the inspection and did not open. I recommend having all windows serviced in both buildings.

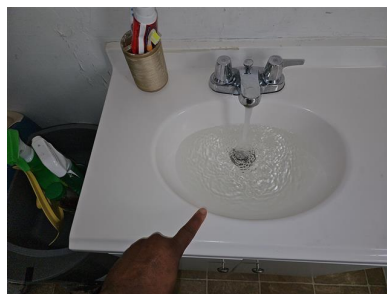
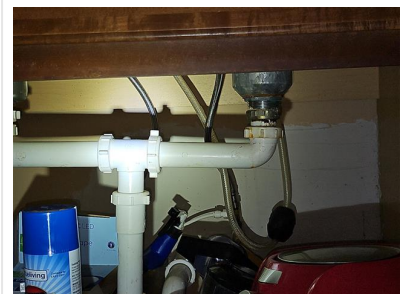
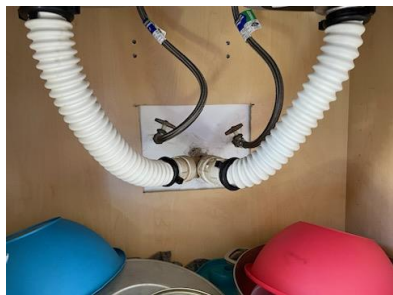
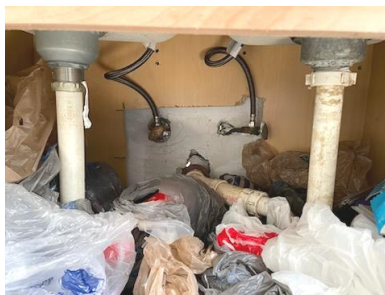
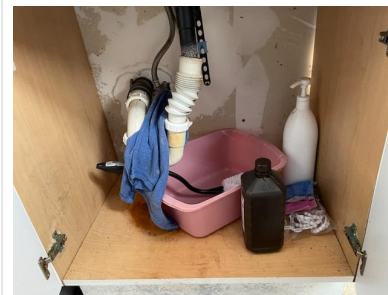
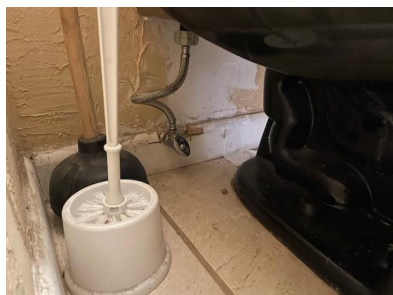
(3) Multiple bathroom in both duplexes drain lines have flex pipe installed. This plumbing tends to trap debris. The left side unit bathroom sink drains slow. Multiple interior plumbing drain lines and toilet supply lines have corrosion.

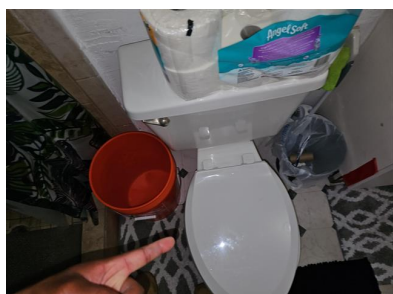
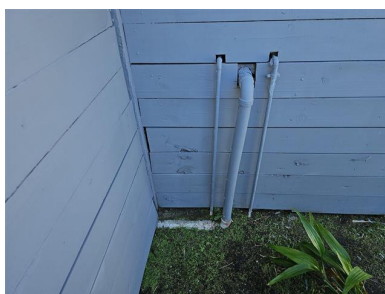
(4) The front right side building bathroom toilet flapper valve does not seal. The toilet continuous runs after toilet is flushed. The plumbing exiting home are not fully sealed at the wall.

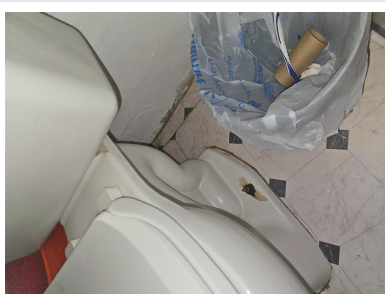
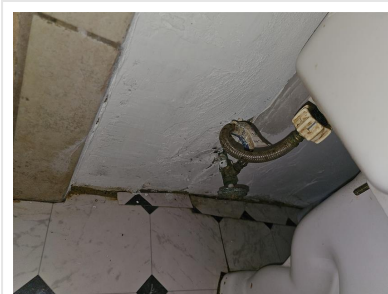
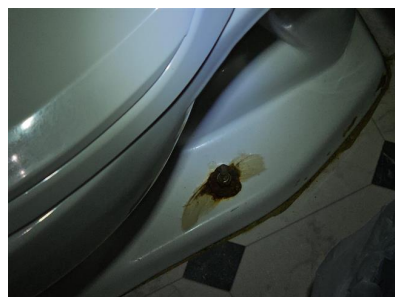
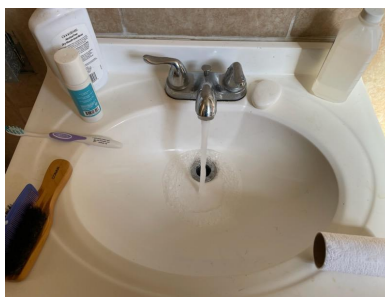
(5) The front right side unit sink stop did not function at the time of the inspection. The front right side unit toilet secure bolts have corrosion in areas. The toilet supply lines are in need of updating. Multiple sink stops were missing.

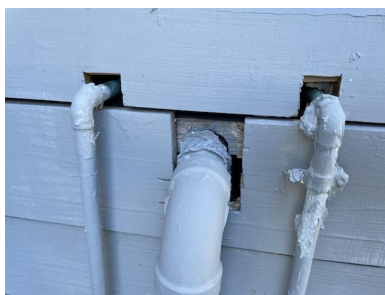
5.3 Item 6 (Picture)

(3) The front right building left side plumbing lines are not fully sealed at the wall. This is allowing moisture intrusion. The water pressure inside the left side building right unit was low at the time of the inspection.

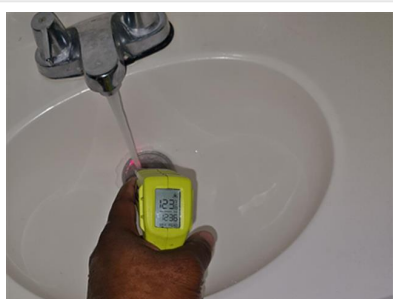
5.4 Item 1 (Picture)

(1) The hot water temperature 123 degrees. (Front Right Unit)

120 degrees Fahrenheit is the safety recommendation against scalding, but 140° is the common default setting. Most experts agree that anything below 120 degrees creates a risk for bacteria to develop inside your water heater from stagnant water, such as legionella that causes Legionnaire's disease.

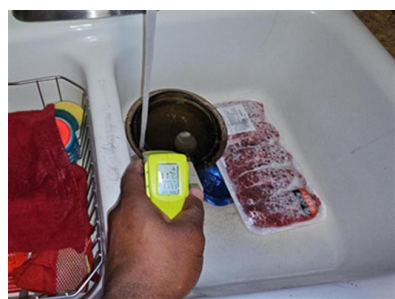
5.4 Item 2 (Picture)

(3) The hot water temperature 117 degrees. (Left Side Building Right Unit)

120 degrees Fahrenheit is the safety recommendation against scalding, but 140° is the common default setting. Most experts agree that anything below 120 degrees creates a risk for bacteria to develop inside your water heater from stagnant water, such as legionella that causes Legionnaire's disease.

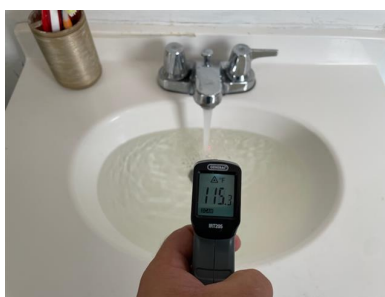
5.4 Item 4 (Picture)

(4) The hot water temperature 115 degrees. (Left Side Building Left Unit)
120 degrees Fahrenheit is the safety recommendation against scalding, but 140° is the common default setting. Most experts agree that anything below 120 degrees creates a risk for bacteria to develop inside your water heater from stagnant water, such as legionella that causes Legionnaire's disease.

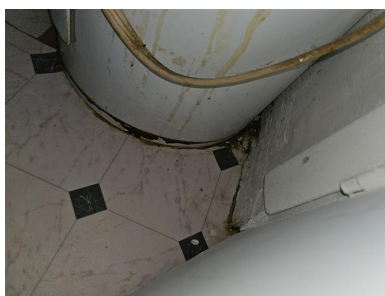
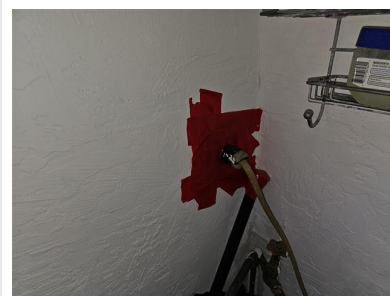
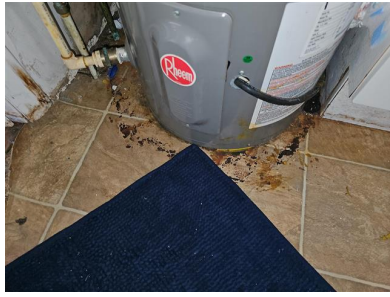
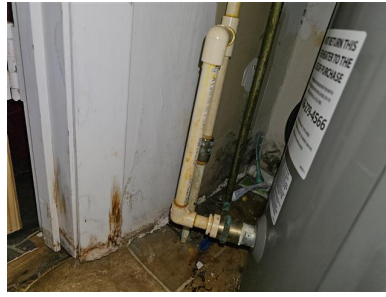
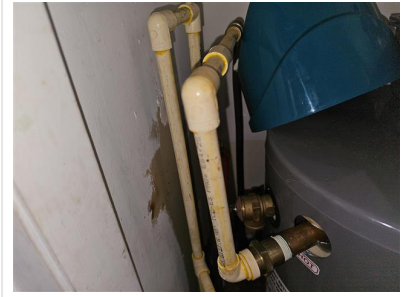
(6) The water heater overflow pans are missing at the right side building units. The water heaters have rust and corrosion at the bottom and top. The water main cord has been installed improperly and the wiring is not protected. Duct tape is used for support.

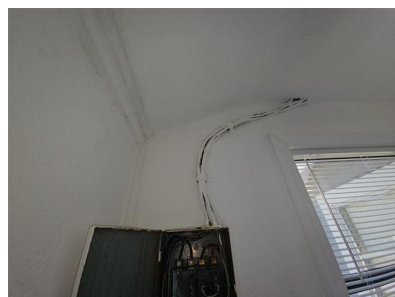
6.0 Item 1 (Picture)

(1) The main panel box and service disconnect are located in the master bedroom. (Left Side Building Right Unit)

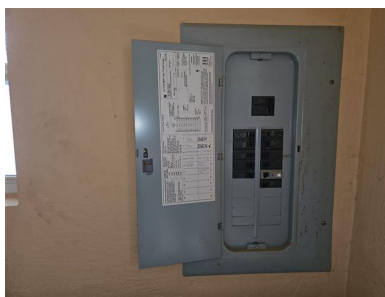
6.0 Item 2 (Picture)

(2) The main panel boxes and service disconnects are located inside the kitchen. (Right Side Building Unit)-(Left Side Building Unit)(Left Side Building Left Unit)

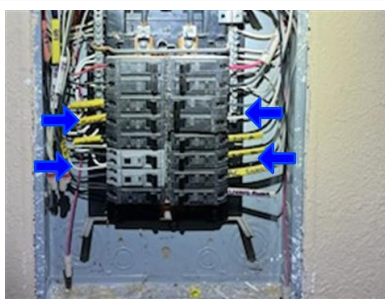
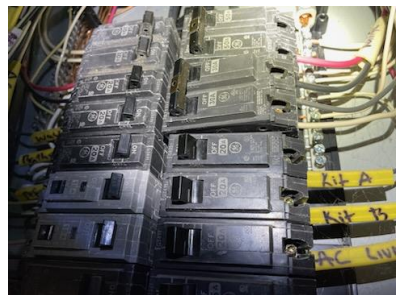
(2) The front right left unit and left side duplex right unit electrical panels have multiple loose circuit breakers. The panel was buzzing at the time of the inspection. Typical indication there's a potential short. I recommend further evaluation licensed electrician.

(3) Wiring is unprotected at multiple electrical panels. Wherever wiring can be damaged during normal day to day use should be protected in conduit. All electrical panels in both buildings do not have proper space requirements per code.

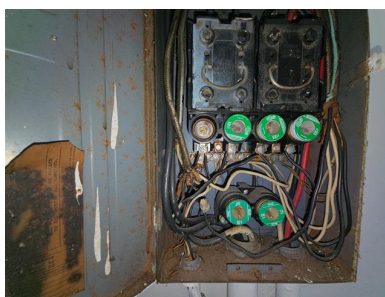
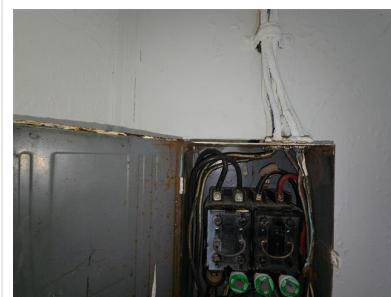
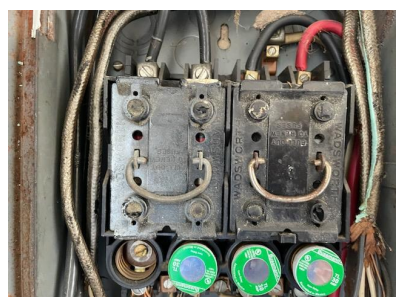
(4) I recommend replacement of the fuse panel located at the front right side unit, loose or damaged wiring, overloaded circuits, or a faulty electrical service. Solutions: Check for loose bulbs or fixtures. If the issue persists, consult an electrician to inspect your wiring and electrical service. They may need to replace damaged wiring or upgrade your electrical panel. Multiple neutrals and grounds were under the same lug. I recommend further evaluation by a licensed electrician.

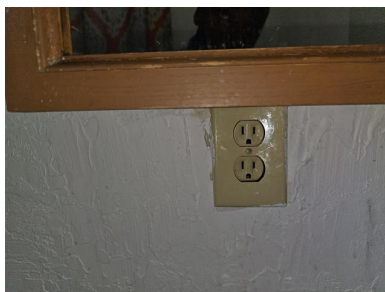
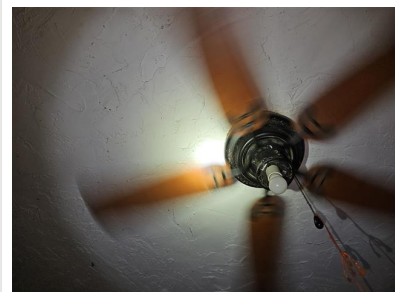
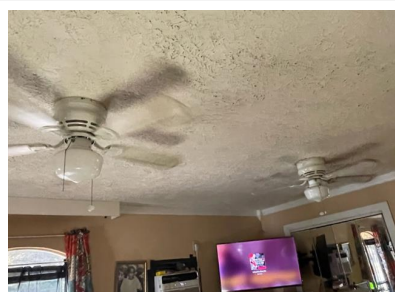
(2) The front right and left side units bedroom ceiling fans were out of balance. Multiple interior outlet junction boxes were loose inside the wall at the time of the inspection including but not limited too ,right building,left-right unit,left side building.

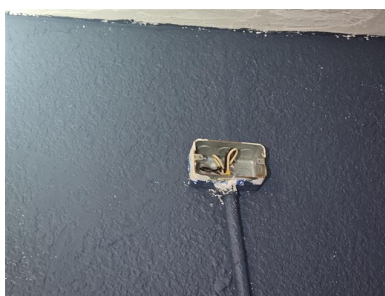
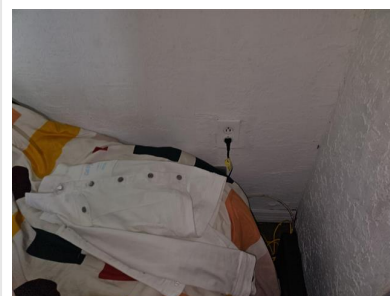
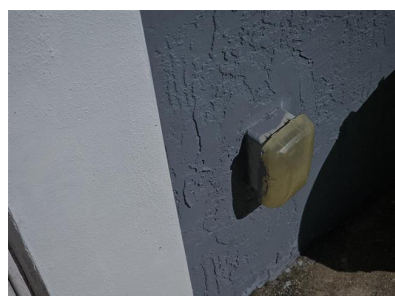
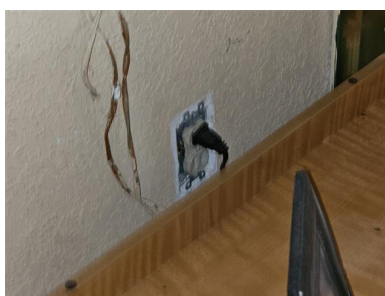
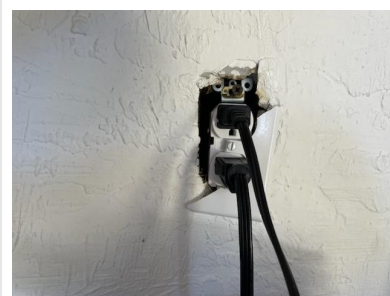
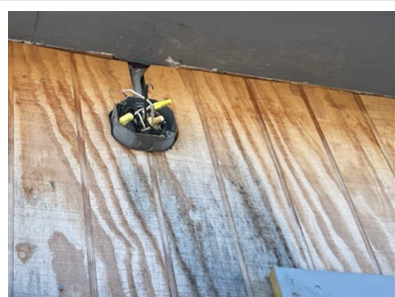
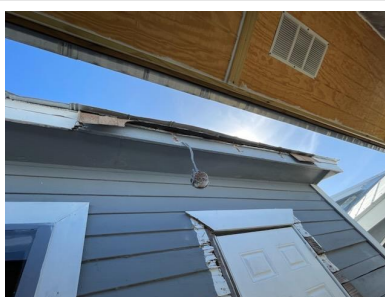
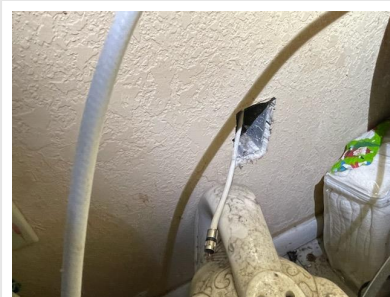
(3) Multiple interior and exterior outlet cover plates are missing. There was wiring exposed in multiple locations around the home including but not limited too interior, exterior. Multiple exterior outlet cover plates were damaged at the time of the inspection.

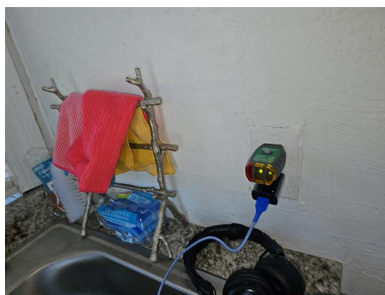
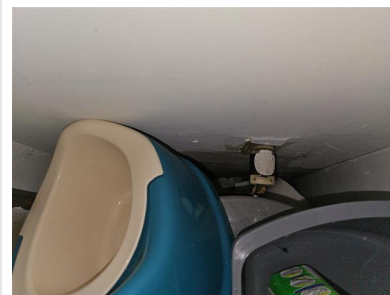
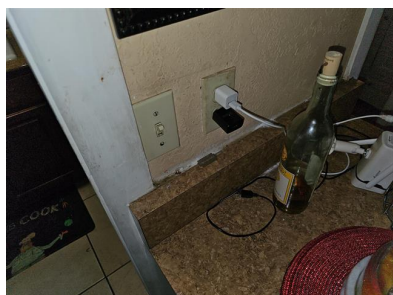
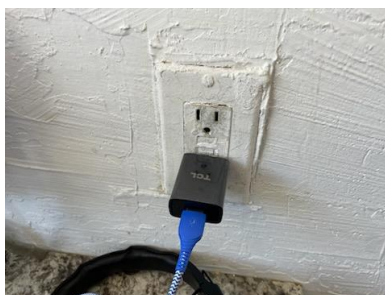
The kitchen and exterior and some of the bathroom outlets are not GFCI protected, are designed to prevent bodily harm from electrical faults that could cause electricity to flow through you to ground. When a GFCI breaker trips, it quickly disconnects the current flowing through an unintended ground path even if the amount of current is too small to trip a typical circuit break

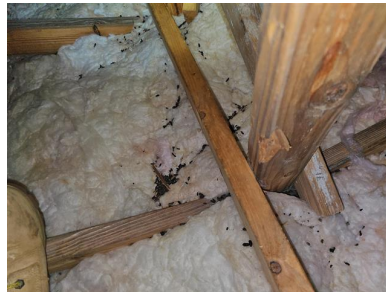
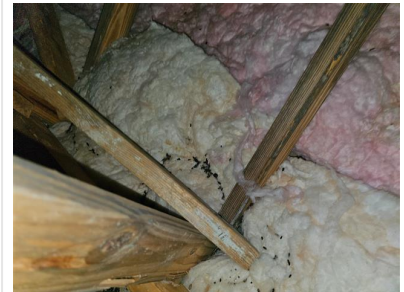
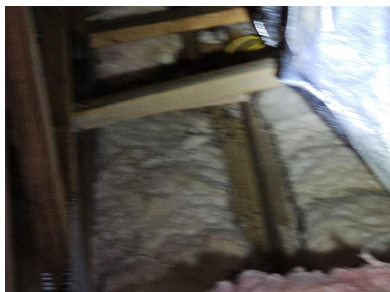
The left side building attic insulation is matted down with rodent feces in urine. I recommend further evaluation by a pest control company.

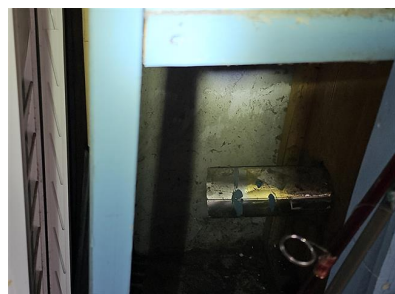
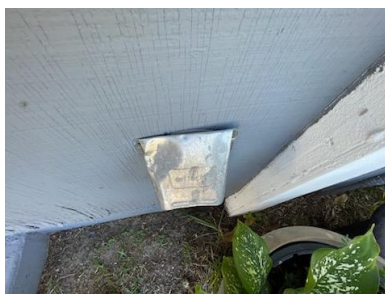
(2) The left side budling right side unit dryer vent was not attached at the time of the inspection. I recccomend servicing dryer vents in both units tomorrow

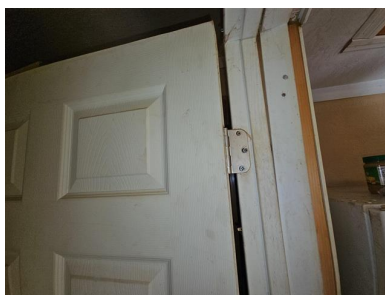
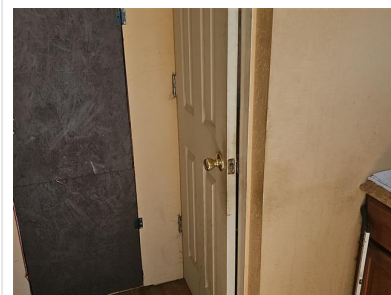
(1) The left side building left unit entry door was damaged and missing multiple door hinge attachment screws. The left side building left unit bathroom entry door was damaged.

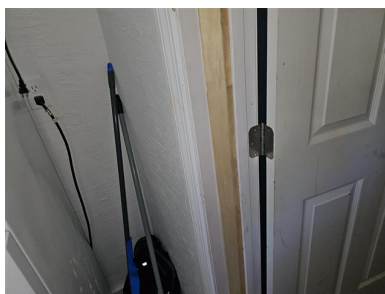
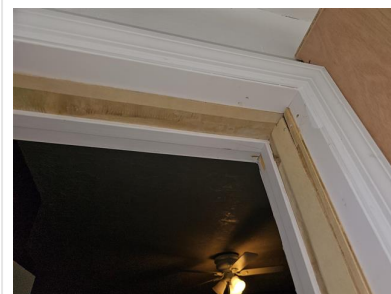
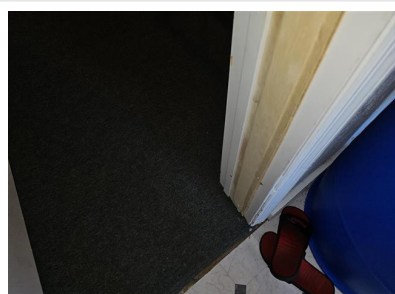
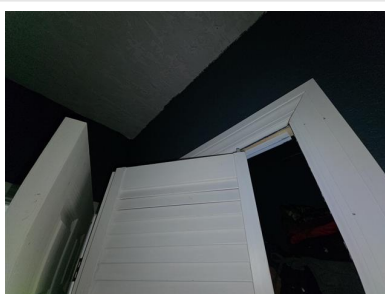
(2) The right side front unit bedroom entry door frame is improperly installed. The front right side unit bedroom closet pivot wheel is missing.

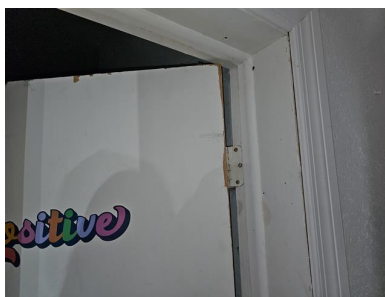
8.1 Item 10 (Picture)

(3) The front right side building left side unit bedroom entry door was damaged at the time of the inspection. The door is missing multiple attachment screws.

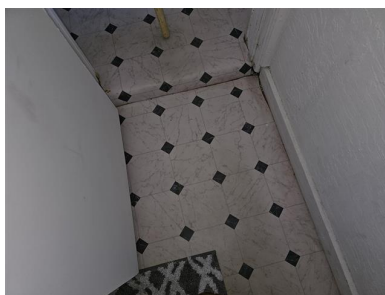
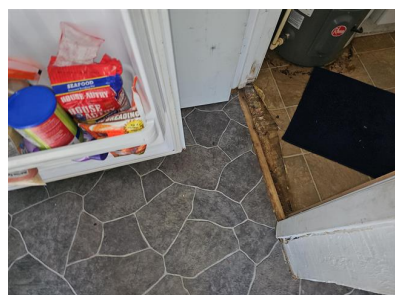
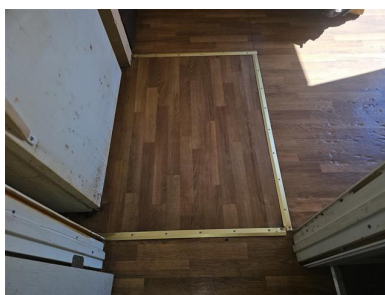
(2) The interior floors in the right side building have multiple soft spots. I recommend further evaluation. The sub floor has moisture damage. The vinyl flooring in the front right building left side unit is tearing in areas. There was active moisture at the time of the inspection.

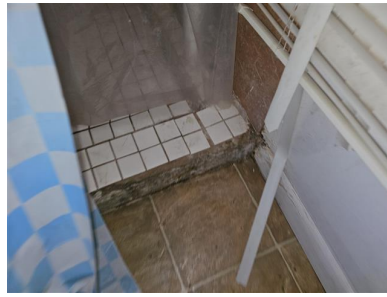
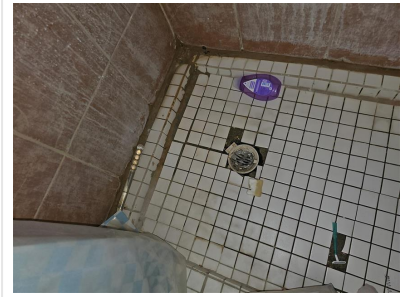
The front right duplex left side unit shower does not have a shower pan installed. Concrete shower enclosure is not code. Moisture is present underneath tiles. I recommend further evaluation. The shower's has grout missing in areas. Multiple tiles were damaged at the time of the inspection. The shower head was leaking. Multiple showers drain slow.

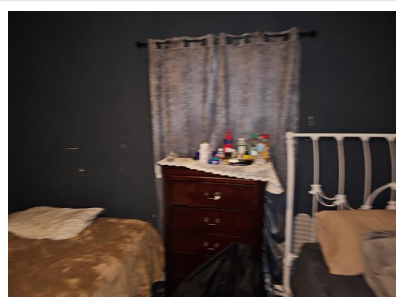
8.5 Item 1 (Picture)

I was unable to inspect the windows in both building due to renters personal items.

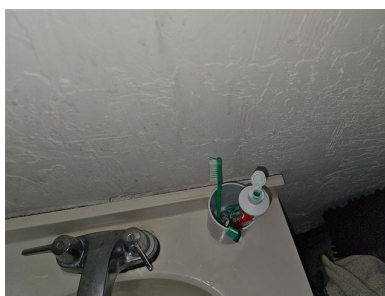
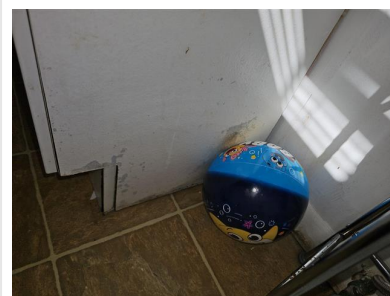
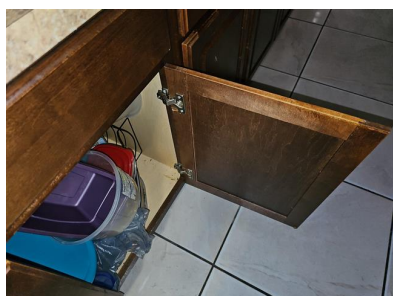
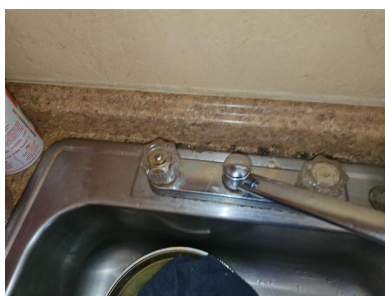
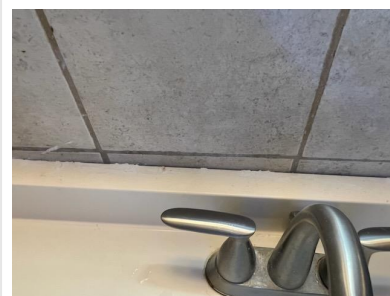
(2) Multiple kitchen and bathroom backsplash caulking was missing in areas. Multiple kitchen cabinets were not fully secured at the time of the inspection.

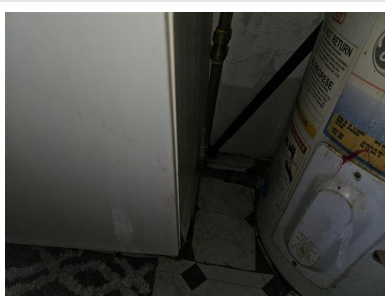
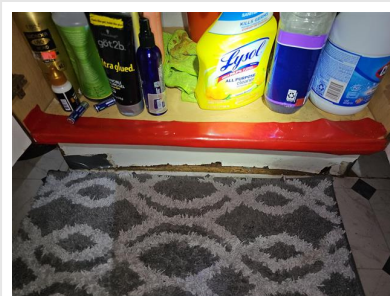
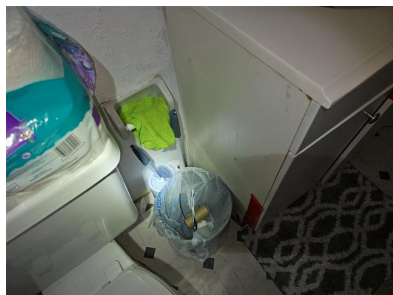
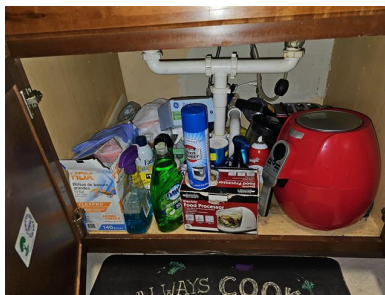
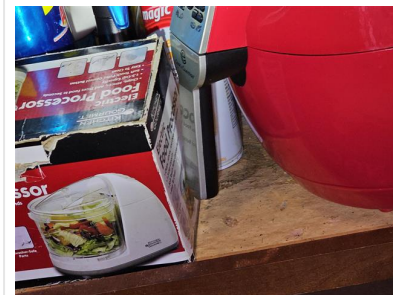
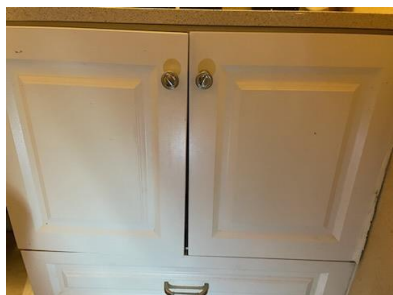
(3) The kitchen and bathroom cabinets and both right and left side duplex unit's have water damage. There was active moisture at the time of the inspection. Moisture can cause unseen damage. The cabinets are starting to cave in.
