Re: Construction Summary and Report of In-Place Density Testing

Fulton Hills - Stormwater Management Pond

Cecil County, Maryland

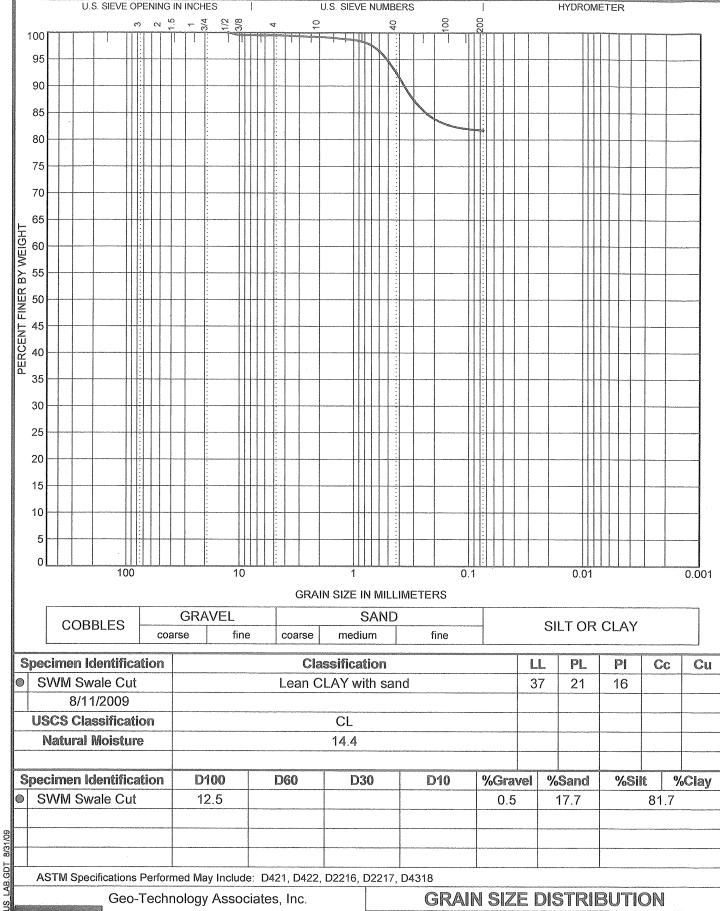
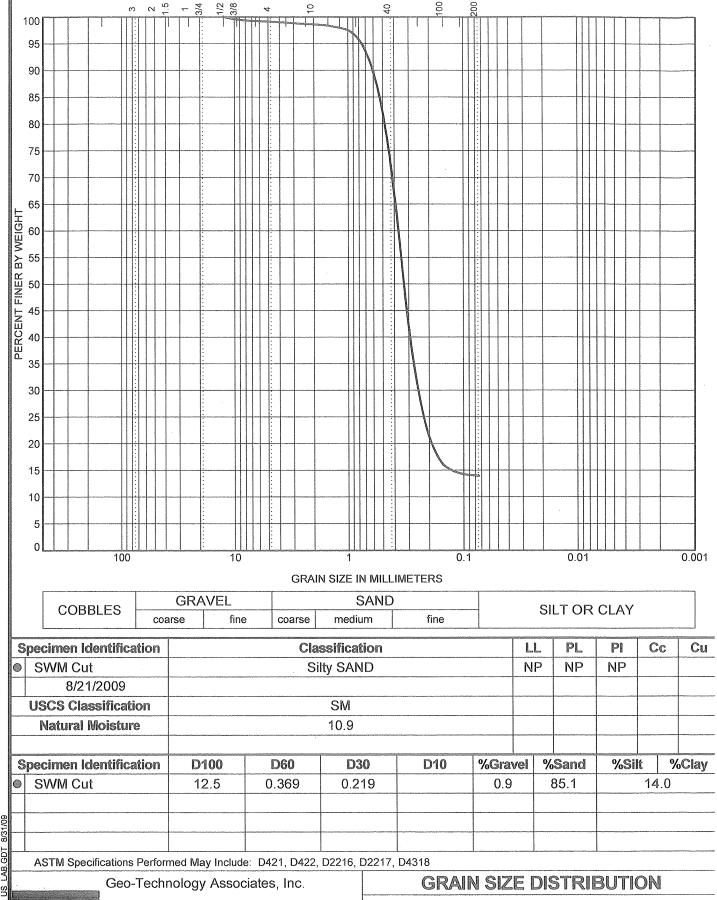
U.S. SIEVE NUMBERS

HYDROMETER

Test Results (#1 through #58) Moisture Density Relationship Curves (2) Grain Size Distribution Curves (2)
