WOOD DESTROYING PESTS AND ORGANISMS INSPECTION REPORT

Building No.	Street	City	Zip	Date of Inspection	Number of Pages
451	COLLEGE AVE. SANTA ROSA		95401	03-31-2025	12

General Description: TWO STORY COMMERCIAL BUILDING	Inspection Tag Posted: SUBAREA
	Other Tags Posted:

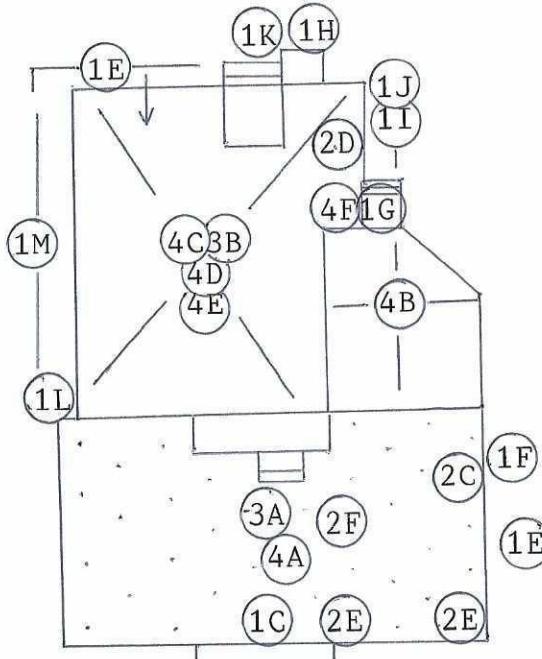
An inspection has been made of the structure(s) shown on the diagram in accordance with the Structural Pest Control Act. Detached porches, detached steps, detached decks and any other structures not on the diagram were not inspected.

THERE IS A CONCRETE BALCONY AT THE SECOND STORY PORTION OF THE BUILDING AT 1C ON THE DIAGRAM. THERE IS A DRAIN IN THE BALCONY. THERE WERE CRACKS NOTED. THE UNDER FRAMING IS INACCESSIBLE FOR INSPECTION DUE TO IT BEING ENCLOSED.

THERE WAS FUNGUS DAMAGE NOTED TO THE METER BOX AT 1E ON THE DIAGRAM. THERE WERE ALSO SIGNS OF DRYWOOD TERMITE INFESTATIONS NOTED IN THIS AREA.
