SURVEYOR'S REPORT

The purpose of this survey was to perform an ALTA/NSPS Land Title survey of the parcel owned by 7260 Georgetown Road, LLC and recorded as Instrument Number A201800025600 in the Office of the Recorder of Marion County. Information and data used to perform this survey includes, but is not limited to, the following: the deeds and/or plats of the subject property and adjoining properties, reference surveys completed by the undersigned and others in the vicinity of the surveyed property and monuments and physical evidence found as shown on the plat of the survey.

The survey was prepared by Jacob T. Hoffman, Weihe Engineers, 10505 N. College Avenue, Indianapolis, Indiana 46280.

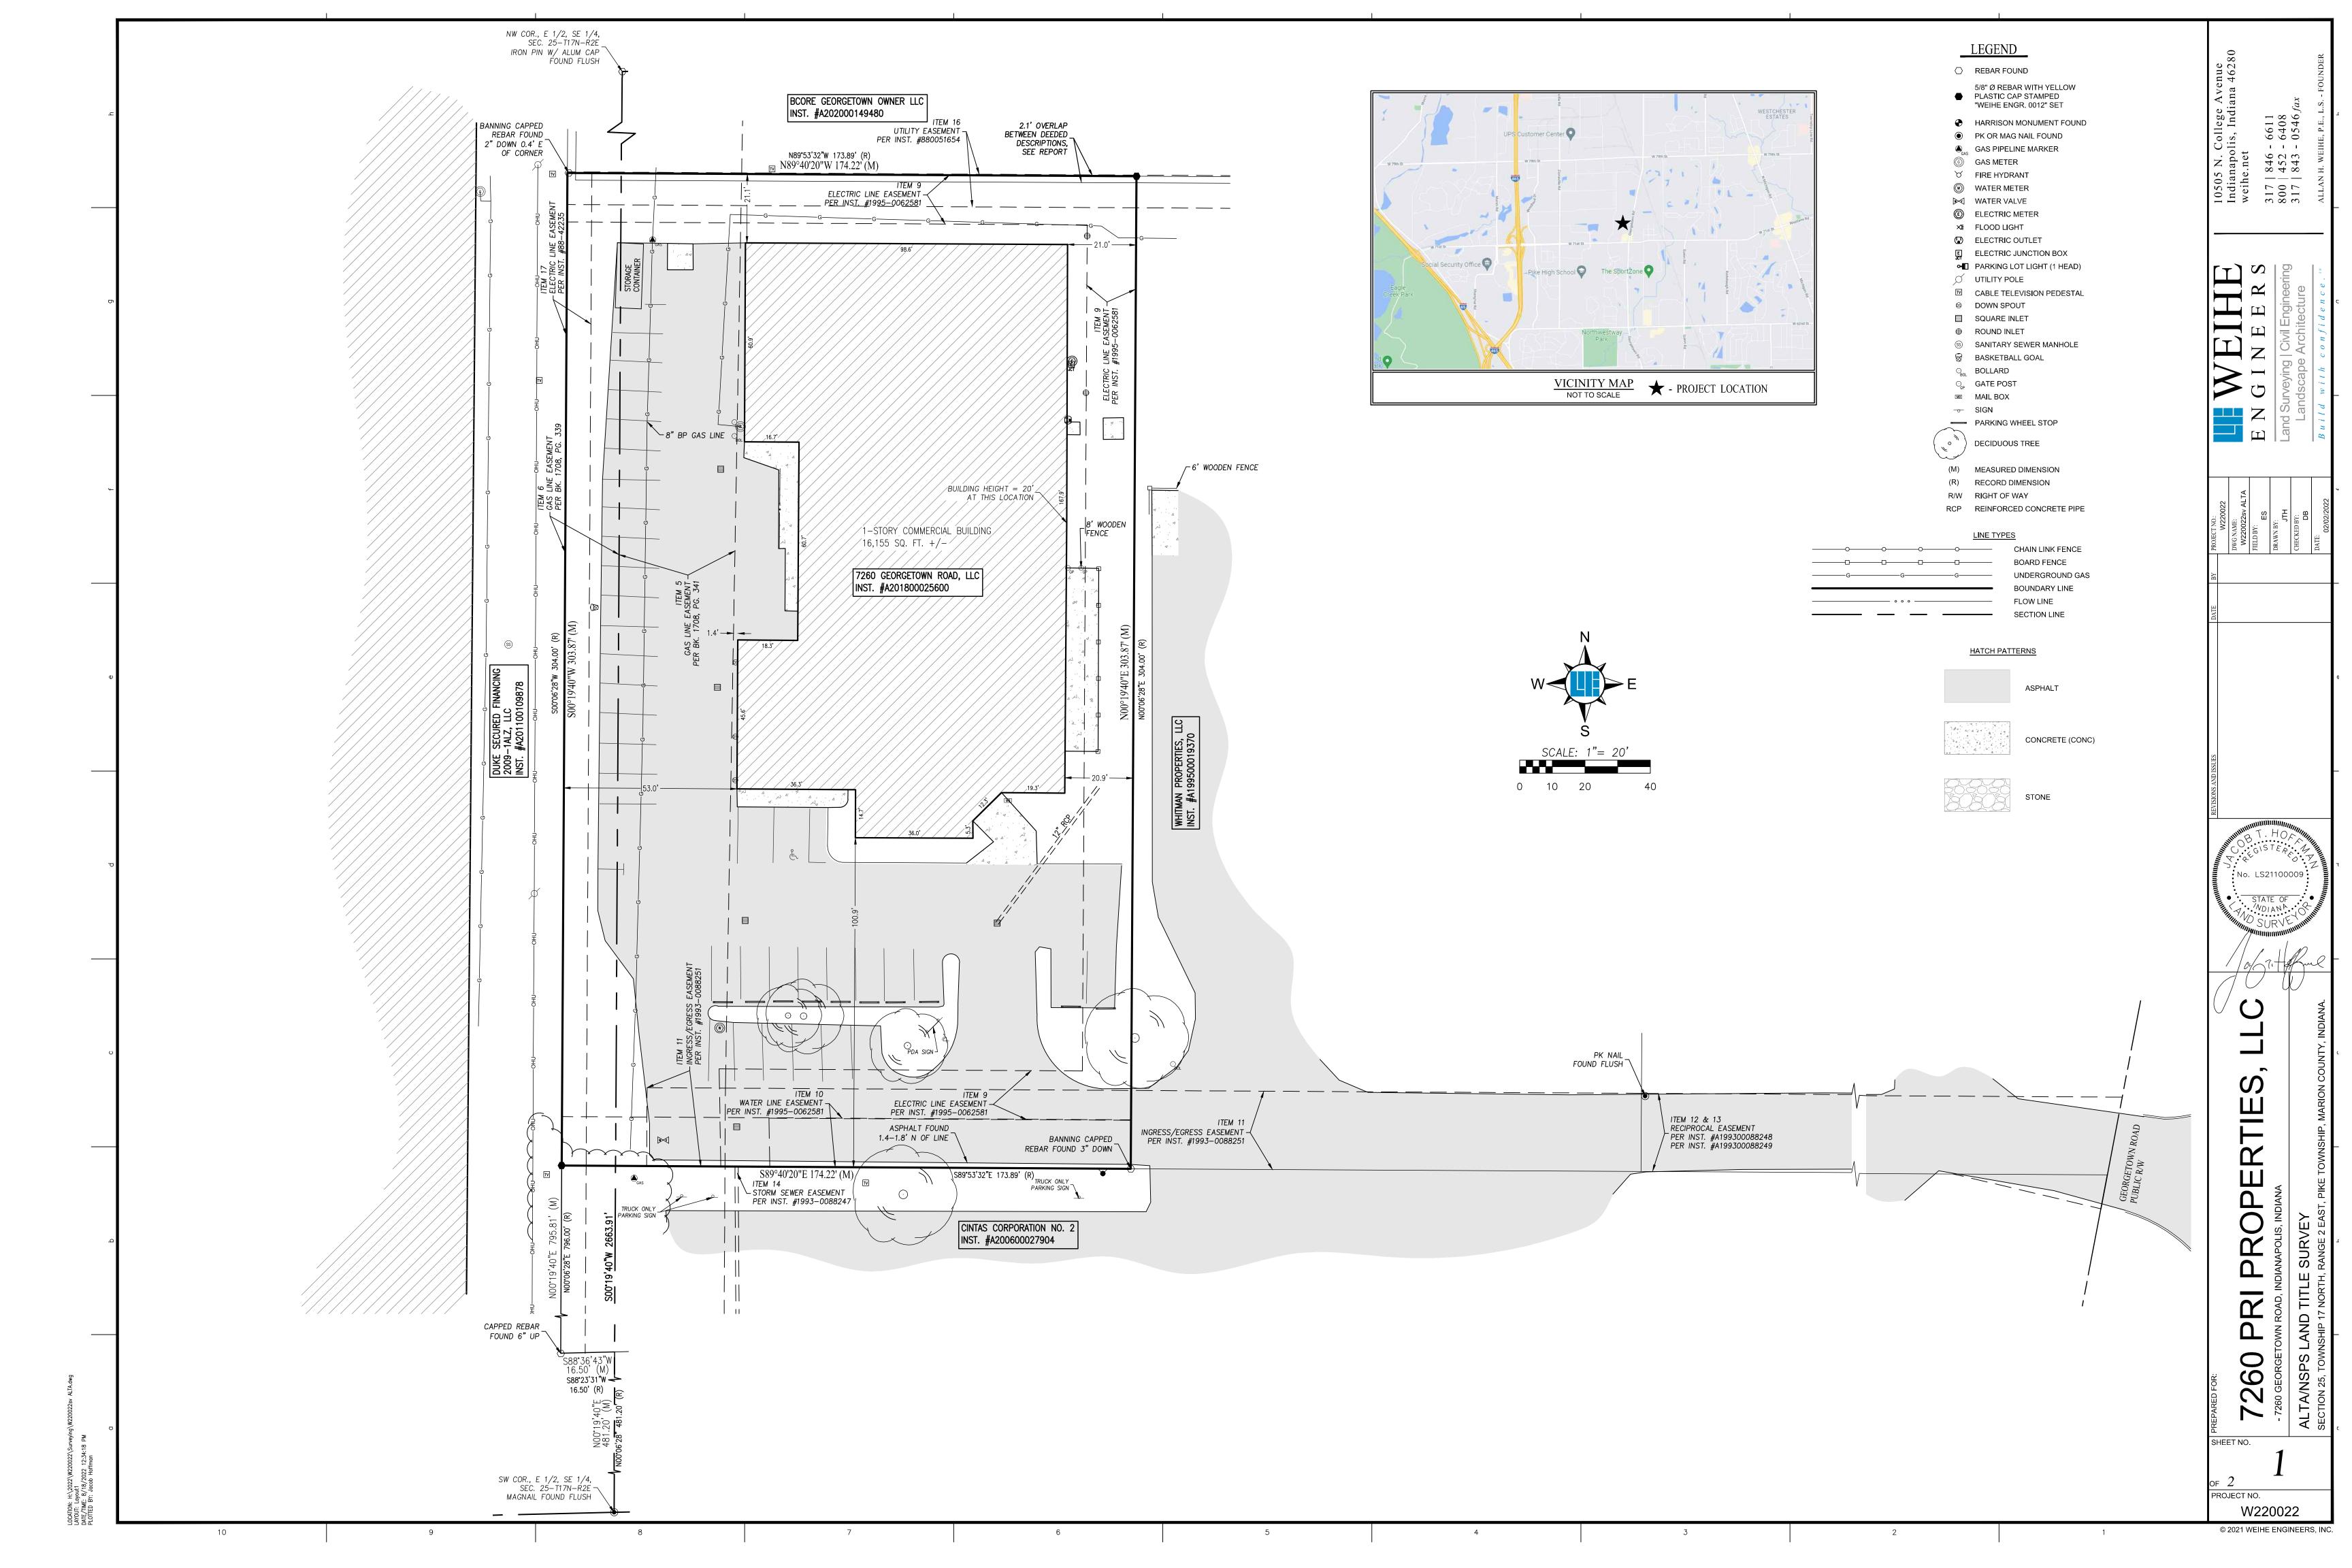
The location of the lines and corners of the subject tract are dependent upon the geometric data shown and the monuments found, accepted, and/or located with this survey. Those monuments shown with no variation were found to be within 0.3 feet of the computed position and it is the undersigned's opinion that their variations do not need to be addressed.

All additional monuments shown on the plat of survey were found without any reference to their origin and were not held this survey. All monuments found were found flush with the ground surface unless otherwise noted.

There may be differences of deed (D) or platted (P) dimensions versus measured (M) or calculated (C) dimensions along the surveyed lines shown hereon and, likewise, survey markers may be found near, but not precisely at, some title corners. In cases where the magnitude of this difference is less than the Relative Positional Accuracy (stated below) and/or less than the uncertainty identified for the reference monumentation (discussed below), the difference may be considered insignificant and is shown only for the purposes of mathematical closure. Such differences that are greater than the Relative Positional Accuracy and/or the uncertainty in reference monumentation shall be considered worthy of notice and are therefore discussed further below.

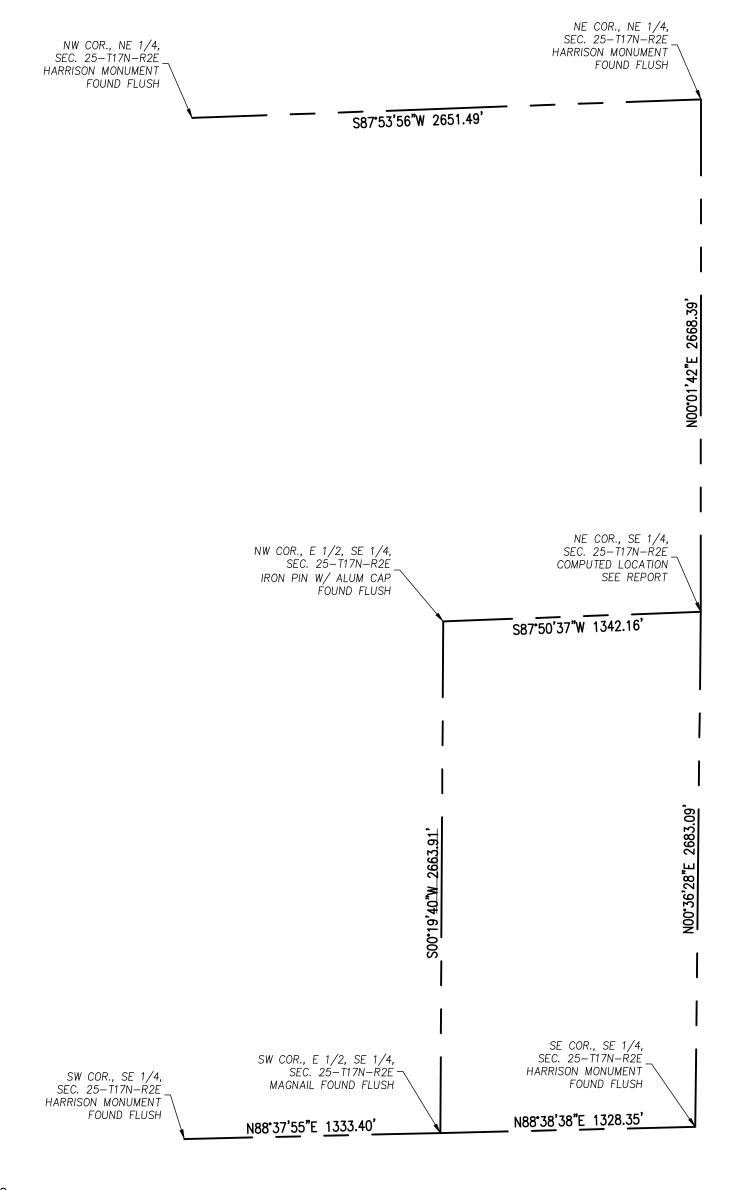
SECTION DETAIL

A Harrison Monument was found flush and in good, stable condition at the Southwest Corner of the Southeast Quarter of Section 25, Township 17 North, Range 2 East. The MCSO Tie Sheet stated that the Harrison was set in place of a frost pin at the corner in 1990 and the measured coordinates of the monument matched the published coordinates shown on the tie sheet within 0.1 feet. Reference Surveys A, E, H, and I called for a Harrison Monument found at this corner and the monument measured within 0.1 feet of its computed location shown on the reference survey. Reference Surveys F and G called for a Harrison Monument found at this corner and the monument measured within 0.2 feet of its computed location shown on the reference survey. Based upon this evidence the monument was held as the corner. The estimated uncertainty for this corner is 0.3 feet.

A Harrison Monument was found flush and in good, stable condition at the Southeast Corner of the Southeast Quarter of Section 25, Township 17 North, Range 2 East. The MCSO Tie Sheet stated that the Harrison was set over a stone found at the corner in 1997 and the measured coordinates of the monument matched the published coordinates shown on the tie sheet within 0.3 feet. Reference Surveys A, H and I called for a Harrison Monument found at this corner and the monument measured within 0.1 feet of its computed location shown on the reference surveys. Reference Survey E called for a pk nail set per MCSO ties at this corner and the monument measured within 0.2 feet of the nail's computed location shown on the reference survey. Reference Surveys F and G called for a monument found at this corner and the monument measured within 0.1 feet of its computed location shown on the reference survey. Based upon this evidence the monument was held as the corner. The estimated uncertainty for this corner

A Harrison Monument was found flush and in good, stable condition at the Northeast Corner of the Northeast Quarter of Section 25, Township 17 North, Range 2 East. The MCSO Tie Sheet stated that the Harrison was set in place of a brass plug found at the corner in 1989 and the measured coordinates of the monument matched the published coordinates shown on the tie sheet within 0.1 feet. Based upon this evidence the monument was held as the corner. The estimated uncertainty for this corner is 0.3 feet.

A Harrison Monument was found flush and in good, stable condition at the Northwest Corner of the Northeast Quarter of Section 25, Township 17 North, Range 2 East. The MCSO Tie Sheet stated that the Harrison was set over a stone found at the corner in 2015 and the measured coordinates of the monument matched the published coordinates shown on the tie sheet within 0.1 feet. Based upon this evidence the monument was held as the corner. The estimated uncertainty for this corner is 0.3 feet.

A magnail was found flush and in good, stable condition at the Southwest Corner of the East Half of the Southeast Quarter of Section 25, Township 17 North, Range 2 East. The MCSO Tie Sheet stated that a survey mark nail was over brass plug found at the corner in 2012 and the measured coordinates of the monument matched the published coordinates shown on the tie sheet within 0.1 feet. Reference Surveys A, E, and H computed this location by holding the midpoint of the south line of the guarter and was found to compute 2.6 feet west and 0.2 feet south of the nail. Reference Surveys B, C, and D called for a pk nail found at this corner and the nail measured within 0.1 feet of its computed location shown on the reference surveys. Reference Surveys F and G computed this location by holding the midpoint of the south line of the quarter and was found to compute 2.4 feet west and 0.2 feet south of the nail. Reference Survey I stated that the corner had been obliterated by construction and computed this corner based upon boundary surveys in the area and recovered monuments. The computed location shown on the reference survey computed within 0.2 feet of the measured location of the nail. Based upon this evidence the nail was held as the corner. The estimated uncertainty for this corner is 2.5 feet.

A MCSO capped rebar was found flush and in good, stable condition at the Northwest Corner of the East Half of the Southeast Quarter of Section 25, Township 17 North, Range 2 East. The MCSO Tie Sheet stated that a MCSO capped rebar was set at corner in 2012 based upon information shown on previous surveys and the measured coordinates of the monument were found to lie 0.9 feet west and 0.6 feet south the published coordinates shown on the tie sheet. Reference Surveys A, E, and H computed this location by holding the midpoint of the south line of the quarter and was found to compute 9.6 feet east and 6.1 feet north of the nail. Reference Surveys B, C, and D called for a rebar found at this corner but did not dimension the line, so the rebar's location could not be computed from these surveys. Reference Survey I stated that the corner had been obliterated by construction and computed this corner based upon boundary surveys in the area and recovered monuments but did not dimension the line, so the corner's location could not be computed from this survey. Based upon this evidence the rebar was held as the corner. The estimated uncertainty for this corner is 1.5 feet.
