**SB 721 EXTERIOR EXPOSED ELEMENT (EEE) INSPECTION REPORT**

FACILITY ADDRESS: 891-899 BELL DRIVE LAFAYETTE CA 94549

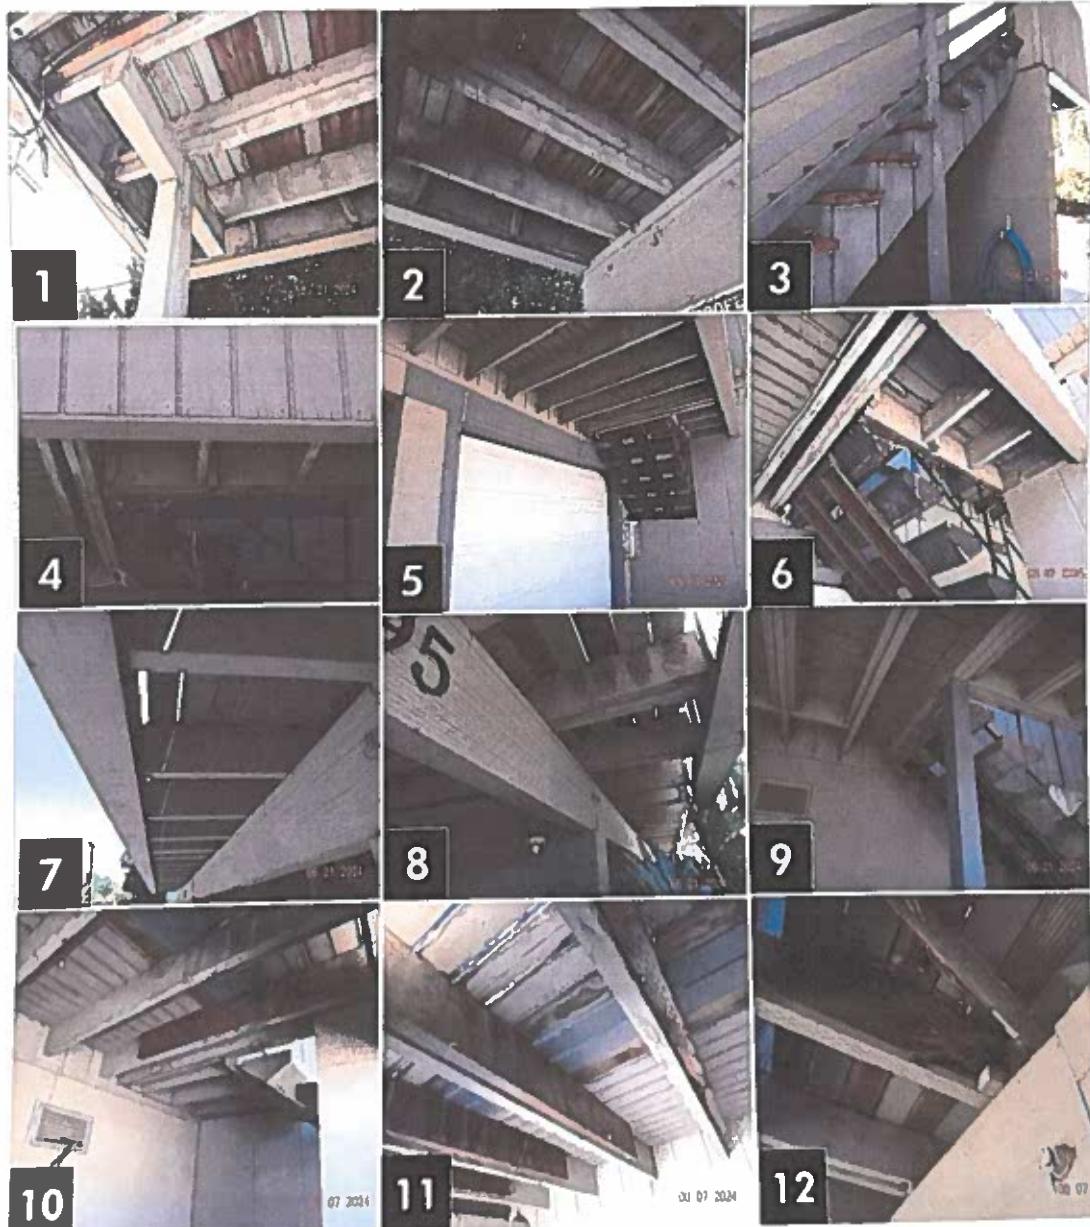
EEE FACILITY ADDRESS: 891-899 BELL OR LAFAYETTE CA
SITE PLAN WITH PHOTO LOCATIONS

- 1 ENTRY LANDING BLOWING RE-PLACED DECKING. POORLY SISTERED JOISTS (REPLACEMENT REQUIRED)
- 2 ENTRY LANDING WITH POORLY CONSTRUCTED SISTERED JOISTS (REPLACEMENT REQUIRED)

- 3 ACCESS STAIRS. NO HANDRAIL. TREADS DEGRADED (REPLACEMENT REQUIRED - COMPLIANT WITH FHA & ADA)
- 4 NO VISIBLE FLASHING FOR PARALLEL GUARD RAIL. BLOWING SIGNS OF WEATHERING (REPLACEMENT REQUIRED)

- 5 CANTILEVER JOISTS. MASONRY NEW SISTERED JOISTS AS NEEDED WITH JOIST TOPS OR END SHOW DETERIORATION (SISTERED JOISTS ADDED AS REQUIRED)
- 6 FRAMING COMBINATIONS DEGRADE (REPAIR WORK INSUFFICIENT) (REFRAME / REPLACE JOISTS AS REQUIRED)

- 7 CANTILEVER JOISTS. MASONRY NEW SISTERED JOISTS AS NEEDED WITH JOIST TOPS OR END SHOW DETERIORATION (SISTERED JOISTS ADDED AS REQUIRED)
- 8 REPAVED / SISTERED JOISTS. NO HANLDR. GEAR FLASHING VISIBLE (REPLACE JOISTS AS REQUIRED, REFLASH)

- 9 REPAVED / SISTERED JOISTS. VISIBLE MASONRY PROTECTIVE FLASHING VISIBLE (REFRAME AND REPLACE JOISTS AS REQUIRED)
- 10 DECK PLANKING BOARDS RE-PLACED. EXISTING JOISTS HAVE NO VISIBLE FLASHING (REFRAME / REPLACE FRAMING AS REQUIRED)

- 11 REPAVED / SISTERED JOISTS. NO STRUCTURAL DECK PLANKING SHOW DETERIORATION (REPLACEMENT REQUIRED)
- 12 DEGRADATED JOISTS. STRUCTURAL FAILURE. DECK PLANKING BOARDS WEAKED & JUST TIGHT FOR INVESTIGATION (REPLACEMENT REQUIRED ASAP) (DECK 6 FT ABOVE GRADE AT LOCATION)

① **PRIMARY PATH OF EXGRESS** ALL BALCONIES AND DECKS OF THIS MULTI-FAMILY FACILITY ARE PRIMARY PATH OF EXGRESS AND THUS REQUIRE EXTRA DILIGENCE TO ASSURE A SAFE AND SOUND STRUCTURE. VISUAL NON-DESTRUCTIVE INSPECTION OF BALCONIES (CAN'T EVER FIND DECKS/LEDGER/R/SIMPLY SUPPORTED) DECKS DO NOT EXHIBIT DANGEROUS CONDITIONS OF STRUCTURAL FAILURE EXCEPT AS NOTED IN NOTE ⑩ - HOWEVER, DUE TO LACK OF PROPER FLASHING AND WEATHERPROOFING SEE PHOTOS 1 2 3 6 9 10

⑤ **REPLACEMENT RECOMMENDATION** REPLACE DECK PLANKING, VERIFY CONDITION OF EXISTING CANTILEVER JOISTS FOR BALCONY - SISTERING JOISTS AS NEEDED WITH PT - SEE PHOTOS 1 2 11 12
