**HISTORIC PRESERVATION CERTIFICATION APPLICATION  
PART 2 – DESCRIPTION OF REHABILITATION**

**NPS Project Number**  
44478

**1. Historic Property Name** Flint Mill No. 2 – Burlington Industries, Inc. Plant

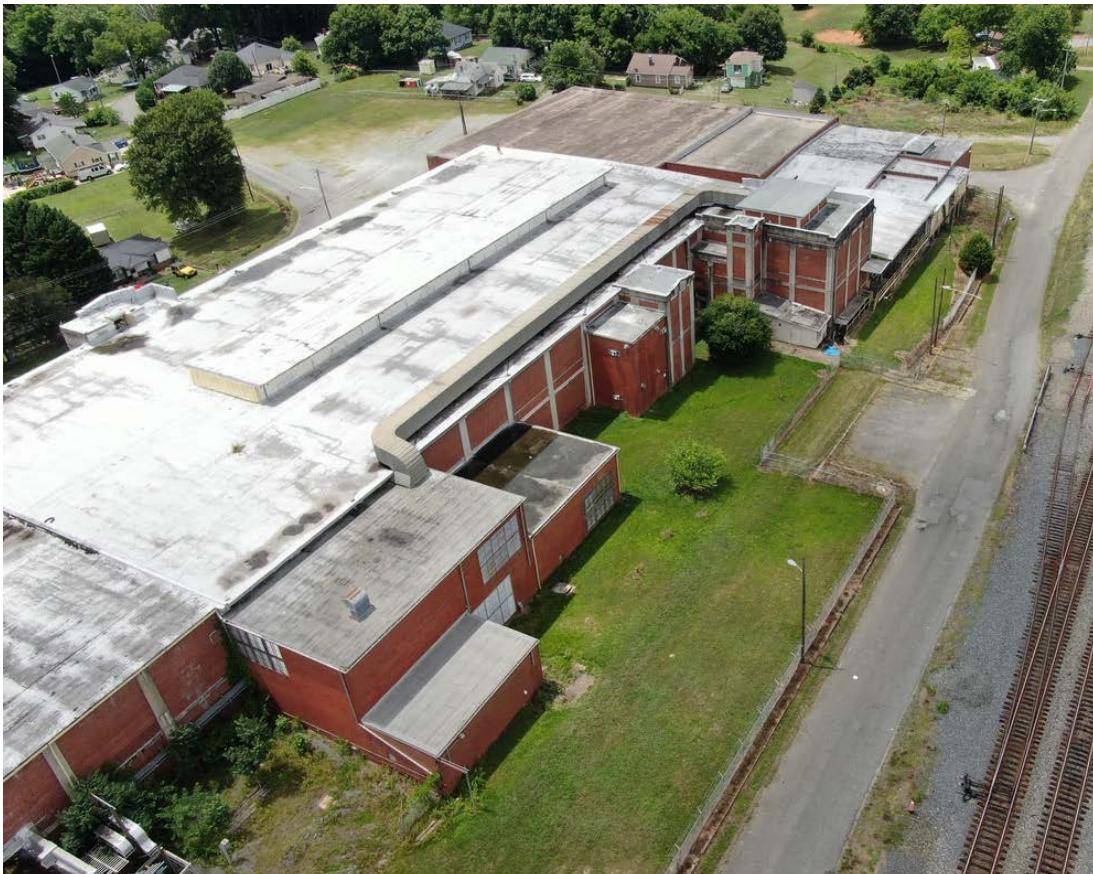
Looking southwest (above)  
Daniel Morton, photographer  
June 23, 2021

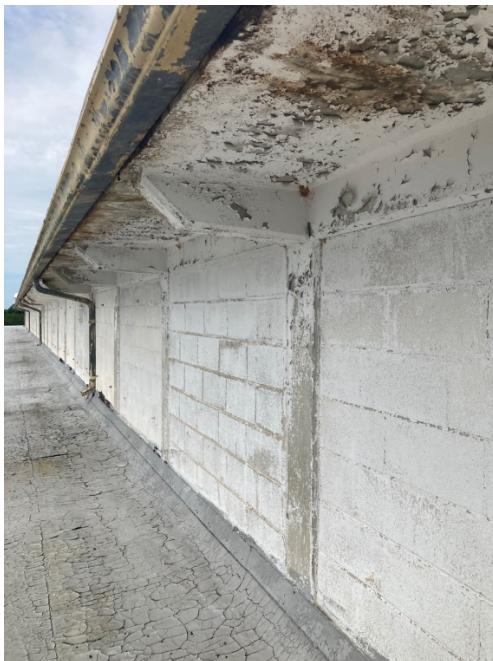
Rectangular roof monitor, north elevation (left)  
Sarah McInerney, photographer, August 2, 2022

Load-bearing walls and original exterior window and door openings will be maintained throughout the building. The brick will be thoroughly cleaned and repaired as needed. All brick walls that were originally painted will be repainted. Kalamein doors will either be fixed in the open position or removed and rehung near their original locations. The original ceiling height will be preserved to the greatest possible extent. Concrete and steel columns, posts, beams, and wood roof decking will remain exposed. The reopened roof monitor will illuminate the 1923 second story.

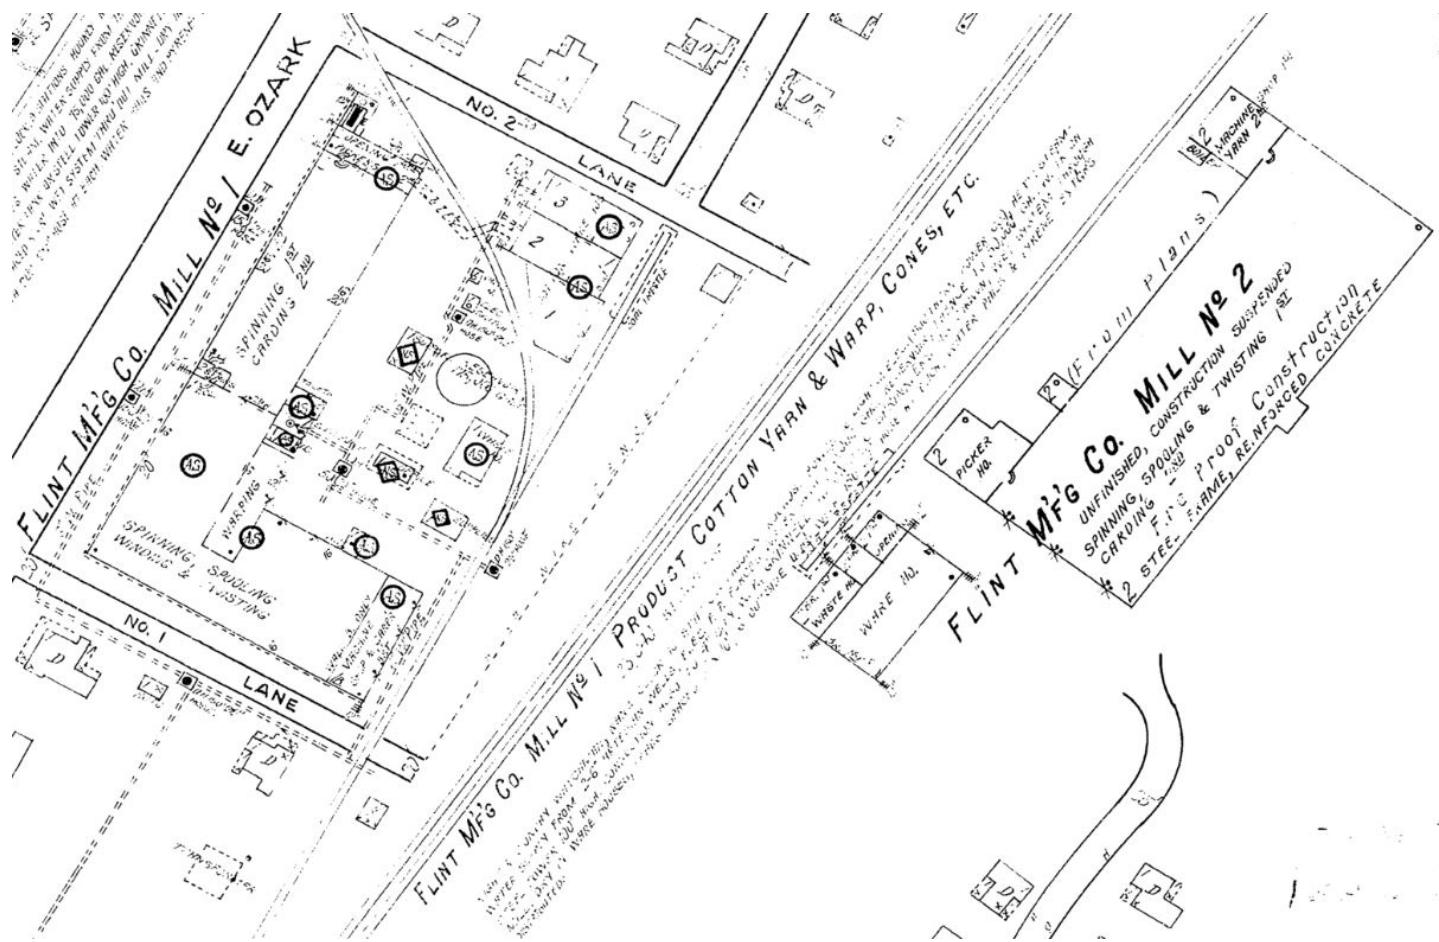
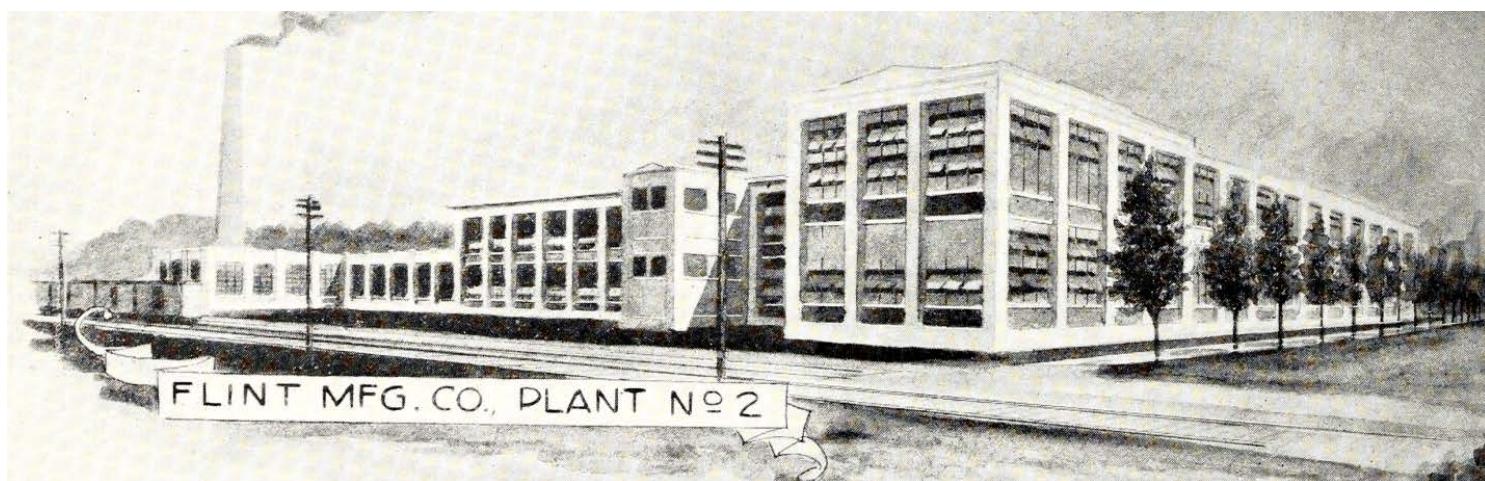
Sanborn Map Company, "Gastonia," June 1922, Sheet 28 (above)

Flint Mill No. 2, northwest oblique, "Gray-Separk Group of Mills," *Southern Textile Bulletin*, 1923 (below)

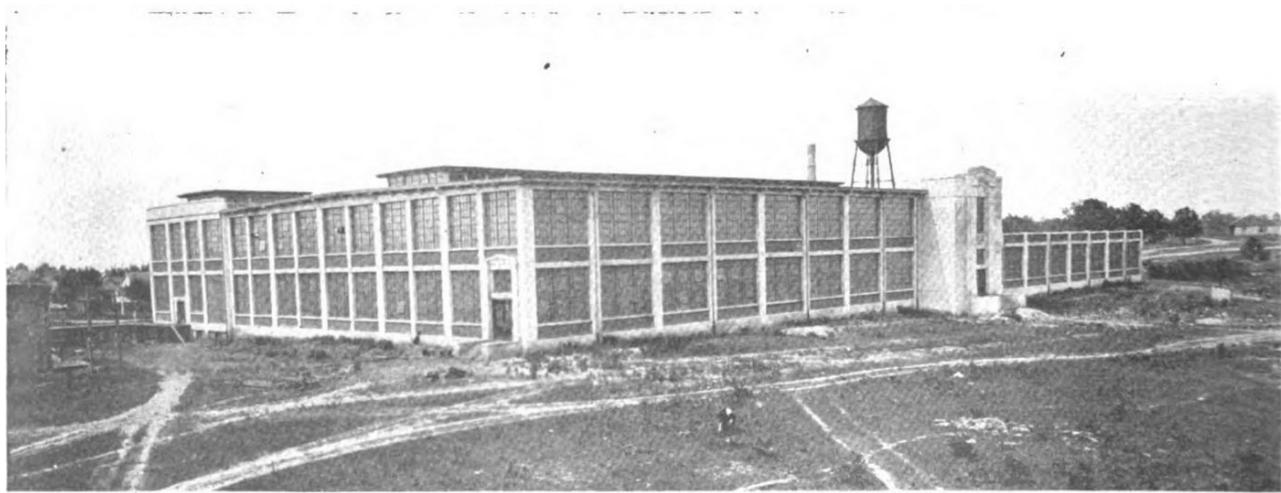
FLINT MANUFACTURING COMPANY PLANT RECENTLY PLACED IN OPERATION.

Flint Mill No. 2, southwest oblique, *Manufacturers' Record*, November 22, 1923, p. 78 (above)  
Sanborn Map Company, "Gastonia," March 1930, Sheet 44 (below)

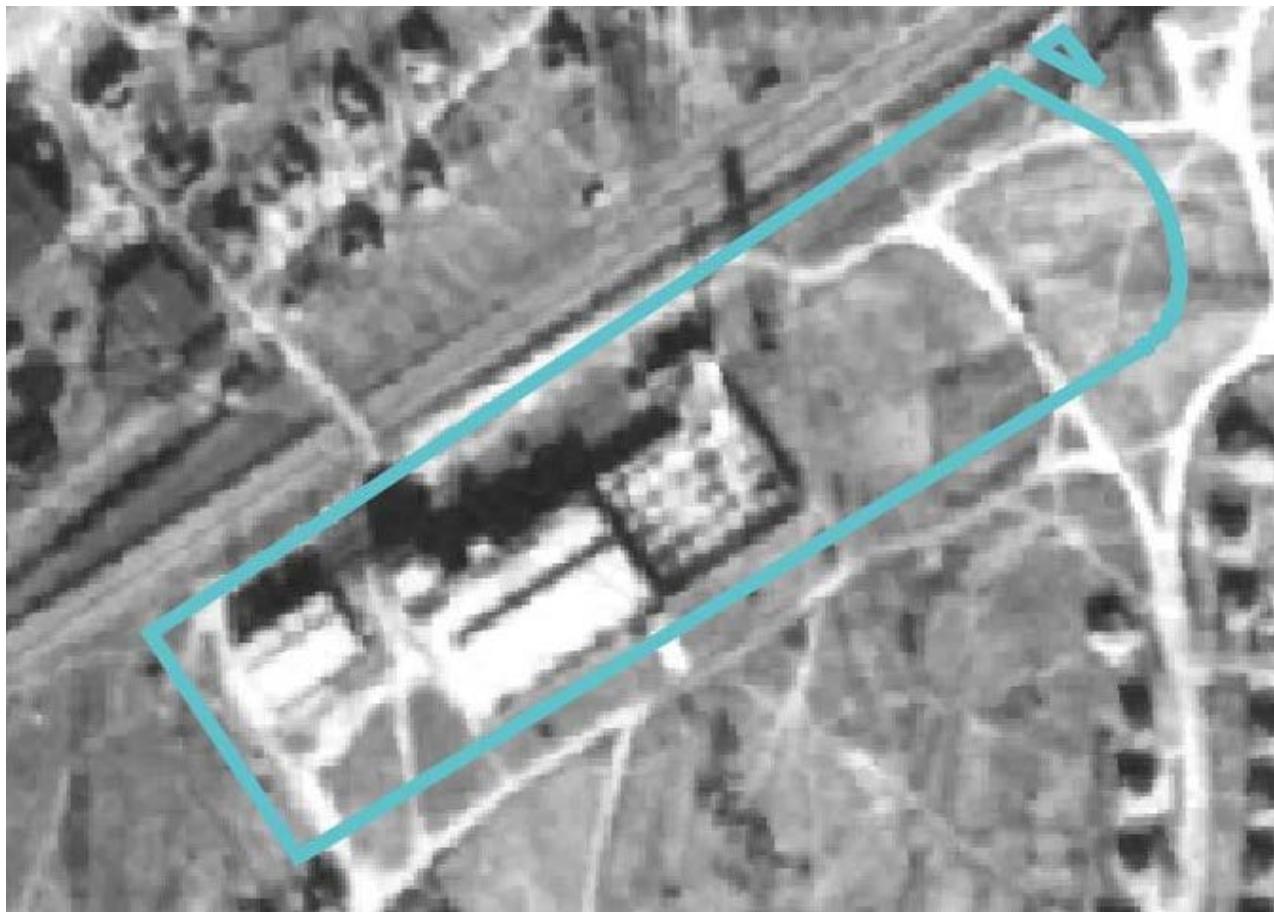
Gaston County GIS aerial photographs, 1938 (above) and 1951 (below)

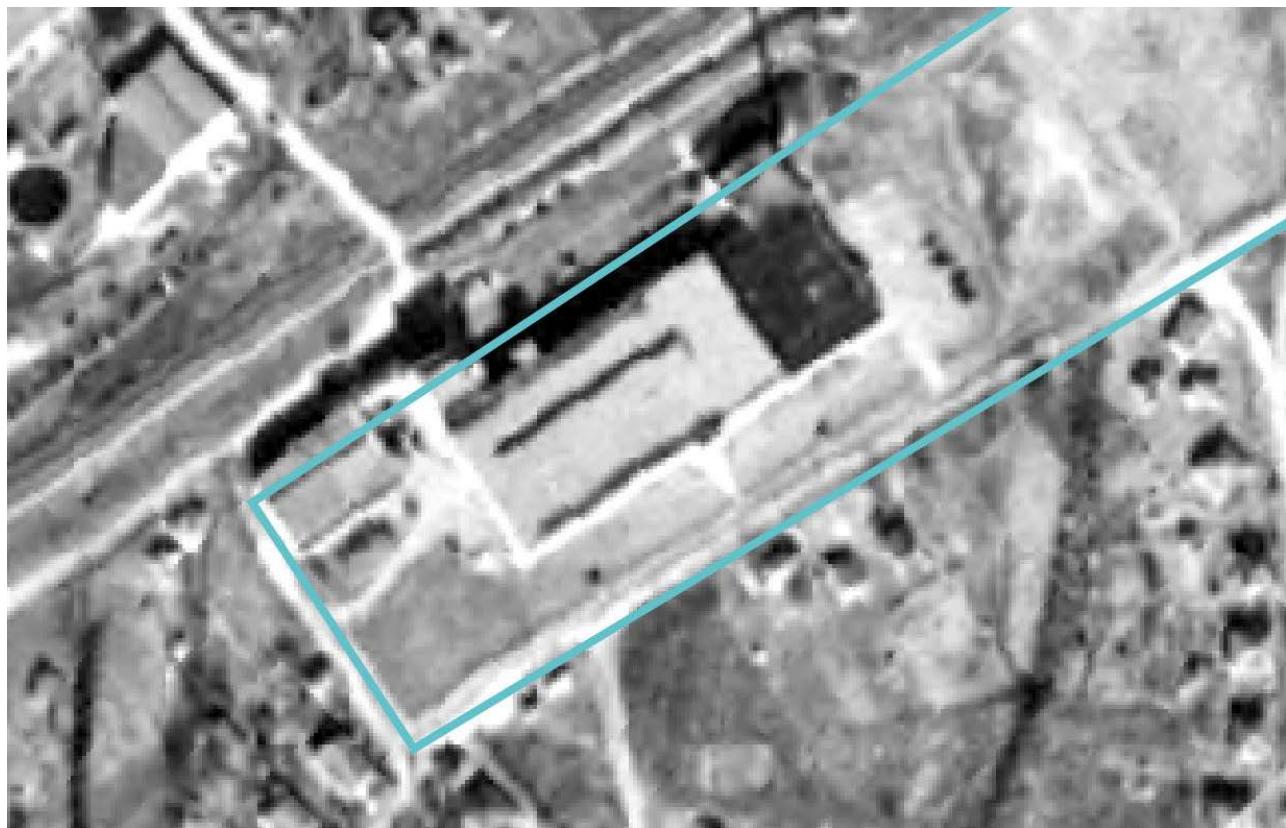
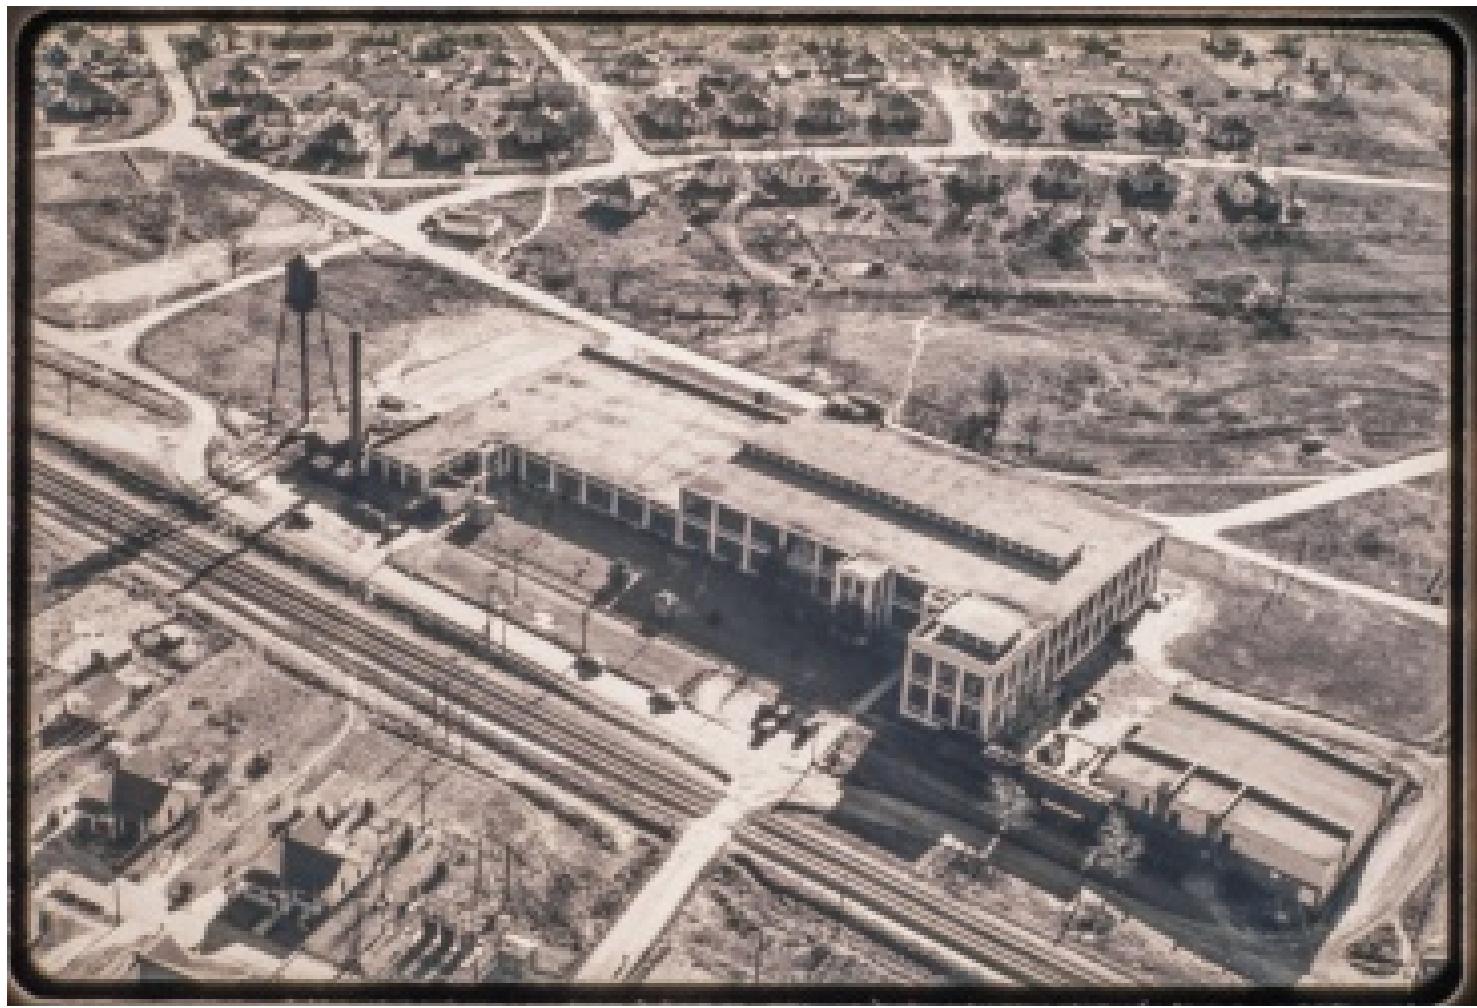
**Northwest oblique, image #04995\_pf1120\_0007, undated (circa 1946-1949)**  
**Burlington Industries, Inc. Records, Southern Historical Collection, Wilson Library,**  
**University of North Carolina at Chapel Hill**

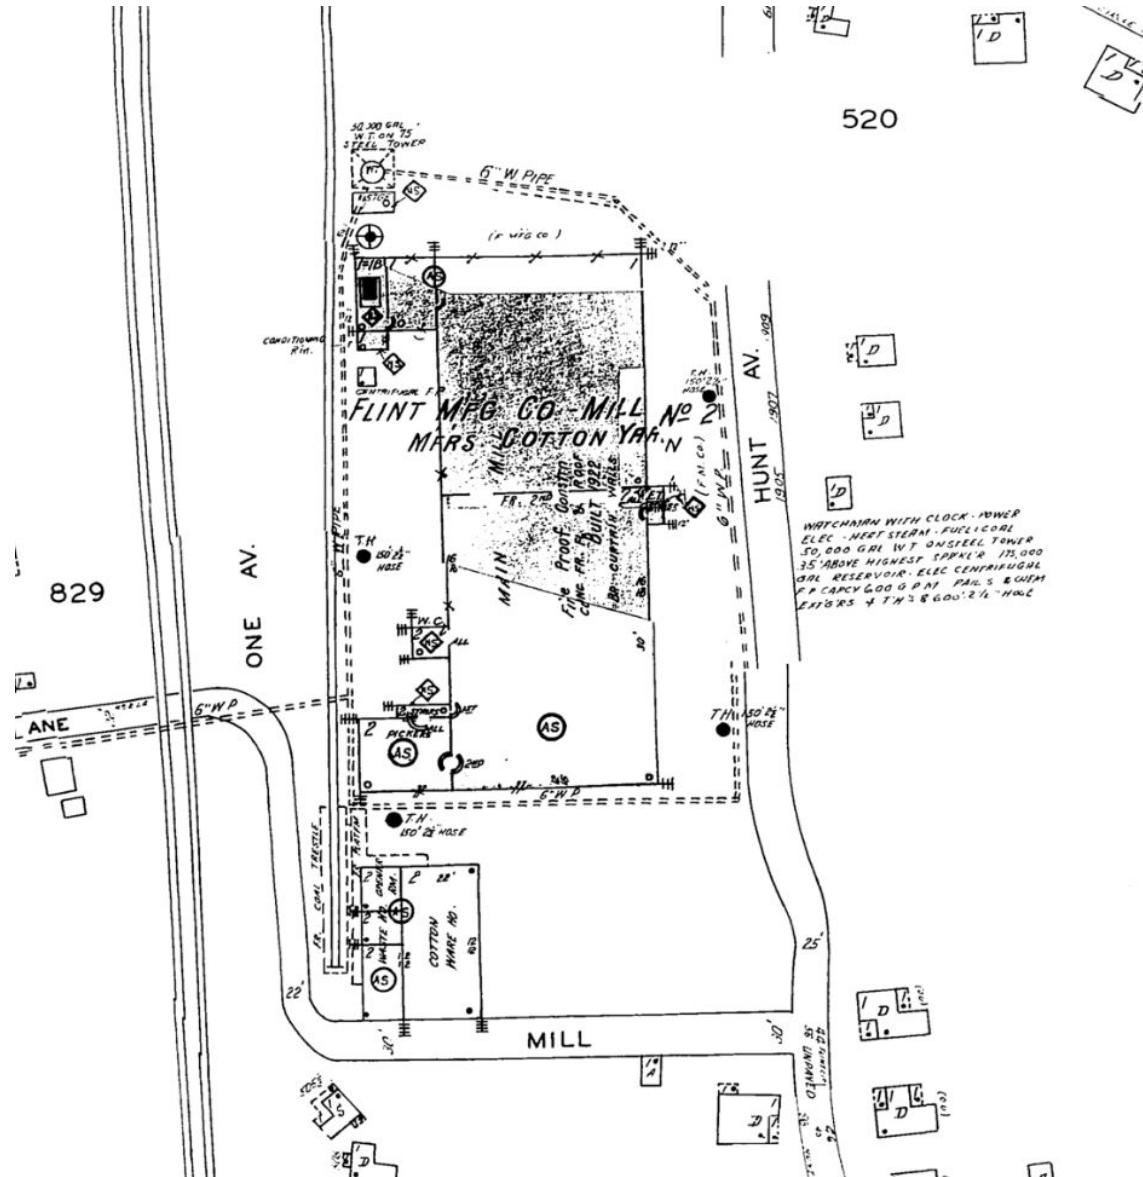
Sanborn Map Company, "Gastonia," February 1950, Sheet 44 (above)  
*Gastonia Gazette*, October 17, 1950, p. 2G (below)

ONE OF SIX BURLINGTON PLANTS—Flint No. 2 is one of six Burlington Mills' plants in Gaston county. Acquired by the company in 1948, it is presently producing cotton yarns for use in other Burlington weave mills. A. H. Thomas is superintendent.

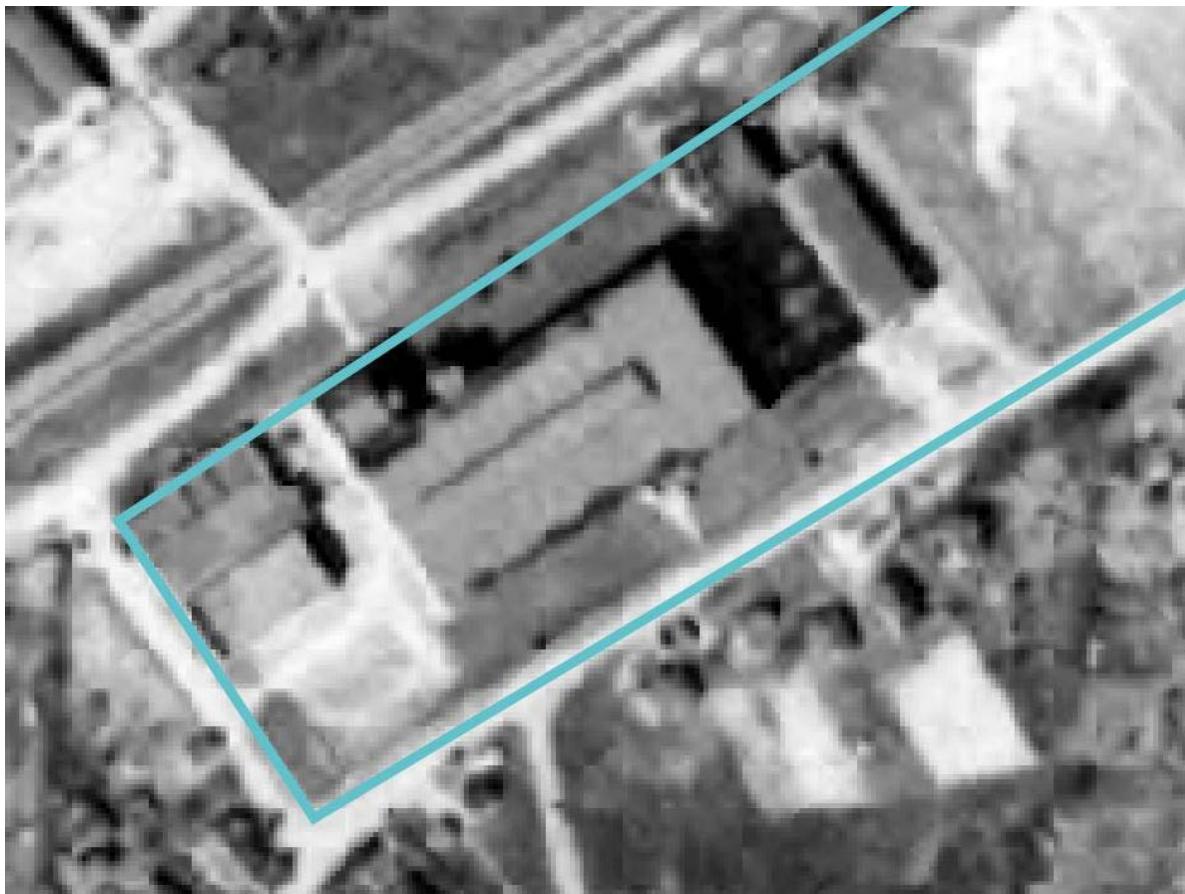
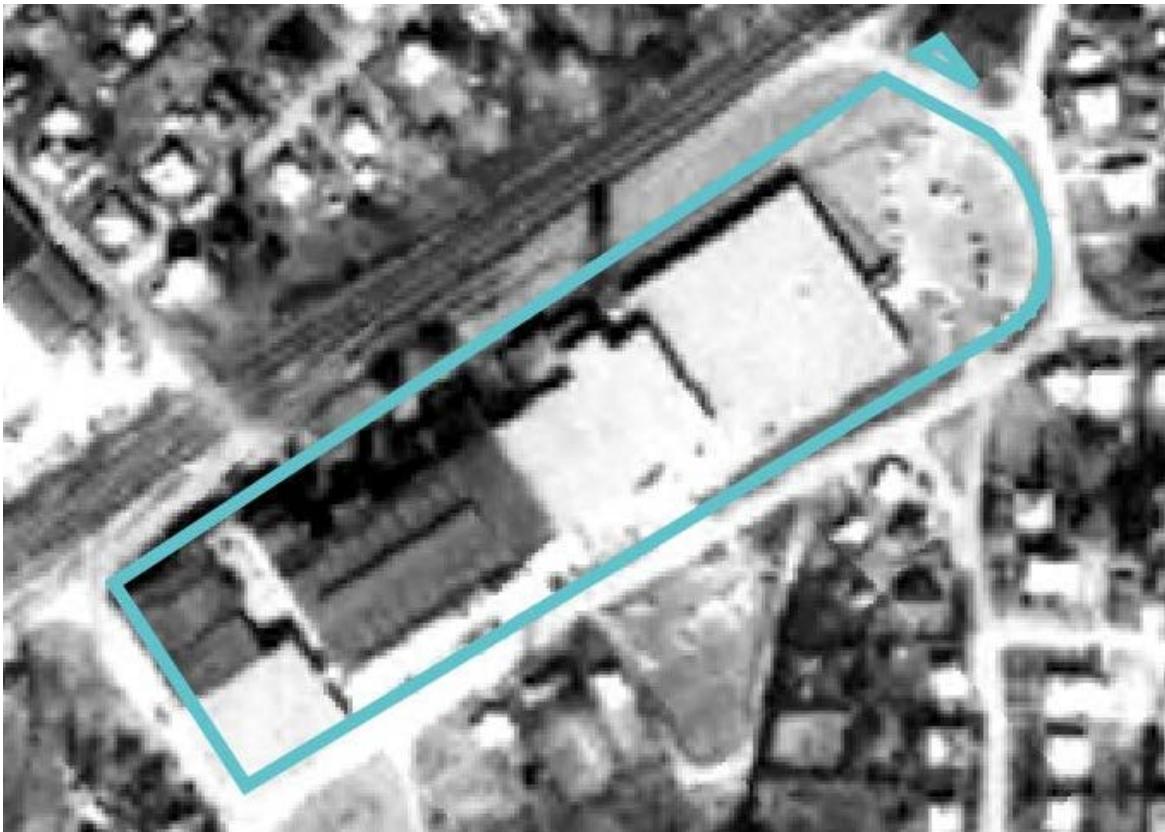
Gaston County GIS aerial photographs, 1956 above and 1968 below

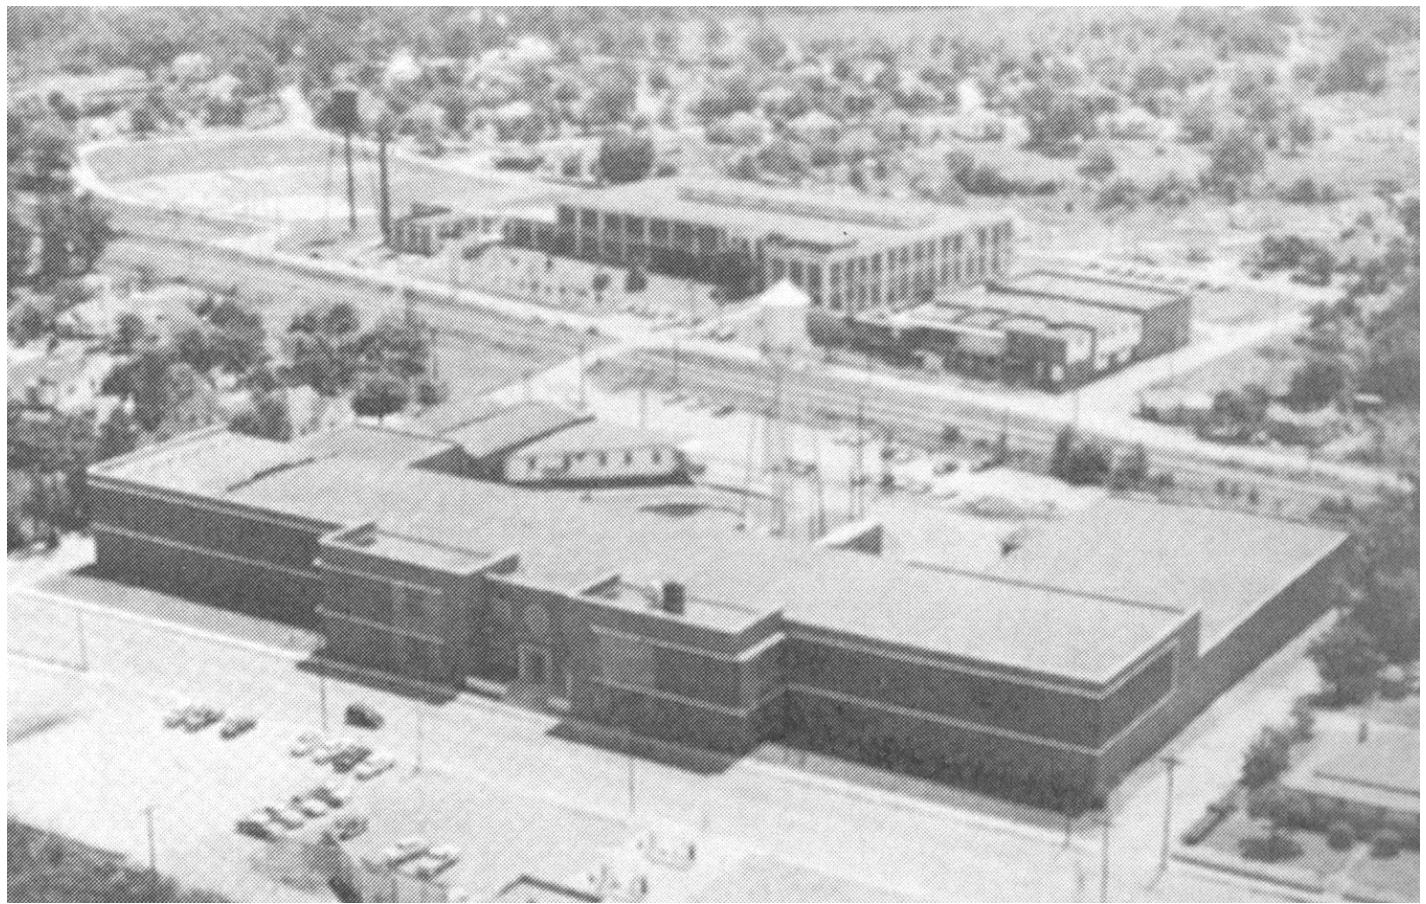
Flint No. 1 (foreground) and No. 2, northwest oblique, 1959 photograph in Robert Allison Ragan, *The Textile Heritage of Gaston County, North Carolina, 1848-2000* (Charlotte: R.A. Ragan and Company, 2001), 194
