# WOOD DESTROYING PESTS AND ORGANISMS INSPECTION REPORT

Building No. <b>206</b>	Street <b>Cypress Ave</b>	City <b>Pacific Grove</b>	Zip <b>93950-3206</b>	Date of Inspection <b>04/01/2025</b>	Number of Pages <b>1 of 7</b>
----------------------------	------------------------------	------------------------------	--------------------------	---	----------------------------------

General Description: <b>2 Story, Single Family House, Attached Garage, Occupied and Furnished</b>	Inspection Tag Posted: <b>Attic</b>
	Other Tags Posted: <b>None</b>

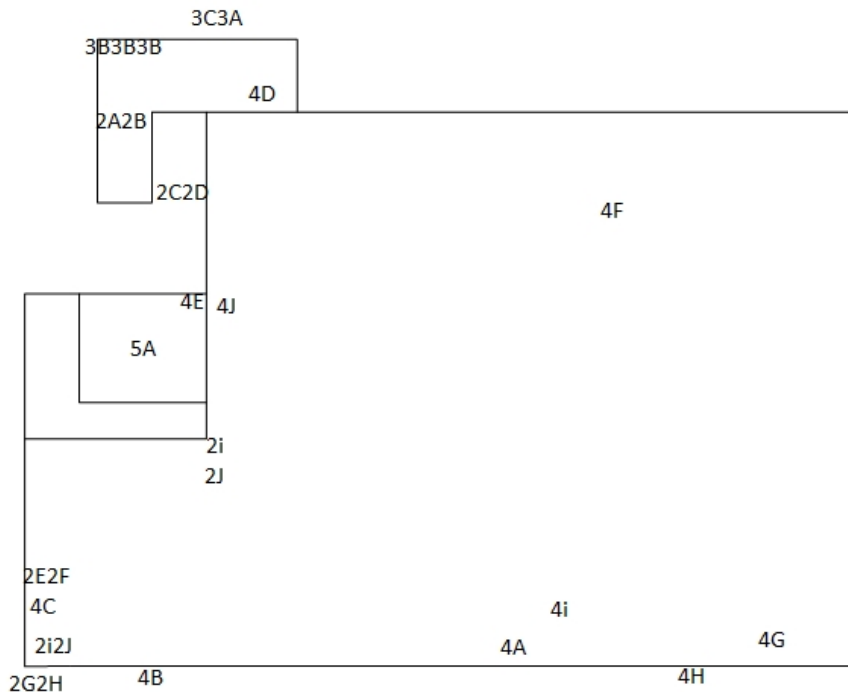
Subterranean Termites ☐    Drywood Termites ☒    Fungus/Dryrot ☒    Other Findings ☒    Further Inspection ☒

Key:   1 = Subterranean Termites      2 = Drywood Termites      3 = Fungus/Dryrot      4 = Other Findings      5 = Unknown Further Inspection
