# ±134 Acres FOR SALE BEST ROCK QUARRY/MINE

## Best Rock Quarry/Mine

26282 Neuman Rd. • Barstow, CA

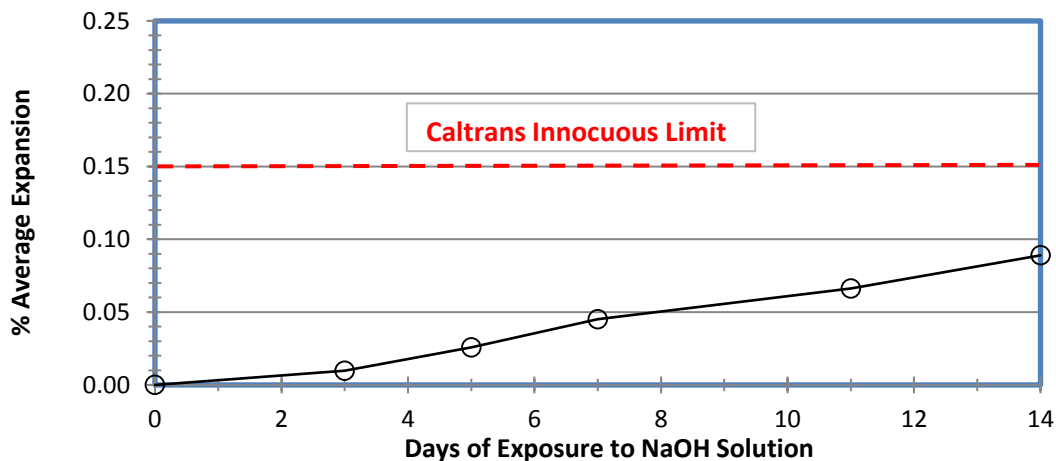
<b>CEMENT USED FOR TESTING</b>		<b>AGGREGATE SOURCE</b>	BEST ROCK INC.
<b>CEMENT, TYPE I/III/V:</b>	Mitsubishi, TYPE I/III/V	<b>AGGREGATE SIZE</b>	3/8"-MSA
<b>PROPERTIES OF CEMENT:</b>		<b>CALTRANS REGISTRATION #:</b>	17-36071-2
*Total Alkalies as Na <sub>2</sub> O, %	0.46		
*Autoclave Expansion, %	0.03		
<b>TEST SOLUTION:</b>	1N NaOH		
<b>DATE CAST:</b>	August 22, 2018

Date	NaOH Exposure (Days)	Expansion of Bars (%)				Average
		A	B	C	D	
8/24/2018	0	0.000	0.000	0.000	0.000	0.00
8/27/2018	3	0.009	0.010	0.010	0.010	0.01
8/29/2018	5	0.025	0.026	0.026	0.026	0.03
8/31/2018	7	0.042	0.042	0.047	0.050	0.05
9/4/2018	11	0.065	0.061	0.069	0.070	0.07
9/7/2018	14	0.090	0.084	0.091	0.091	0.09

**Notes:** *This aggregate demonstrated average expansion at 14-day exposure (in solution of sodium hydroxide) of 0.09% when tested in accordance with ASTM C1260. This is below the maximum expansion limit of 0.15% set forth by Caltrans.*

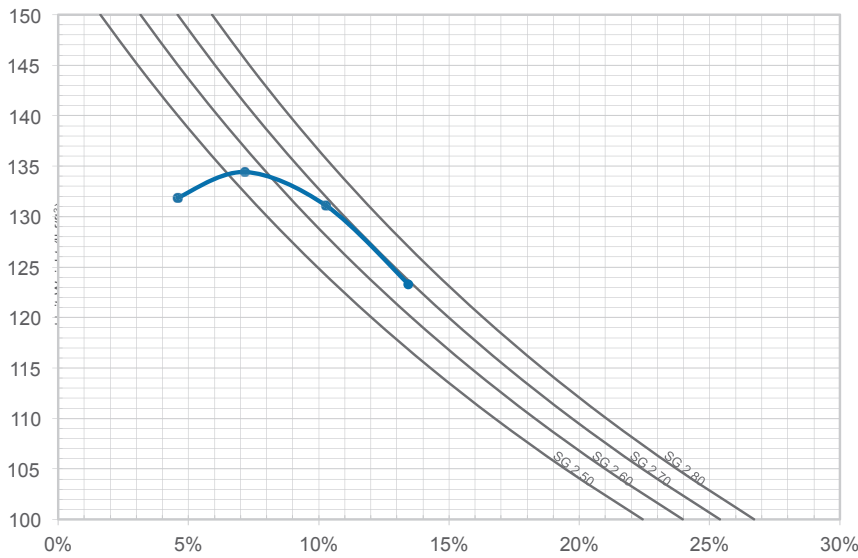
Sample ID: PJM05161802      Maximum Dry Unit Weight (lb/ft<sup>3</sup>): 134.4      Optimum Moisture Content (%): 7.2

Classification, ASTM D2488: (Class 2 Aggregate Base) On Site Stockpile  
 Sample Origin:  
 Laboratory Remarks:

Tested By: Cheyenne Oravets  
 Received Moisture: 0.5%  
 Preparation: Wet  
 Specific Gravity: ND  
 SG Method: NA  
 Start Weight (lb): 57.9  
 Retained on 3/4" (lb): 1.0  
 Retained on 3/8" (lb): 20.4  
 Retained on No. 4 (lb): 32.6  
 Retained on 3/4" (%): 1.7%  
 Retained on 3/8" (%): 35.2%  
 Retained on No. 4 (%): 56.3%  
 Oversize Correction: ND  
 Mold Volume Factor: 13.36  
 Tare Weight (lb): 6.24  
 Rammer Used: Mechanical  
 Method Used:  A  B  C

Weight of Soil and Tare (lb):	16.56	17.02	17.06	16.71
Wet Weight (g):	500.6	500.4	502.1	506.3
Dry Weight (g):	478.7	467.0	455.3	446.3
Moisture Content (%):	4.6%	7.2%	10.3%	13.4%
Dry Unit Weight (lb/ft <sup>3</sup> ):	131.8	134.4	131.1	123.3

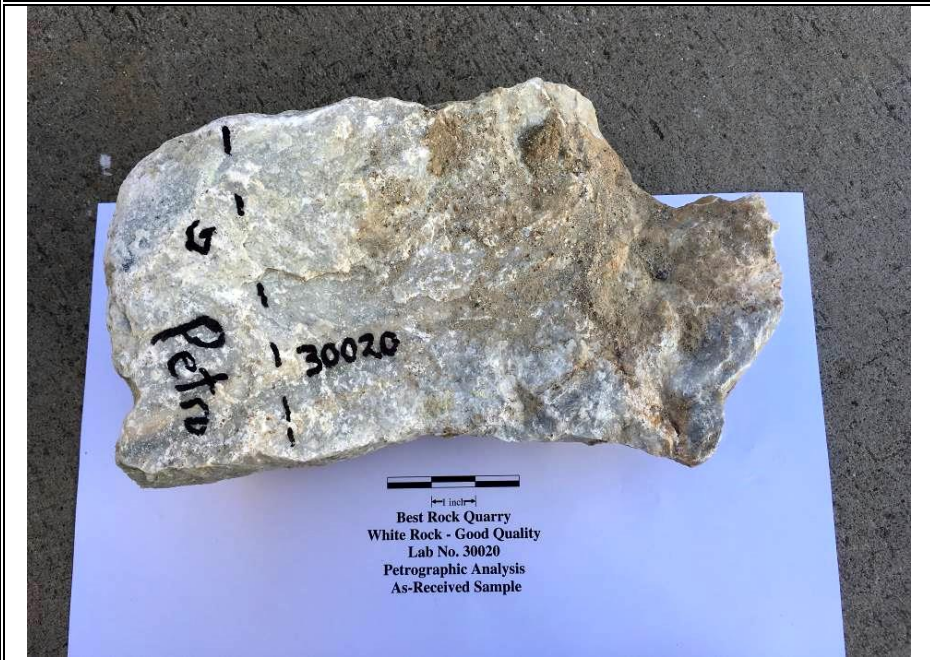
PHOTOGRAPH 1	Remarks

<p>Best Rock Quarry White Rock - Good Quality Lab No. 30020 Petrographic Analysis As-Received Sample</p>	<p>Good quality marble (white rock), Lab No. 30020, as received sample.</p>

The good quality white rock polished section exhibits a few readily visible fractures with a maximum width of about 1/16 inch. Most of the fractures are discontinuous. Fracture filling material is primarily calcite, with subordinate iron-oxide. A limited number of carbonate and/or iron-oxide filled microfractures are also visible through the stereographic microscope.

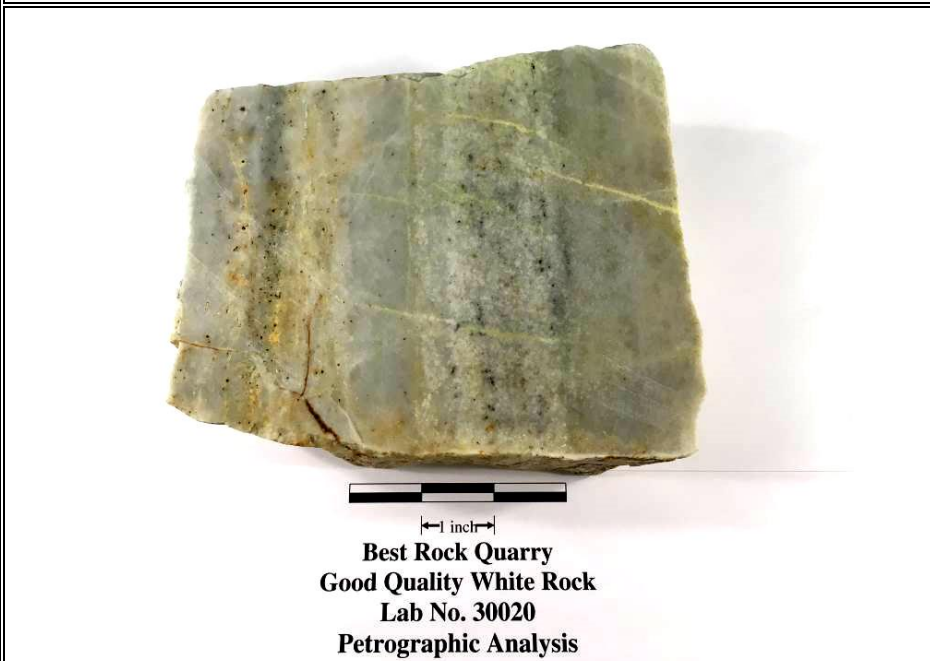
PHOTOGRAPH 2	Remarks

<p>Best Rock Quarry Good Quality White Rock Lab No. 30020 Petrographic Analysis</p>	<p>Good quality marble (white rock), Lab No. 30020, polished section.</p>

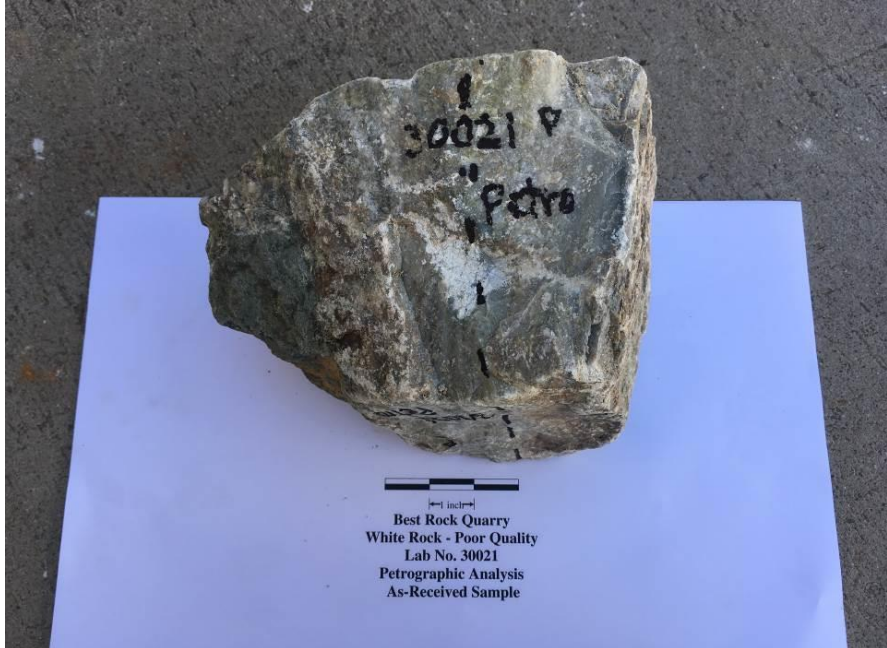
PHOTOGRAPH 3	Remarks

<p>Best Rock Quarry White Rock - Poor Quality Lab No. 30021 Petrographic Analysis As-Received Sample</p>	Poor quality marble (white rock), Lab No. 30021, as received sample.

**As-Received and Polished Section Observations:** The as-received poor quality white rock sample is an angular, quarried piece of marble with a maximum dimension of about 7 inches. Some sides of the rock sample are semi-planar and may coincide with jointing patterns within the rock. The rock is generally white to light gray to medium gray in color. The rock generally appears to be slightly weathered, very strong, and very hard. Oxidation visible in the as-received sample and polished section is somewhat more prevalent than in the good quality sample, and generally consists of staining on weathered surfaces, fracture linings, and round to ovoid zones of oxidation staining visible in the polished section surface.

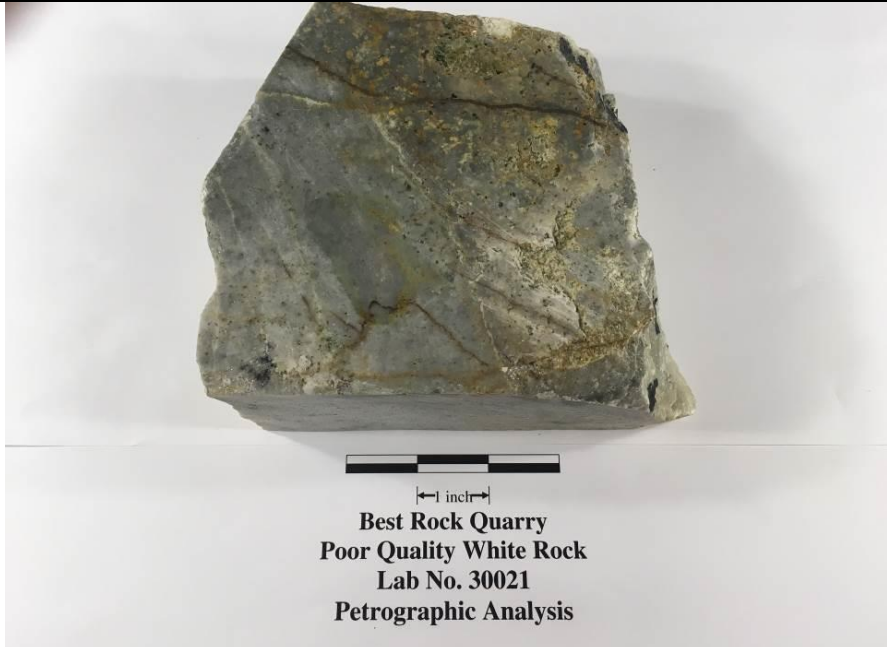
PHOTOGRAPH 4	Remarks

<p>Best Rock Quarry Poor Quality White Rock Lab No. 30021 Petrographic Analysis</p>	Poor quality marble (white rock), Lab No. 30021, polished section.

The poor quality white rock polished section exhibits somewhat more extensive fracturing than the good quality sample, including some readily visible fractures with a maximum width of about 1/16 inch. Both continuous and discontinuous fractures were observed. Fracture filling material is primarily calcite and iron-oxide. Several carbonate and/or iron-oxide filled microfractures were also observed through the stereographic microscope.

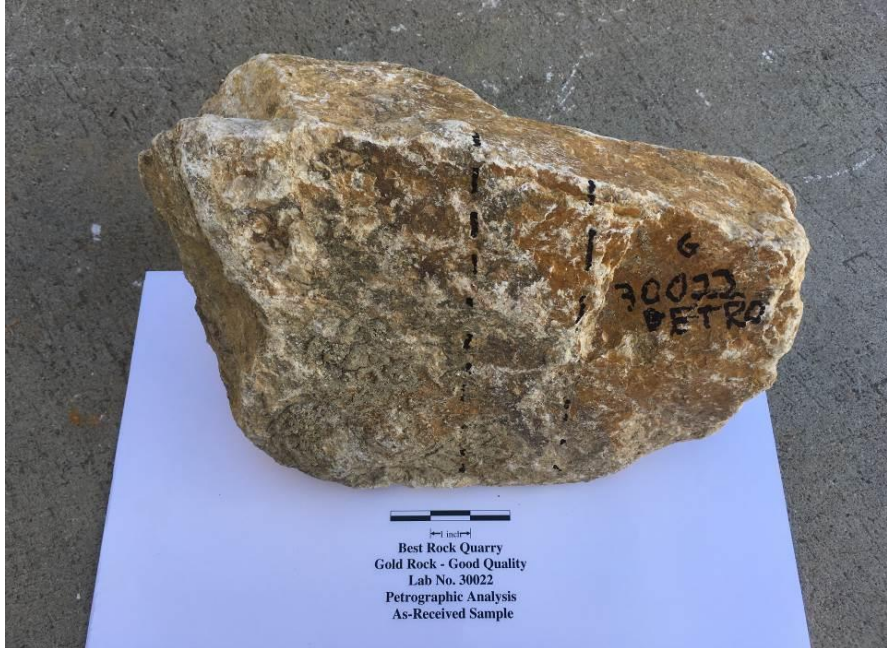
PHOTOGRAPH 5	Remarks

<p data-bbox="488 814 646 930">Best Rock Quarry Gold Rock - Good Quality Lab No. 30022 Petrographic Analysis As-Received Sample</p>	<p data-bbox="1040 342 1500 407">Good quality marble (gold rock), Lab No. 30022, as received sample.</p>

**As-Received and Polished Section Observations:** The as-received good quality gold rock sample is an angular, quarried piece of marble with a maximum dimension of about 8 inches. Some sides of the rock sample are semi-planar and may coincide with jointing patterns within the rock. The rock is generally gold to gray in color. The rock generally appears to be slightly weathered, very strong, and very hard. Oxidation visible in the as-received sample and polished section generally consists of staining on weathered surfaces, fracture linings, and splotchy zones of oxidation staining visible in the polished section surface.

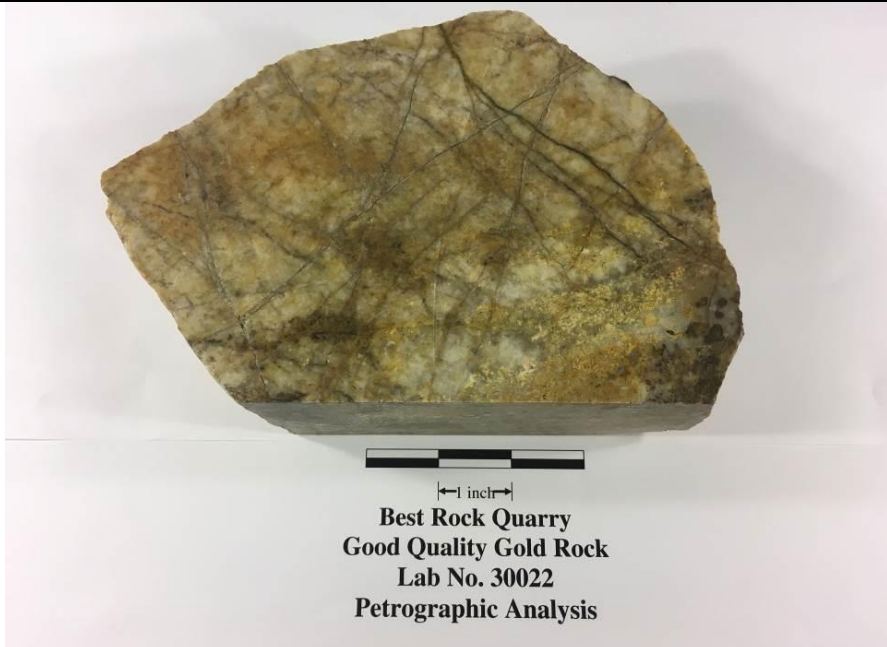
PHOTOGRAPH 6	Remarks

<p data-bbox="456 1549 727 1728">Best Rock Quarry Good Quality Gold Rock Lab No. 30022 Petrographic Analysis</p>	<p data-bbox="1040 1140 1500 1205">Good quality marble (gold rock), Lab No. 30022, polished section.</p>

The good quality gold rock polished section exhibits several cross-cutting fractures with a maximum width of about 1/16 inch. Most of the fractures are discontinuous. Fracture filling material is primarily calcite, with subordinate iron-oxide. Numerous carbonate and/or iron-oxide filled microfractures are also visible through the stereographic microscope.

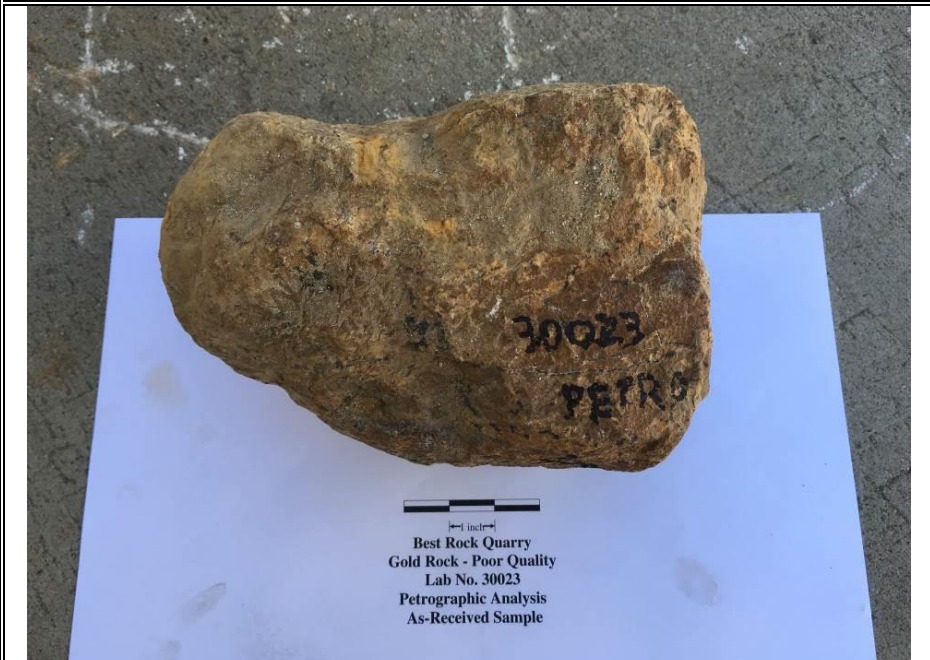
PHOTOGRAPH 7	Remarks

<p>Best Rock Quarry Gold Rock - Poor Quality Lab No. 30023 Petrographic Analysis As-Received Sample</p>	<p>Poor quality marble (gold rock), Lab No. 30023, as received sample.</p>

**As-Received and Polished Section Observations:** The as-received poor quality gold rock sample is an angular, quarried piece of marble with a maximum dimension of about 9 inches. The rock is generally gold to dark brown in color. The rock generally appears to be moderately to highly weathered, moderately strong to strong, and hard. Oxidation is extensive throughout the as-received sample and polished section as staining on weathered surfaces, fracture linings, and disseminated within the rock mass.

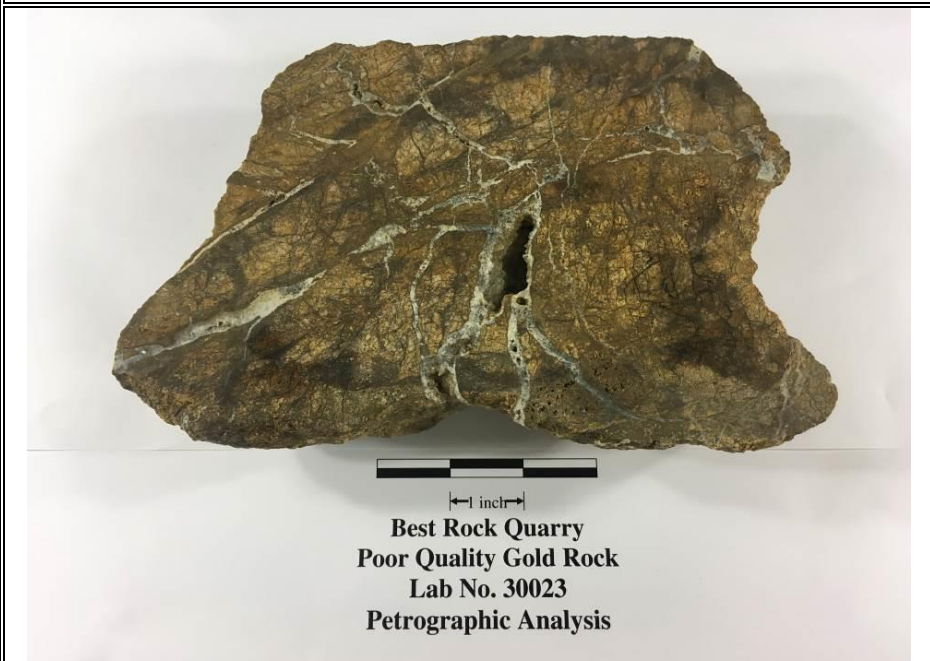
PHOTOGRAPH 8	Remarks

<p>Best Rock Quarry Poor Quality Gold Rock Lab No. 30023 Petrographic Analysis</p>	<p>Poor quality marble (gold rock), Lab No. 30023, polished section.</p>

The poor quality gold rock polished section exhibits abundant cross-cutting fractures. The finer fractures are generally iron-oxide filled. Several large, discontinuous, carbonate-filled fractures ranging up to about 1/4 inch in width were also observed. The fractures and adjacent oxidized zones comprise an estimated 25 percent of the rock mass. Numerous carbonate and/or iron-oxide filled microfractures are also visible through the stereographic microscope. One large irregular void extending about an inch into the surface of the polished section was observed, as well as a few smaller voids.

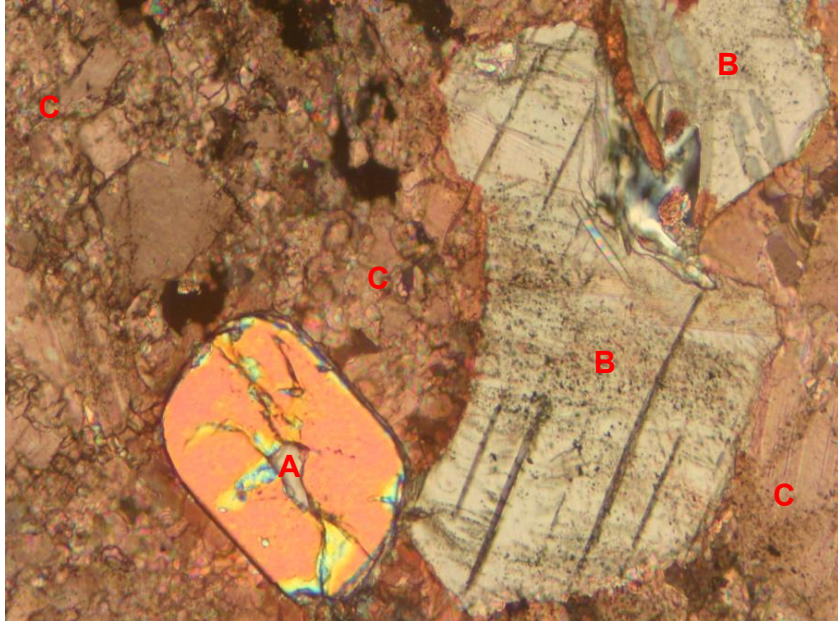
PHOTOGRAPH 9	Remarks

<p>Photomicrograph of good quality marble (white rock) thin section showing large forsterite and dolomite crystals in a fine grained calcite matrix. Lab No. 30020, 100X magnification, cross polarized light, horizontal field of view is about 1 mm.</p> <p><b>Key:</b> A – Forsterite crystal (bright colors) B – Dolomite crystals (light gray) C – Fine grained calcite (stained pinkish red)</p>

Tremolite, wollastonite, mica (primarily muscovite), and forsterite (a variety of olivine) all generally occur as individual, subhedral to euhedral crystals within dolomite crystals and/or within a fine grained calcite matrix. The forsterite crystals exhibit the characteristic olivine fracture pattern. Quartz occurs as minor void filling and/or secondary replacement material. Optically opaque minerals primarily occur as clusters of minute inclusions within dolomite crystals. Microcrystalline, massive iron-oxide occurs as fracture fill material and as oxidation of ovoid grains. Chlorite was observed only in trace amounts.

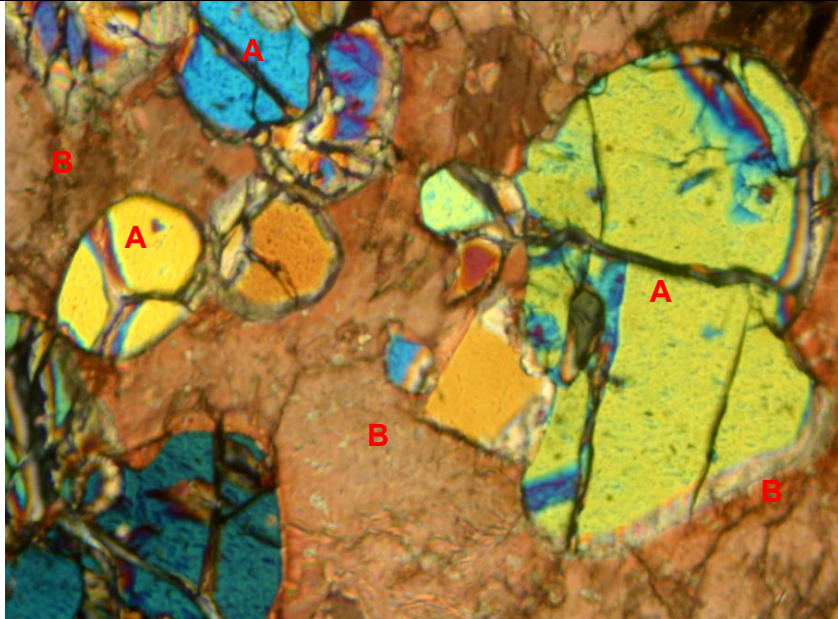
PHOTOGRAPH 10	Remarks

<p>Photomicrograph of poor quality marble (white rock), thin section showing forsterite crystals in a fine grained calcite matrix. Lab No. 30021, 100X magnification, cross polarized light, horizontal field of view is about 1 mm.</p> <p><b>Key:</b> A – Forsterite crystals (bright colors) B – Fine grained calcite (stained pinkish red)</p>

Tremolite, wollastonite, and forsterite all generally occur as individual, subhedral to euhedral crystals within dolomite crystals and/or within a fine grained calcite matrix. Quartz occurs as minor void filling and/or secondary replacement material. Optically opaque minerals occur both as clusters of minute inclusions within dolomite crystals, and as scattered larger masses or individual crystals. Microcrystalline, massive iron-oxide occurs as fracture fill material and as oxidation of ovoid grains. Unlike the good quality white rock sample, no dolomite or mica was observed. Chlorite was observed only in trace amounts.

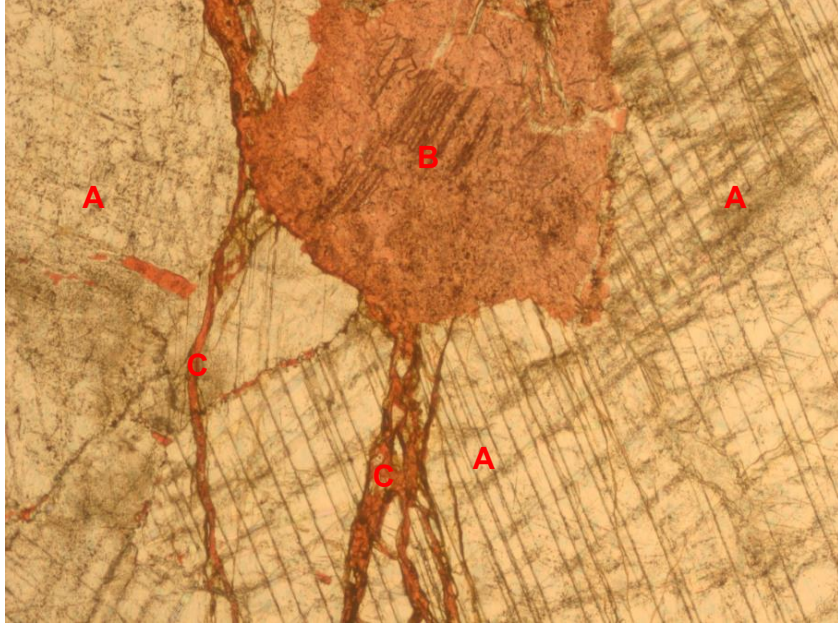
PHOTOGRAPH 11	Remarks

<p>Photomicrograph of good quality marble (gold rock), thin section showing calcite-filled fractures and large dolomite crystals surrounding fine grained calcite. Lab No. 30022, 40X magnification, plane polarized light, horizontal field of view is about 2.5 mm.</p> <p><b>Key:</b> A – Dolomite crystals (pinkish white) B – Fine grained calcite (stained pinkish red) C – Calcite-filled fractures (stained pinkish red)</p>

**Thin Section Observations:** The good quality gold rock sample is comprised primarily of dolomite. The dolomite occurs as very large, subhedral, interlocking crystals with well-developed twinning ranging up to about 5 millimeters in width. In some portions of the thin section, the interlocking dolomite crystals from the entire rock mass with no interstitial minerals. Calcite occurs as fine grained anhedral crystals or masses in the relatively limited interstices between the large dolomite crystals, as well as in ovoid to rectangular masses that appear to represent secondary replacement of other minerals.

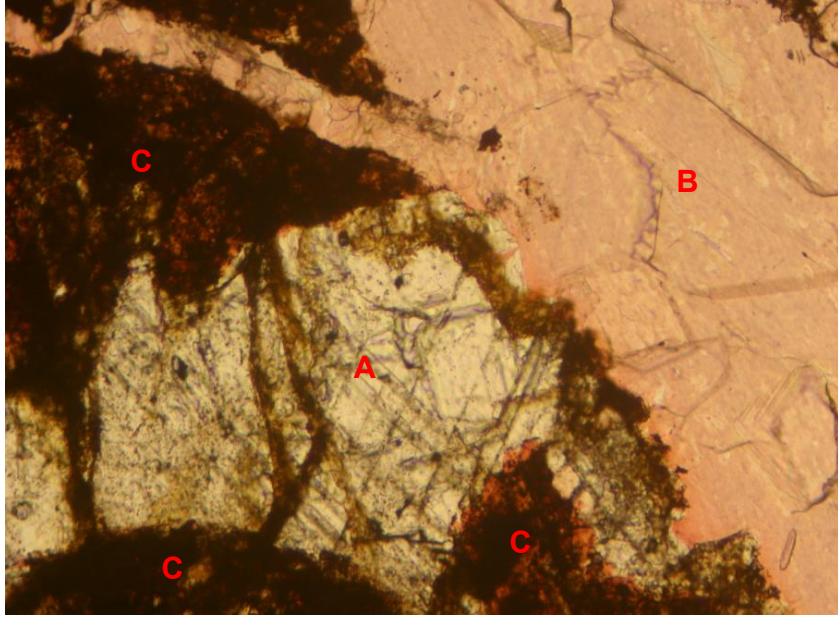
PHOTOGRAPH 12	Remarks

<p>Photomicrograph of poor quality marble (gold rock), thin section showing large calcite-filled fracture, and large dolomite crystal surrounded by highly oxidized fine grained matrix. Lab No. 30023, 100X magnification, plane polarized light, horizontal field of view is about 1 mm.</p> <p><b>Key:</b> A – Dolomite crystal (white) B – Calcite-filled fracture (stained pink) C – Fine grained iron-oxide rich matrix (dark reddish brown)</p>

**Thin Section Observations:** The poor quality gold rock sample is comprised primarily of dolomite and calcite with abundant cross-cutting calcite and iron-oxide lined fractures. The dolomite occurs as anhedral to subhedral, variably twinned crystals ranging up to about 1 millimeter in width. Some crystals appear to exhibit evidence of cataclastic shearing as described below. Calcite occurs as fine grained anhedral crystals and as extensive fracture fill.

The sample is riddled with abundant irregular, cross-cutting fractures and microfractures that are estimated to comprise about 25 percent of the rock by volume. The fractures are lined primarily with calcite and iron-oxide. Some large fractures up to about 2 millimeters in width were observed to be filled with large calcite crystals and subordinate iron-oxide. Many of the fractures cut through dolomite crystals, and in some cases apparent shearing of the crystals is suggestive of some degree of cataclastic deformation.

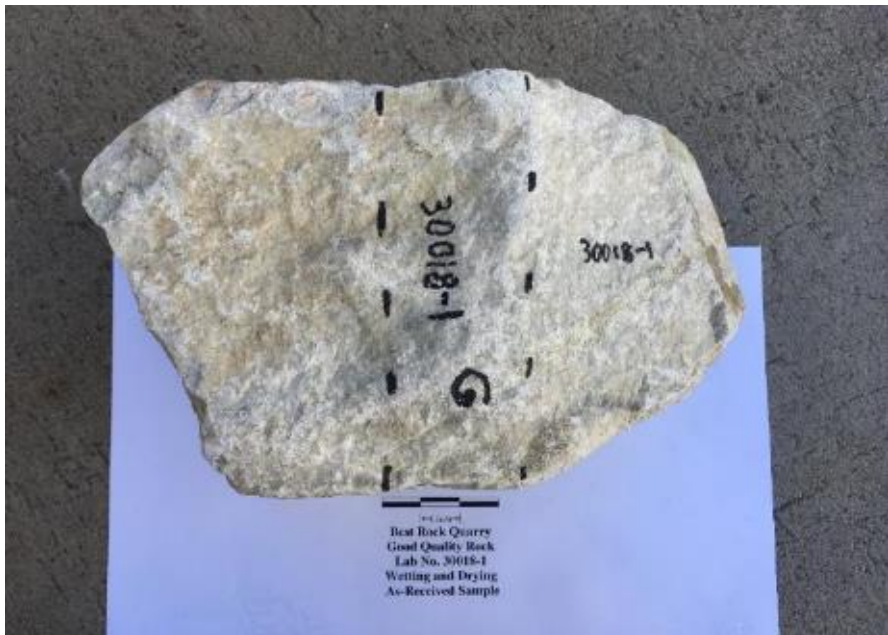
Photograph #1	Remarks

<p>30018-1</p> <p>G</p> <p>30018-1</p> <p>Best Rock Quarry Good Quality Rock Lab No. 30018-1 Wetting and Drying As-Received Sample</p>	<p>Wetting and drying test (ASTM D5313-12), good quality sample, white rock, as-received sample for Slab 1 (30018-1). Black dashed lines indicate approximate location of cuts for test slabs.</p>

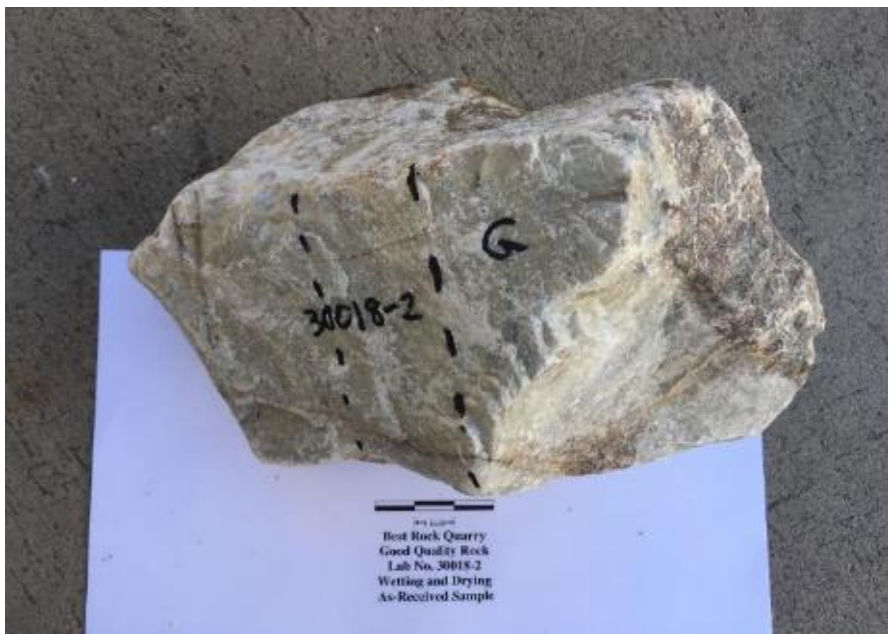
Photograph #2	Remarks

<p>30018-2</p> <p>G</p> <p>30018-2</p> <p>Best Rock Quarry Good Quality Rock Lab No. 30018-2 Wetting and Drying As-Received Sample</p>	<p>Wetting and drying test (ASTM D5313-12), good quality sample, white rock, as-received sample for Slab 2 (30018-2). Black dashed lines indicate approximate location of cuts for test slabs.</p>

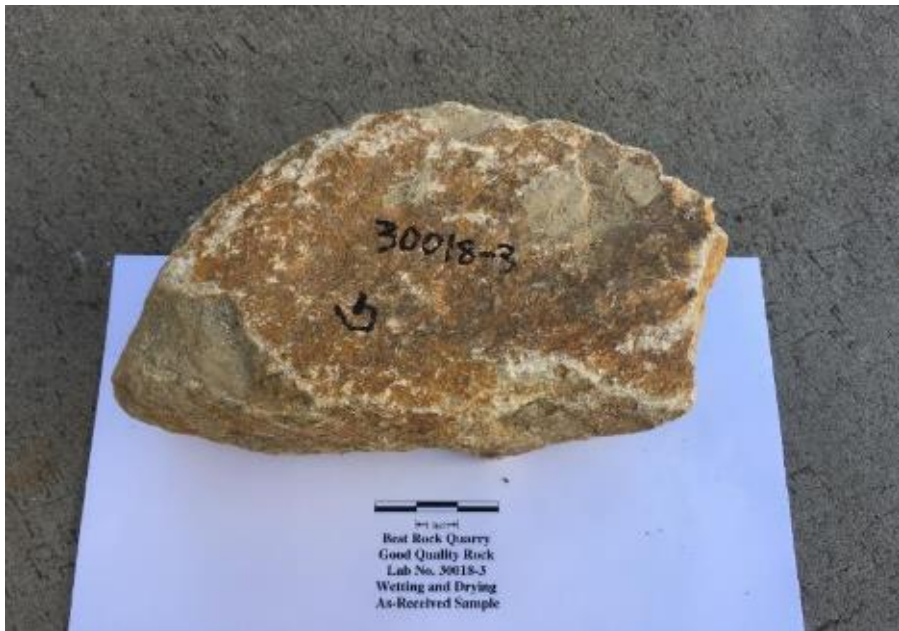
Photograph #3	Remarks

<p>Wetting and drying test (ASTM D5313-12), good quality sample, gold rock, as-received sample for Slab 3 (30018-3).</p>

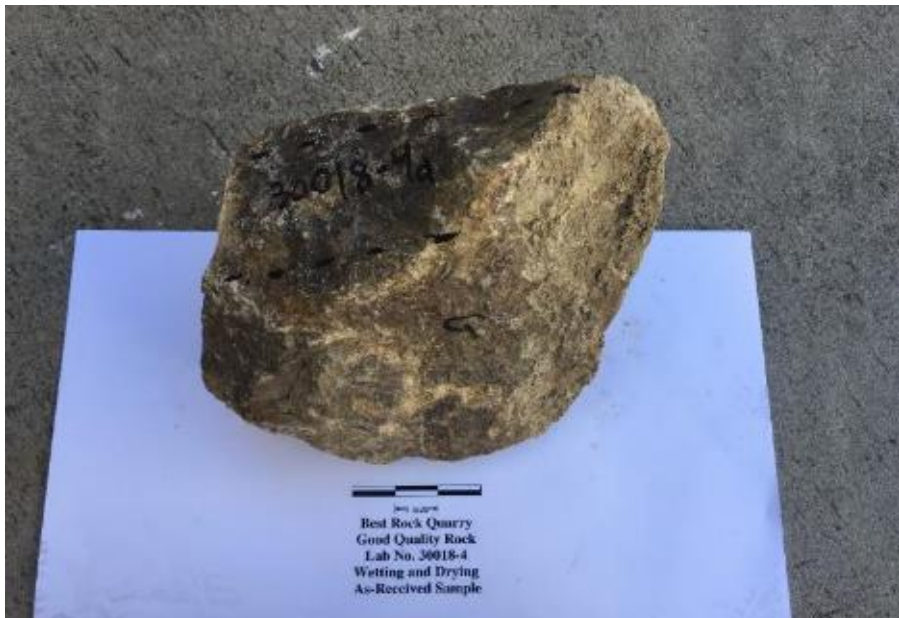
Photograph #4	Remarks

<p>Wetting and drying test (ASTM D5313-12), good quality sample, gold rock, as-received sample for Slab 4 (30018-4). Black dashed lines indicate approximate location of cuts for test slabs.</p>

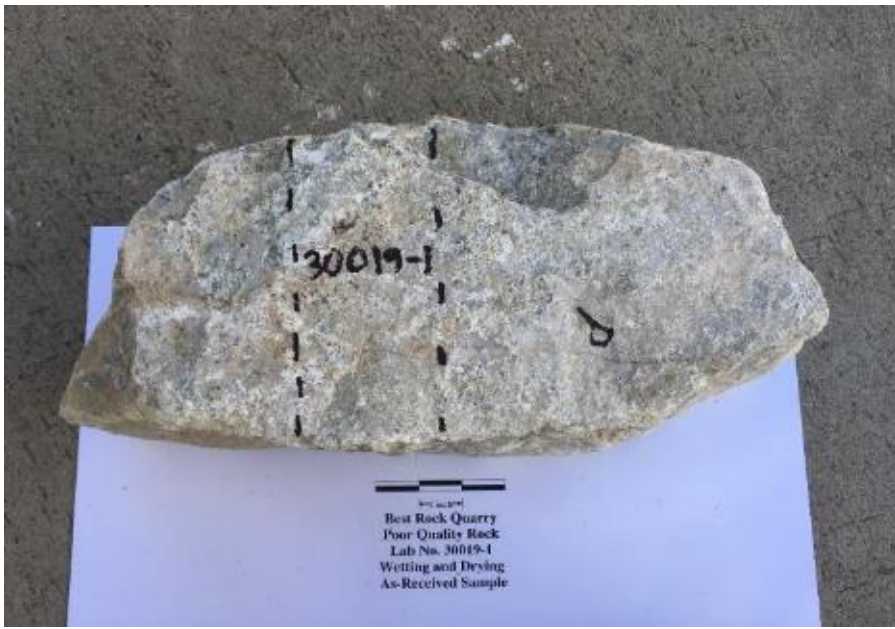
Photograph #5	Remarks

<p>30019-1 P</p> <p>Best Rock Quarry Poor Quality Rock Lab No. 30019-1 Wetting and Drying As-Received Sample</p>	<p>Wetting and drying test (ASTM D5313-12), poor quality sample, white rock, as-received sample for Slab 5 (30019-1). Black dashed lines indicate approximate location of cuts for test slabs.</p>

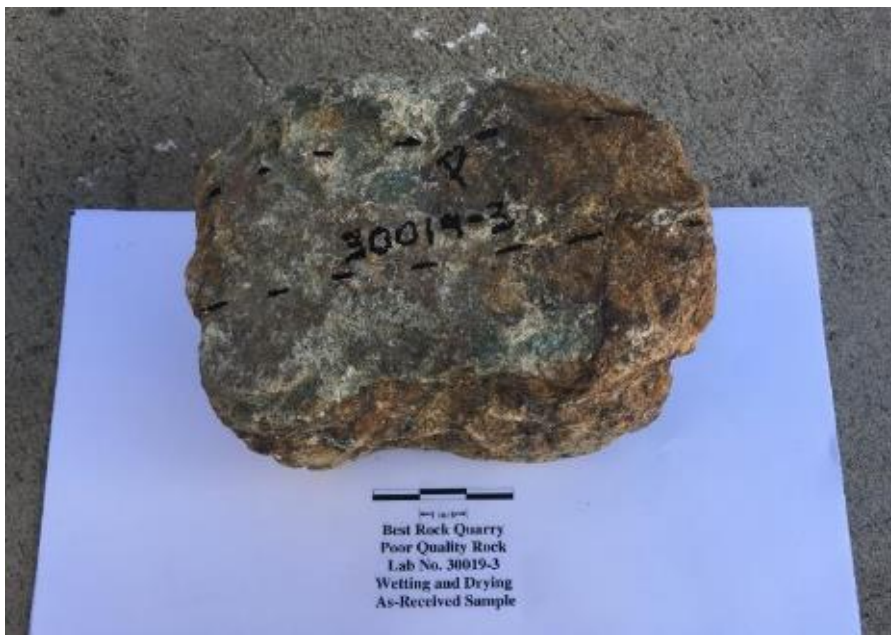
Photograph #7	Remarks

<p>Best Rock Quarry Poor Quality Rock Lab No. 30019-3 Wetting and Drying As-Received Sample</p>	<p>Wetting and drying test (ASTM D5313-12), poor quality sample, gold rock, as-received sample for Slab 7 (30019-3). Black dashed lines indicate approximate location of cuts for test slabs.</p>

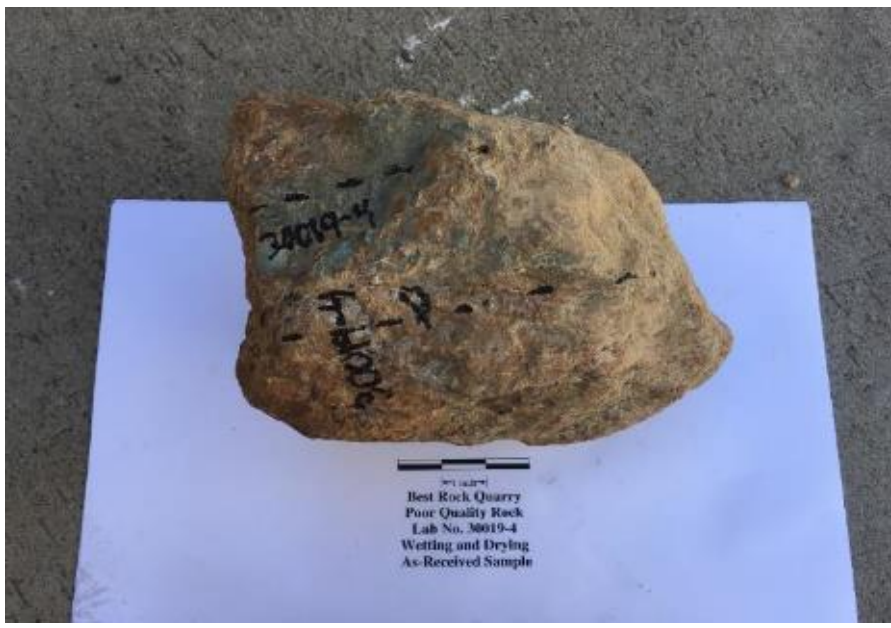
Photograph #8	Remarks

<p>Best Rock Quarry Poor Quality Rock Lab No. 30019-4 Wetting and Drying As-Received Sample</p>	<p>Wetting and drying test (ASTM D5313-12), poor quality sample, gold rock, as-received sample for Slab 8 (30019-4). Black dashed lines indicate approximate location of cuts for test slabs.</p>

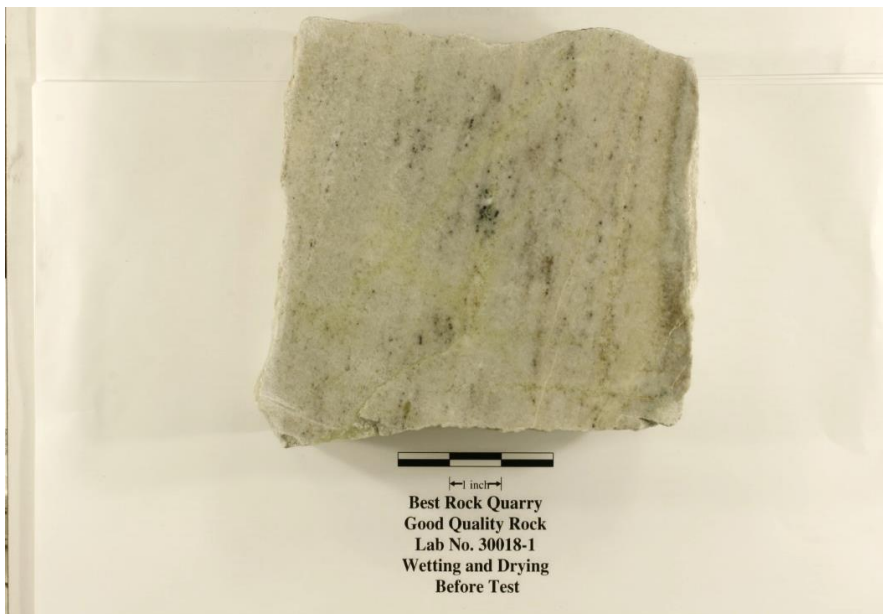
Photograph #9	Remarks

<p data-bbox="609 777 771 924">1 inch Best Rock Quarry Good Quality Rock Lab No. 30018-1 Wetting and Drying Before Test</p>	<p data-bbox="1128 325 1412 535">Wetting and drying test (ASTM D5313-12), good quality sample, Slab 1 (30018-1), white rock, before testing.</p>

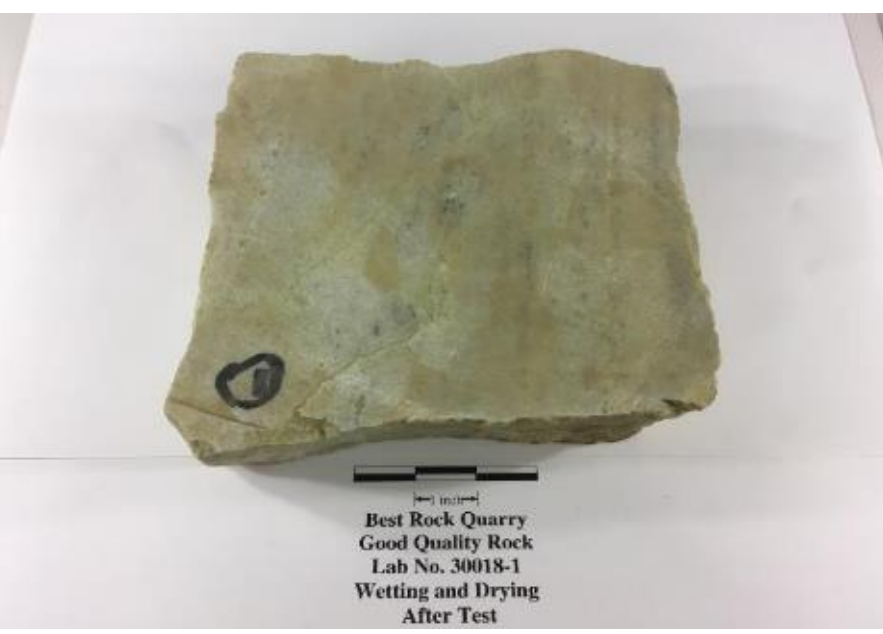
Photograph #10	Remarks

<p data-bbox="560 1627 755 1774">1 inch Best Rock Quarry Good Quality Rock Lab No. 30018-1 Wetting and Drying After Test</p>	<p data-bbox="1128 1144 1412 1354">Wetting and drying test (ASTM D5313-12), good quality sample, Slab 1 (30018-1), white rock, after testing.</p>

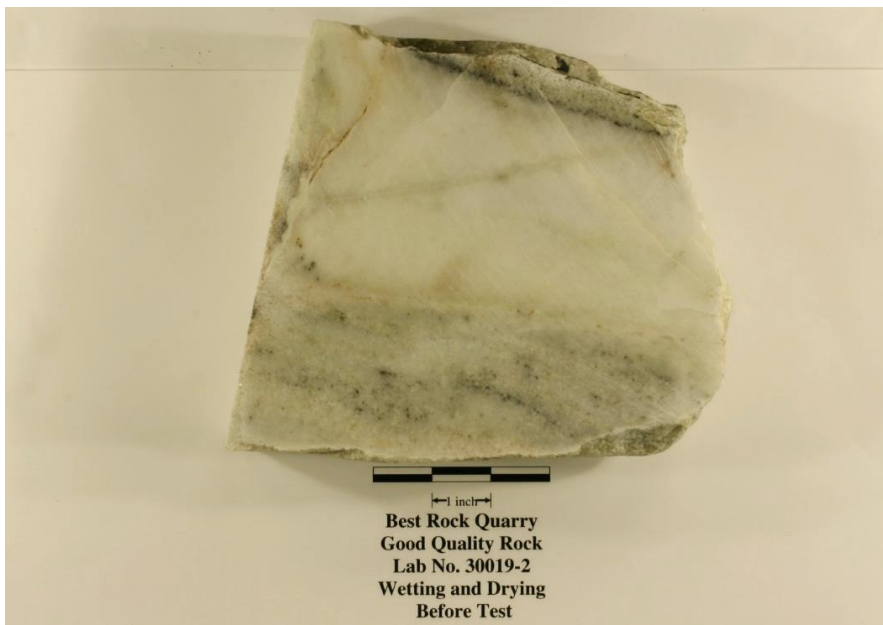
Photograph #11	Remarks

<p>Best Rock Quarry Good Quality Rock Lab No. 30019-2 Wetting and Drying Before Test</p>	<p>Wetting and drying test (ASTM D5313-12), good quality sample, Slab 2 (30018-2), white rock, before testing. (Note: lab number in photo should be 30018-2)</p>

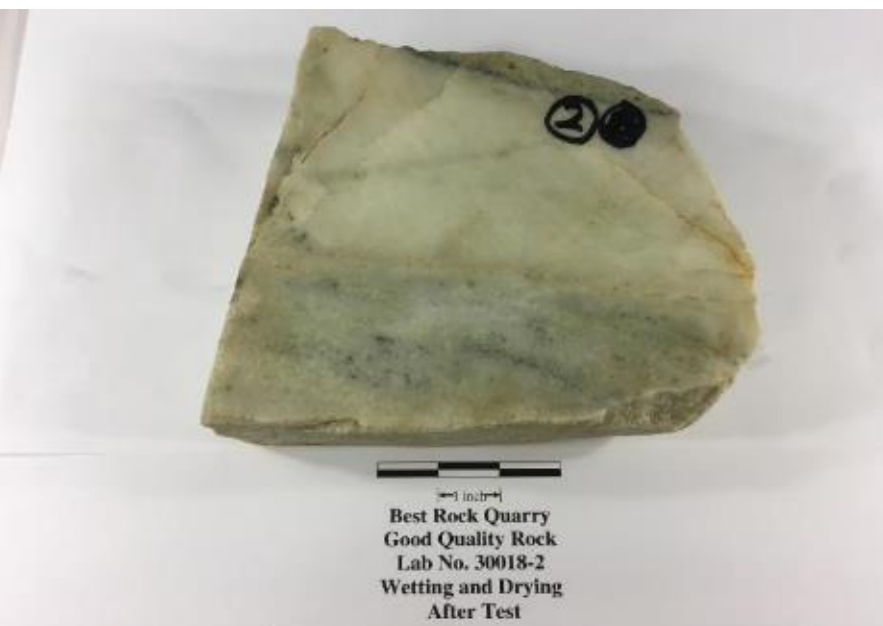
Photograph #12	Remarks

<p>Best Rock Quarry Good Quality Rock Lab No. 30018-2 Wetting and Drying After Test</p>	<p>Wetting and drying test (ASTM D5313-12), good quality sample, Slab 2 (30018-2), white rock, after testing.</p>

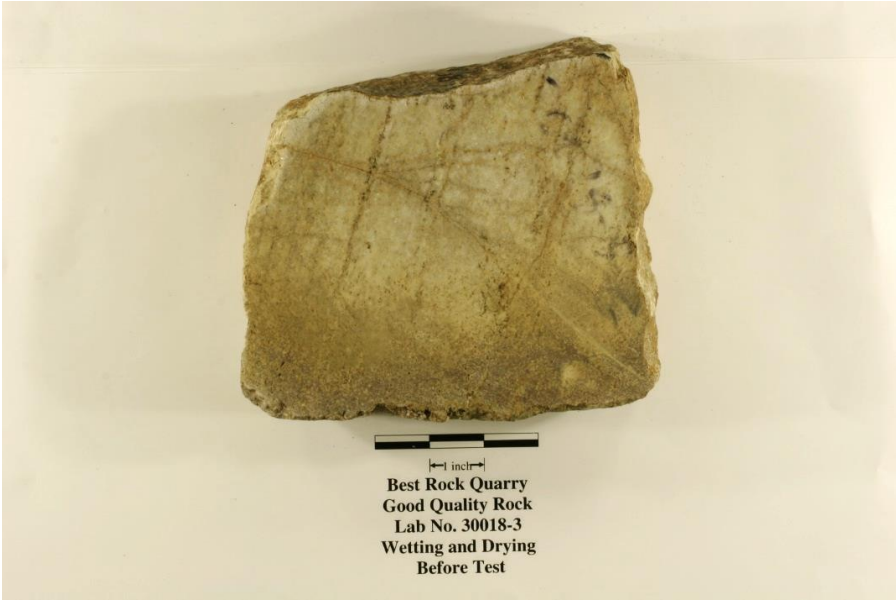
Photograph #13	Remarks

<p data-bbox="589 762 748 905">1 inch Best Rock Quarry Good Quality Rock Lab No. 30018-3 Wetting and Drying Before Test</p>	<p data-bbox="1133 331 1398 527">Wetting and drying test (ASTM D5313-12), good quality sample, Slab 3 (30018-3), gold rock, before testing.</p>

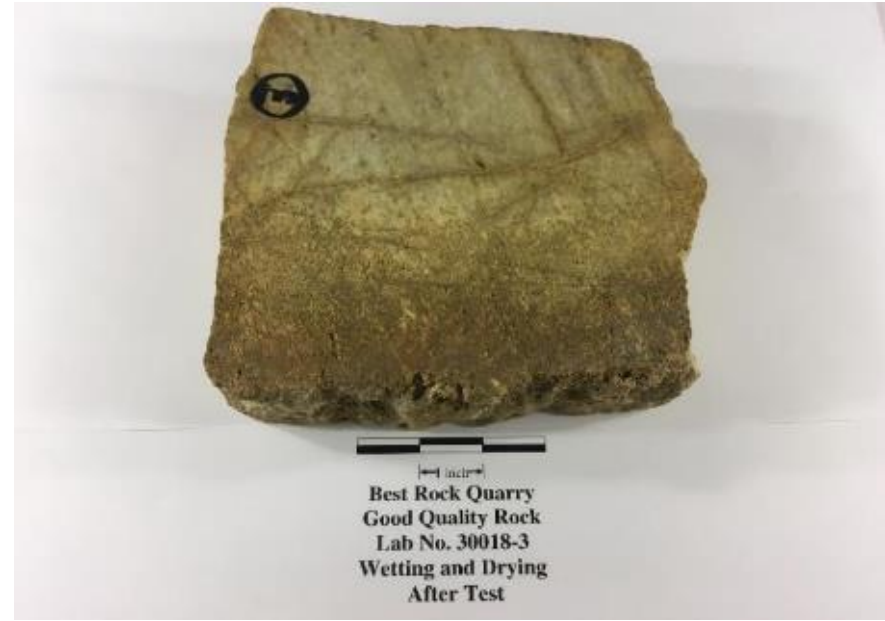
Photograph #14	Remarks

<p data-bbox="570 1612 761 1755">1 inch Best Rock Quarry Good Quality Rock Lab No. 30018-3 Wetting and Drying After Test</p>	<p data-bbox="1133 1155 1398 1350">Wetting and drying test (ASTM D5313-12), good quality sample, Slab 3 (30018-3), gold rock, after testing.</p>

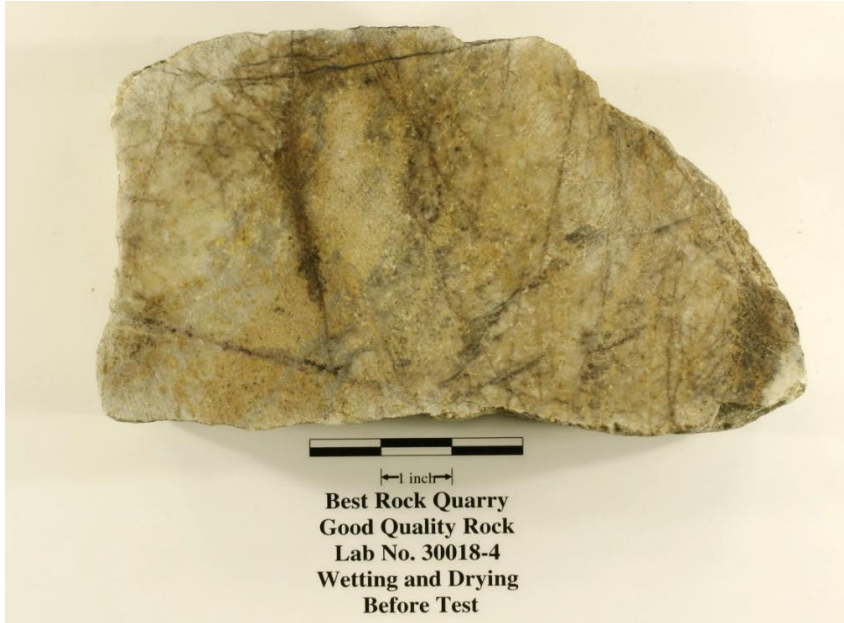
Photograph #15	Remarks

<p>Best Rock Quarry Good Quality Rock Lab No. 30018-4 Wetting and Drying Before Test</p>	<p>Wetting and drying test (ASTM D5313-12), good quality sample, Slab 4 (30018-4), gold rock, before testing.</p>

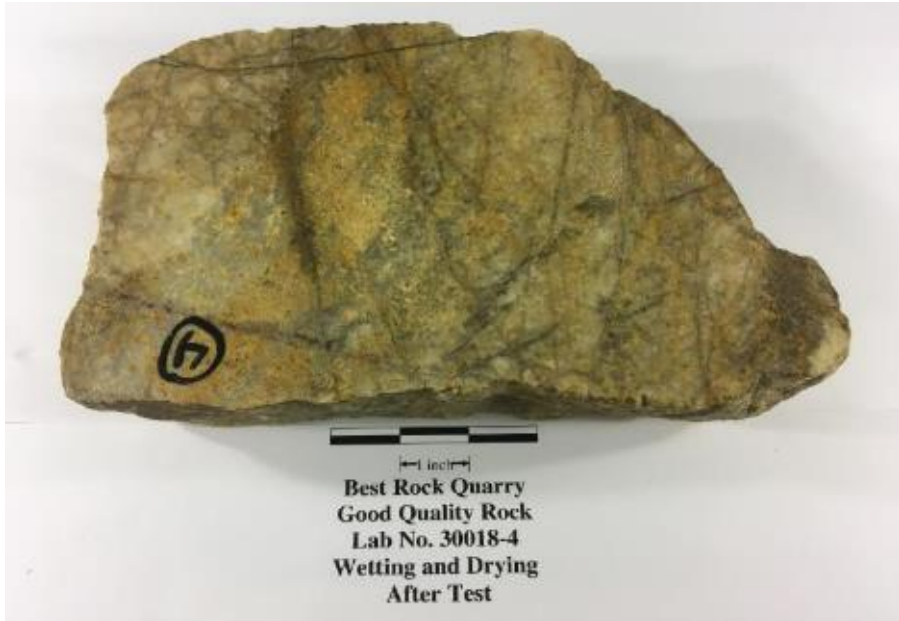
Photograph #16	Remarks

<p>Best Rock Quarry Good Quality Rock Lab No. 30018-4 Wetting and Drying After Test</p>	<p>Wetting and drying test (ASTM D5313-12), good quality sample, Slab 4 (30018-4), gold rock, after testing.</p>

Slab 4 (30018-4) Good Quality Gold Rock Tap Water	i=4,201.3 f=4,203.2	+1.9g +.05%	<p>The Slab 4 sample is an angular, quarried piece of good quality gold rock (marble). The slab is approximately 2-1/2-inches thick, with general dimensions of about 9 inches by 6 inches. Some of the slab edges are semi-planar and may coincide with jointing patterns within the rock. The rock is generally gold to medium gray in color, with some reddish-brown oxidation staining. The rock generally appears to be slightly weathered, very strong, and very hard. The slab surface exhibits a splotchy texture lacking well-defined layering. Oxidation staining is variable on the slab edges, and also occurs as relatively limited fracture filling.</p> <p>Slab 4 exhibits several readily visible, continuous and discontinuous fractures with a maximum width of about 1/32 inch. Fracture filling material is primarily calcite and iron-oxide. Several carbonate and/or iron-oxide filled microfractures are also visible through the stereographic microscope.</p> <p>No significant changes were noted during testing.</p>

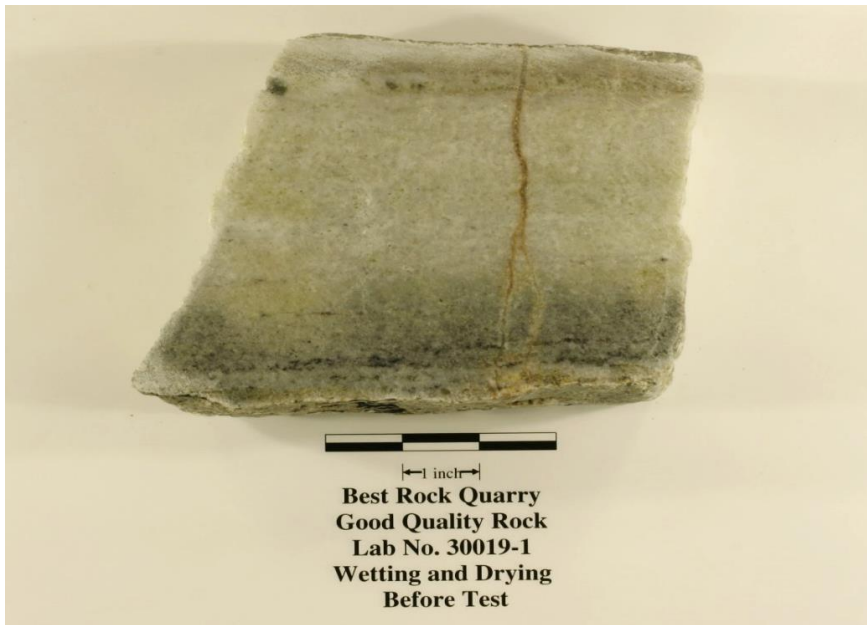
Photograph #17	Remarks

<p>Wetting and drying test (ASTM D5313-12), poor quality sample, Slab 5 (30019-1), white rock, before testing. (Note: label in photo should say "Poor Quality Rock")</p>

Sample ID/Bath Type	Initial/ Final Weight (grams)	Weight/ Percent Change	Description
Slab 5 (30019-1) Poor Quality White Rock Tap Water	i=3,071.2 f=3,071.8	+.6g +.02%	<p>The Slab 5 sample is an angular, quarried piece of poor quality white rock (marble). The slab is approximately 2-1/2-inches thick, with general dimensions of about 6 inches by 5 inches. Some of the slab edges are semi-planar and may coincide with jointing patterns within the rock. The rock is generally white to medium gray in color, with limited light reddish-brown oxidation staining. The rock generally appears to be slightly weathered, strong, and very hard. Subtle layering defined by alternating bands of lighter and darker minerals is visible in the slab surface. Oxidation occurs as variable staining on some of the slab edges and as fracture filling.</p> <p>Slab 5 exhibits a few readily visible, continuous and discontinuous fractures with a maximum width of about 1/16 inch. Fracture filling material is primarily calcite and iron-oxide. Several carbonate and/or iron-oxide filled microfractures are also visible through the stereographic microscope.</p> <p>No significant changes were noted during testing.</p>

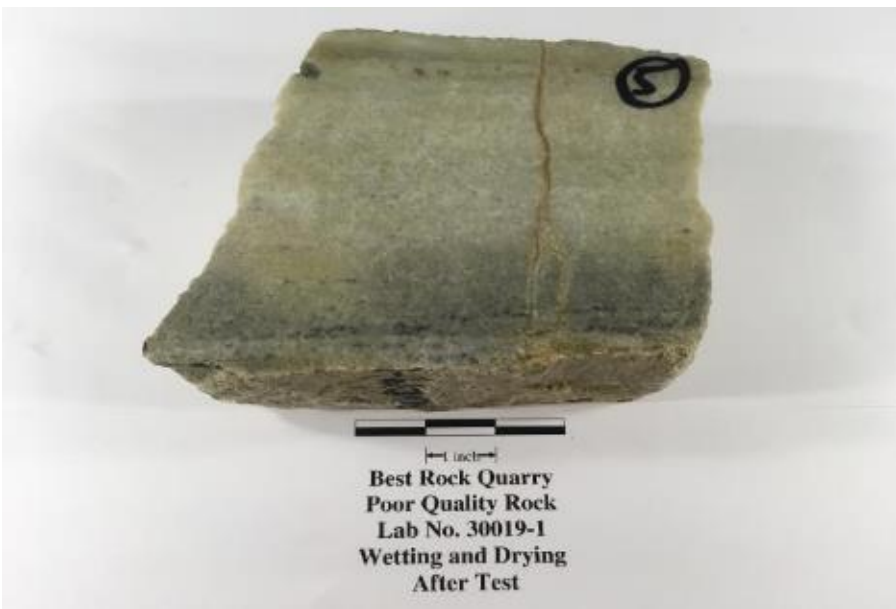
Photograph #18	Remarks

<p>Wetting and drying test (ASTM D5313-12), poor quality sample, Slab 5 (30019-1), white rock, after testing.</p>
