# ±134 Acres FOR SALE BEST ROCK QUARRY/MINE

## Best Rock Quarry/Mine

26282 Neuman Rd. • Barstow, CA

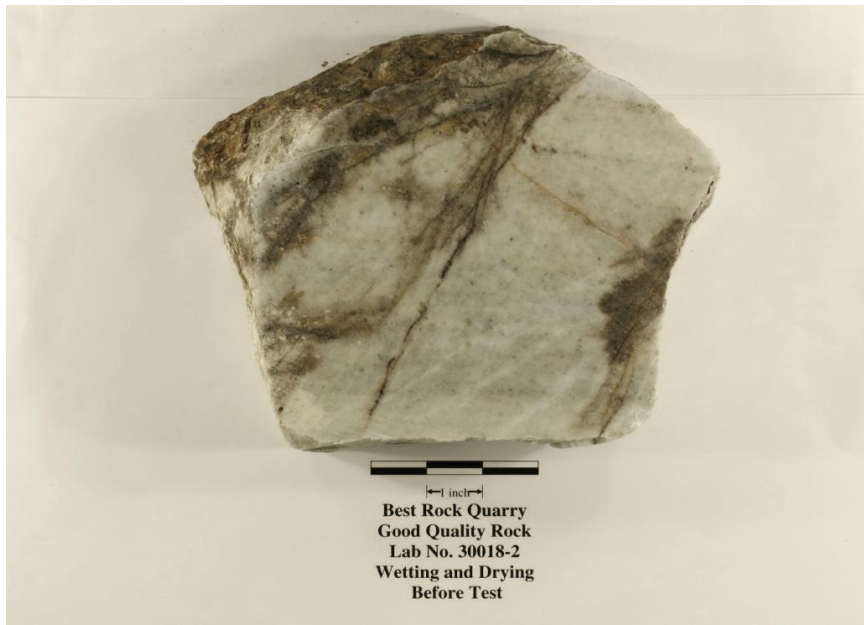
Photograph #19	Remarks

<p>Best Rock Quarry Good Quality Rock Lab No. 30018-2 Wetting and Drying Before Test</p>	<p>Wetting and drying test (ASTM D5313-12), poor quality sample, Slab 6 (30019-2), white rock, before testing. (Note: label in photo should say "Poor Quality Rock", lab number should be 30019-2)</p>

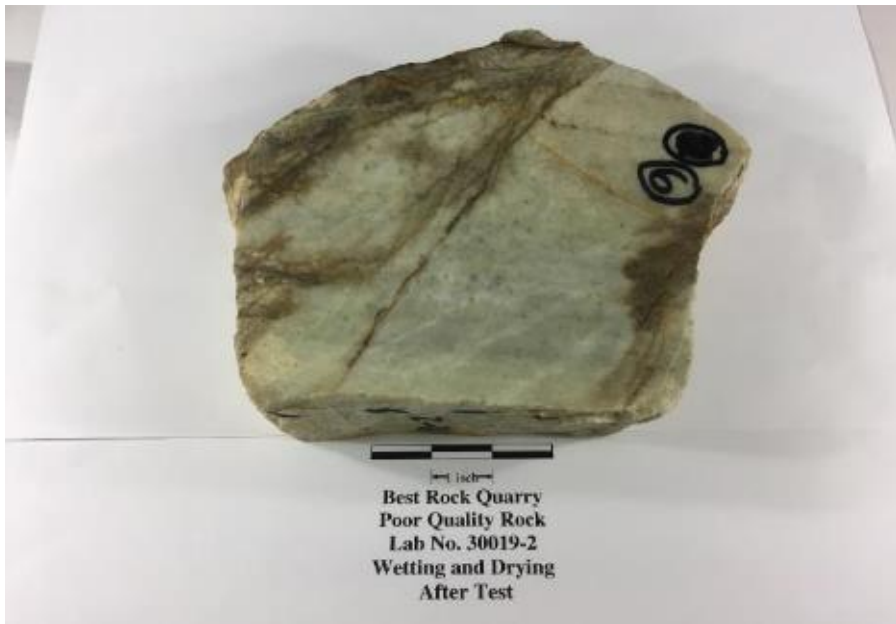
Photograph #20	Remarks

<p>Best Rock Quarry Poor Quality Rock Lab No. 30019-2 Wetting and Drying After Test</p>	<p>Wetting and drying test (ASTM D5313-12), poor quality sample, Slab 6 (30019-2), white rock, after testing.</p>

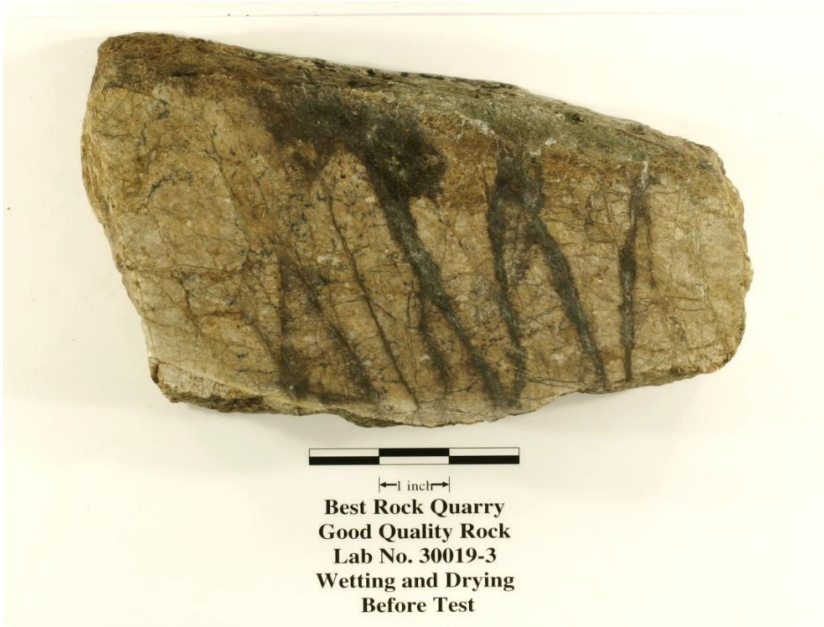
Photograph #21	Remarks

<p>Wetting and drying test (ASTM D5313-12), poor quality sample, Slab 7 (30019-3), gold rock, before testing. (Note: label in photo should say "Poor Quality Rock")</p>

Slab 7 (30019-3) Poor Quality Gold Rock Tap Water	i=3,884.1 f=3,886.1	+2g .05%	<p>The Slab 7 sample is an angular, quarried piece of poor quality gold rock (marble). The slab is approximately 2-1/2-inches thick, with general dimensions of about 9 inches by 5 inches. Some of the slab edges are semi-planar and may coincide with jointing patterns within the rock. The rock is generally gold to dark brown in color. The rock generally appears to be moderately weathered, strong, and very hard. The slab surface and slab edges exhibit an irregular texture dominated by fracturing and oxidation.</p> <p>The surface of Slab 7 is riddled with abundant irregular and/or cross-cutting fractures. Extensive dark brown oxidation is present within and adjacent to the fractures, with the total width of the oxidized zones ranging up to about 1/4 inch. Some carbonate fracture filling is also present, primarily in narrow, discontinuous fractures. Numerous carbonate and/or iron-oxide filled microfractures are also visible through the stereographic microscope.</p> <p>No significant changes were noted during testing.</p>

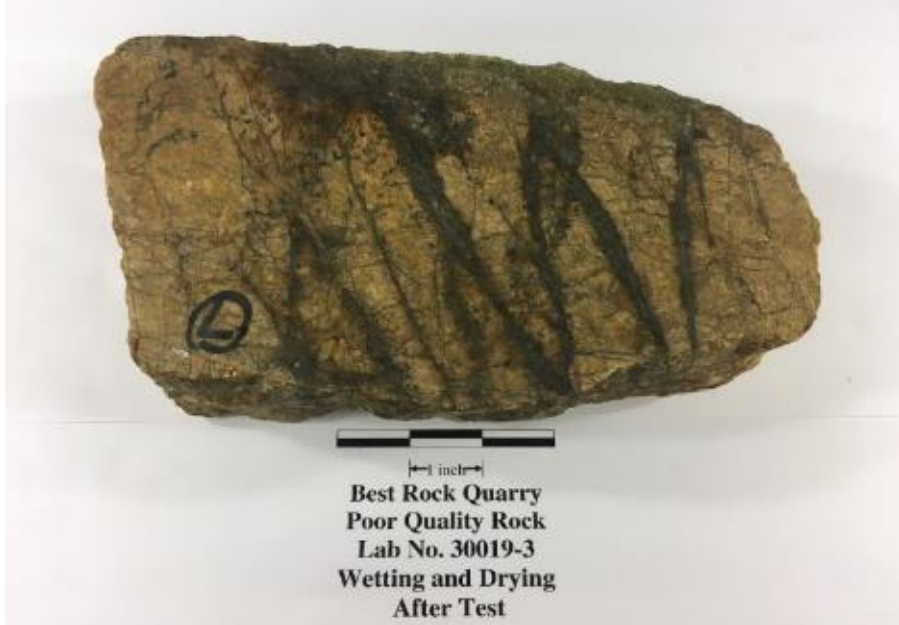
Photograph #22	Remarks

<p>Wetting and drying test (ASTM D5313-12), poor quality sample, Slab 7 (30019-3), gold rock, after testing.</p>

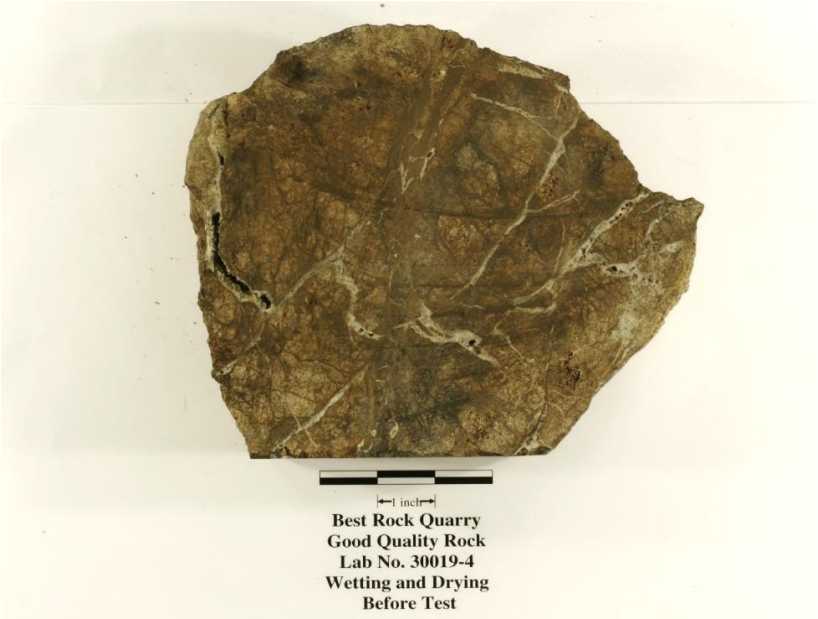
Photograph #23	Remarks

<p>Best Rock Quarry Good Quality Rock Lab No. 30019-4 Wetting and Drying Before Test</p>	<p>Wetting and drying test (ASTM D5313-12), poor quality sample, Slab 8 (30019-4), gold rock, before testing. (Note: label in photo should say "Poor Quality Rock")</p>

Slab 8 (30019-4) Poor Quality Gold Rock Tap Water	i=3,888.4 f=3,891.4	+3g +.08%	<p>The Slab 8 sample is an angular, quarried piece of poor quality gold rock (marble). The slab is approximately 2-1/2-inches thick, with general dimensions of about 8 inches by 8 inches. The rock is generally gold to dark brown in color. The rock generally appears to be moderately weathered, strong, and very hard. The slab surface and slab edges exhibit an irregular texture dominated by fracturing and oxidation.</p> <p>The surface of Slab 8 is riddled with abundant irregular and/or cross-cutting fractures. Extensive dark brown oxidation is present within and adjacent to the fractures, with the total width of the oxidized zones ranging up to about 1/2 inch. In some areas the fractures form a mosaic-like pattern defined by numerous randomly oriented fractures. Some irregular, carbonate-filled fractures generally ranging up to about 1/8 in width are also present. Numerous carbonate and/or iron-oxide filled microfractures are visible through the stereographic microscope. A few scattered voids were observed in the slab surface. The largest void has a width of about 1/4 inch and is lined with euhedral carbonate crystals.</p> <p>No significant changes were noted during testing.</p>

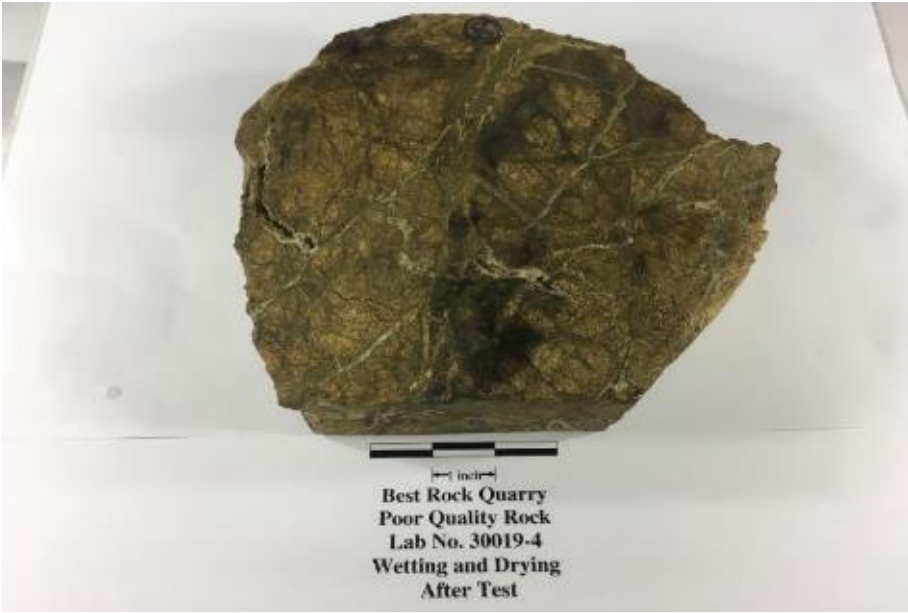
Photograph #24	Remarks

<p>Best Rock Quarry Poor Quality Rock Lab No. 30019-4 Wetting and Drying After Test</p>	<p>Wetting and drying test (ASTM D5313-12), poor quality sample, Slab 8 (30019-4), gold rock, after testing.</p>

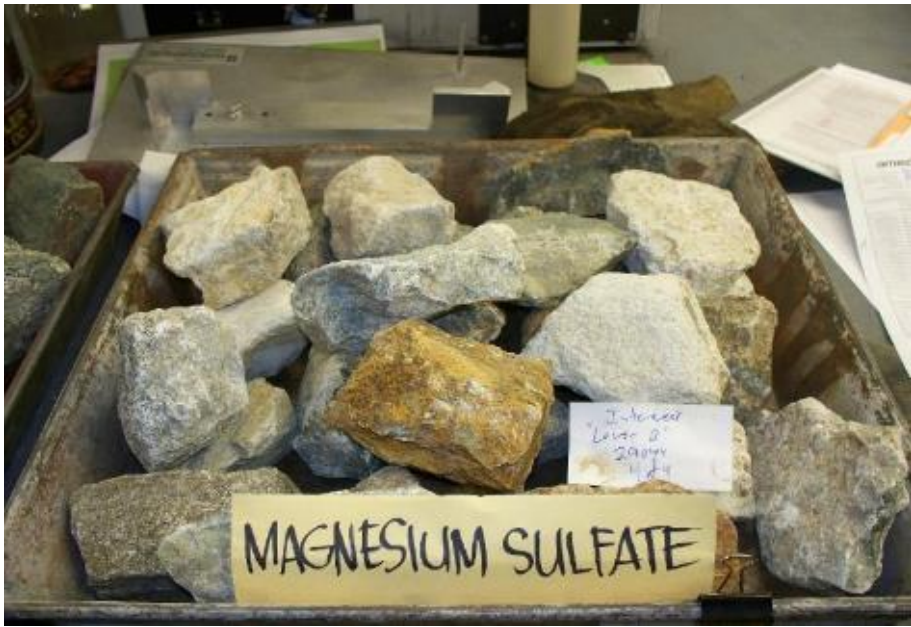
Photograph #31	Remarks

<p>Magnesium sulfate soundness (ASTM C88-13), poor quality rock (29044), before testing.</p>

\*The test method was performed in general accordance of ASTM C88, except the samples consisted of one size which was visually separated to include material that was approximately 3" x 4" per USACE specifications. The loss was calculated by loss of weight after testing of the aggregate and the remaining material was loosely passed over the 3" sieve. USACE project specifications provided to us by the client call for a weight loss of no more than 10%.

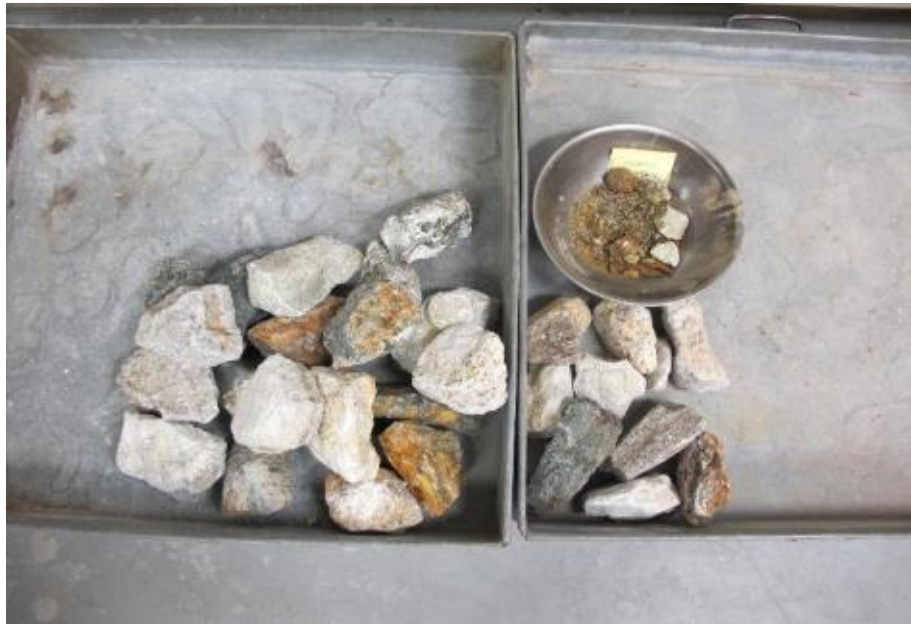
Photograph #32	Remarks

<p>Magnesium sulfate soundness (ASTM C88-13), poor quality rock (29044), after testing.</p>
