Remedial Action Summary for the

Hazelwood Interim Storage Site Property

FUSRAP North St. Louis County Sites, St. Louis, Missouri

Revision 1

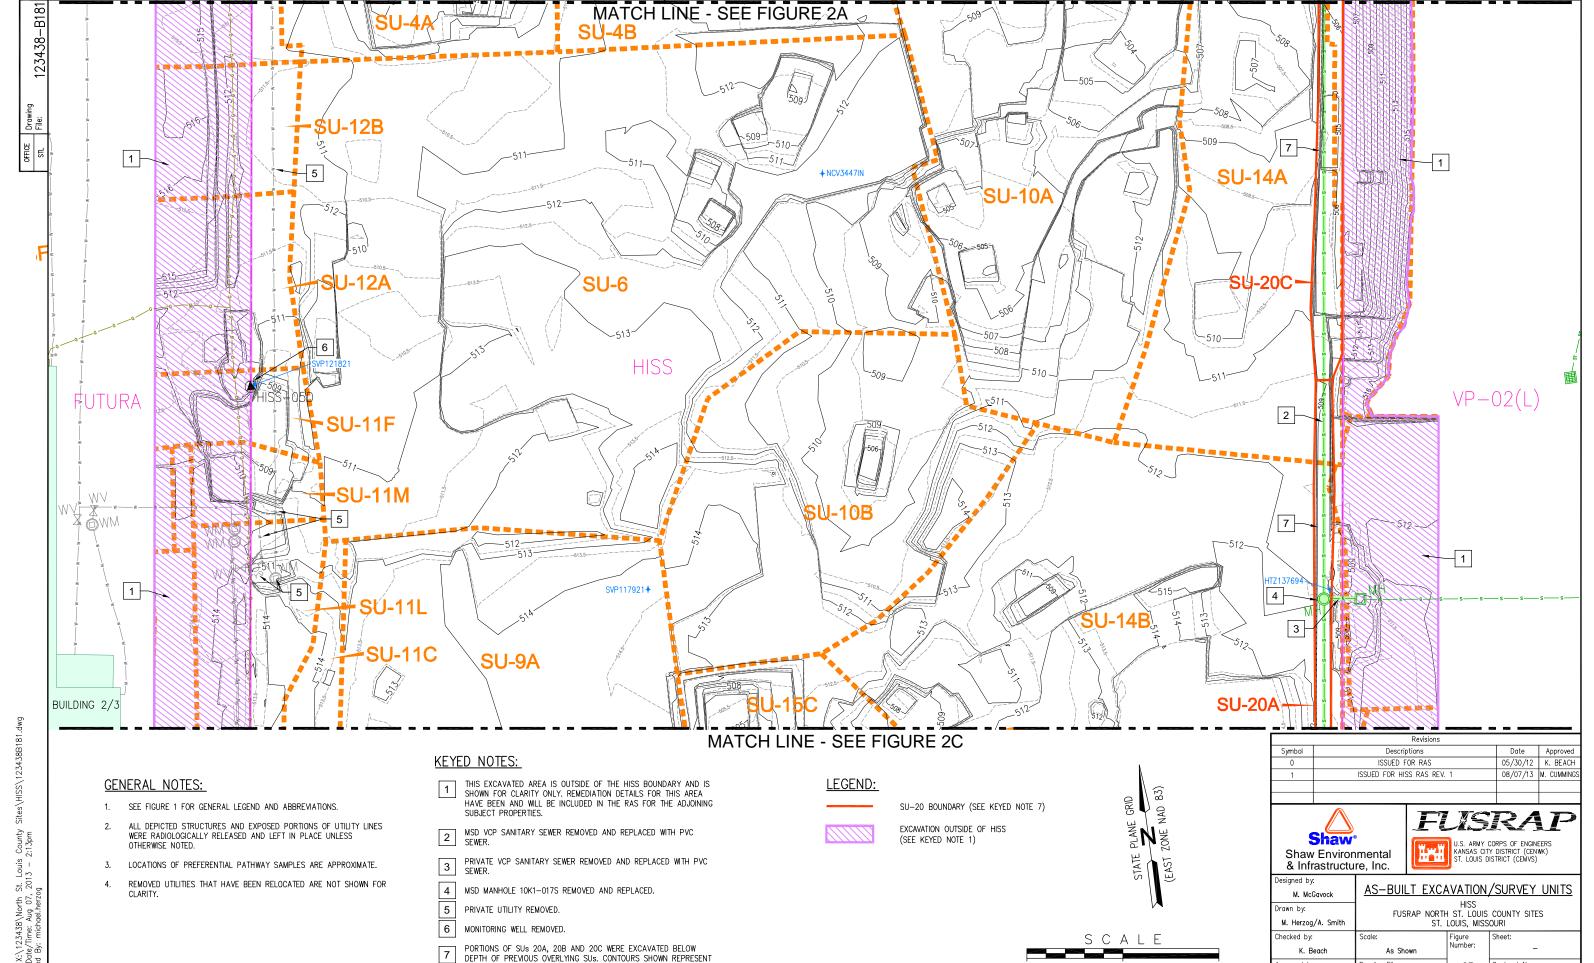
FINAL EXCAVATION SURFACE. SEE FIGURE 2F FOR ENLARGED VIEW.

East – Tract 3, and VP-02(L) properties. Excavations performed on these adjoining properties were generally conducted concurrently with the excavation of the adjoining HISS SUs. The asbuilt EAs and associated SUs are shown on Figures 2A through 2F. The sequence of remediation activities for each area excavated under the RD/RAWDs (Shaw, 2007b; Shaw, 2010a) was generally as follows:

Remediation along the shared Futura/HISS boundary was sequenced to fully remediate corridors to allow for construction of a replacement water main at the Futura property while leaving the existing water main in service. This required excavation in a less efficient piecemeal manner to minimize service interruption. Other portions of sewer utilities were removed and replaced at or near their original locations as needed to facilitate excavation. These areas are shown on Figures 2A through 2F.

Various utilities were removed for remediation, and the active utilities were replaced upon completion of work. The majority of the affected utilities were re-installed to their approximate original location/routing as indicated on Figures 2A through 2F, except as otherwise noted.

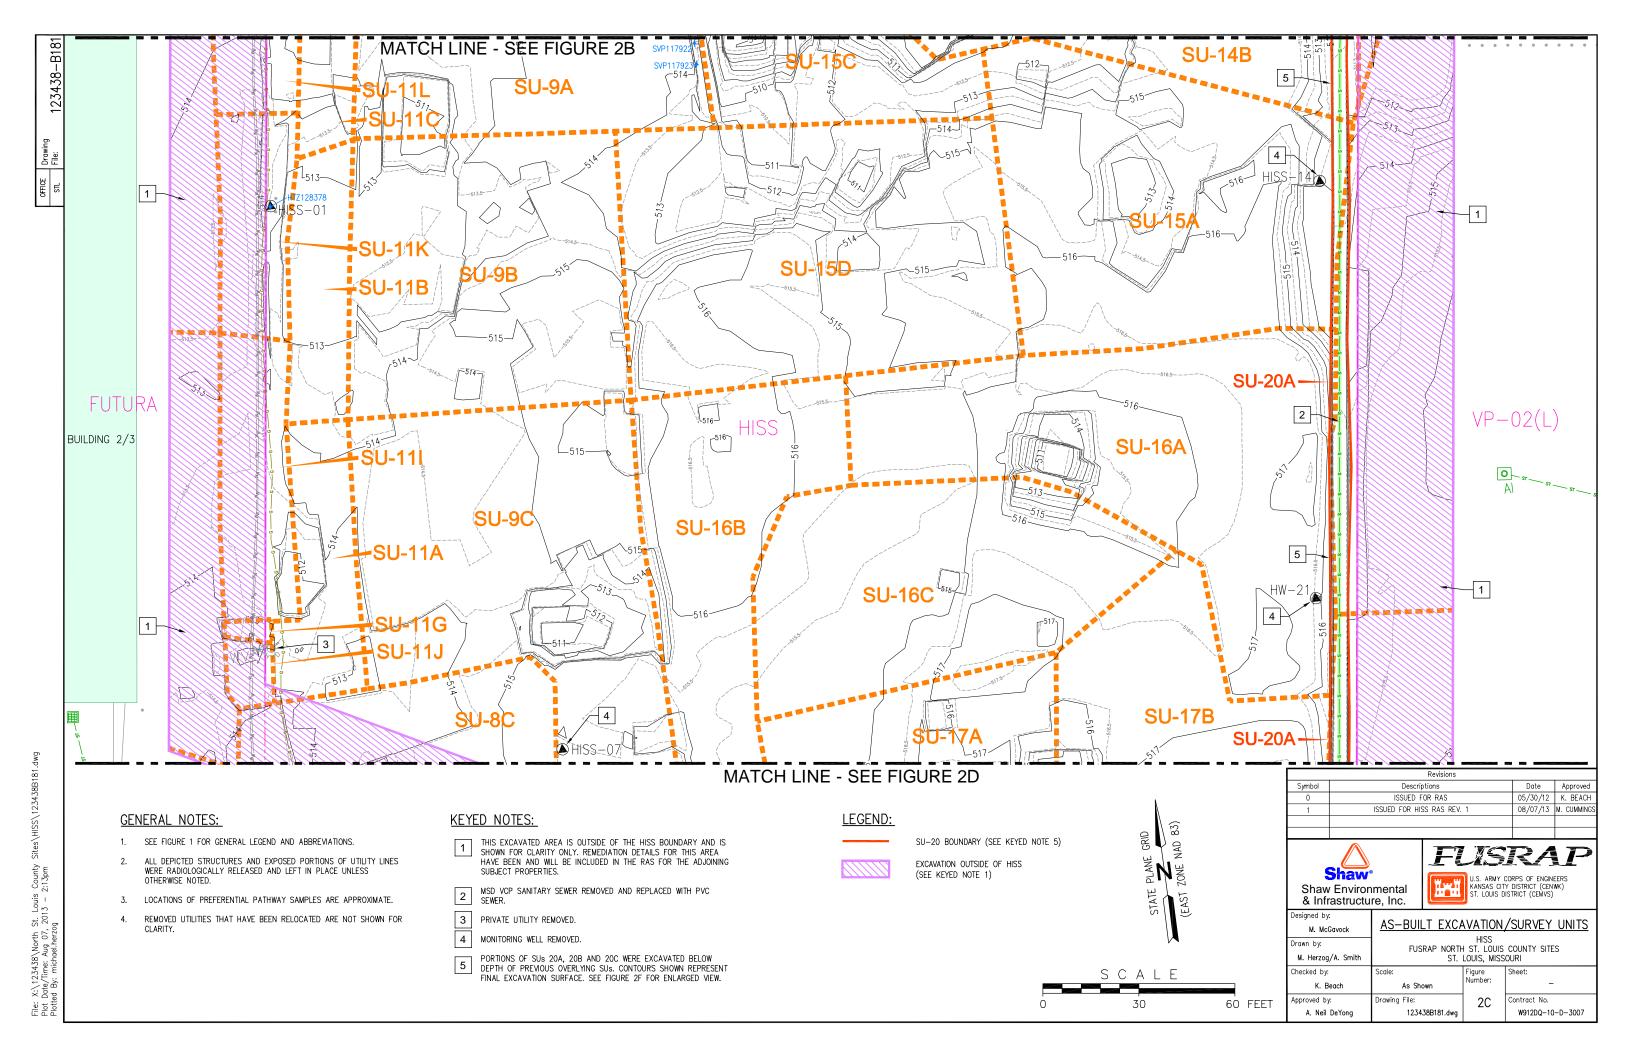
AS-BUILT EXCAVATION/SURVEY UNITS

PRIVATE PVC SANITARY SEWER REMOVED AND REPLACED.

PORTIONS OF SUS 20A, 20B AND 20C WERE EXCAVATED BELOW DEPTH OF PREVIOUS OVERLYING SUS. CONTOURS SHOWN REPRESENT FINAL EXCAVATION SURFACE. SEE FIGURE 2F FOR ENLARGED VIEW.

LOCATIONS OF PREFERENTIAL PATHWAY SAMPLES ARE APPROXIMATE.

Approximately 80 linear feet of 6-inch diameter PVC private sanitary sewer that serves the Futura facilities was also removed and replaced to facilitate excavation on both the Futura and HISS properties.
