**Sunshine Club Treasure Island
12200 Gulf Boulevard, Treasure Island
Coney Island Block 12, Lots 8, 9 & 10 Less Rd
Pinellas County, Florida
Double Ring Infiltration Test
November 2022**

Report Number. 243134

Re: Double Ring Infiltration (DRI) Test for Sunshine Club Treasure Island,
12200 Gulf Boulevard, Treasure Island, FL 33706
CFTL Report No. 243134

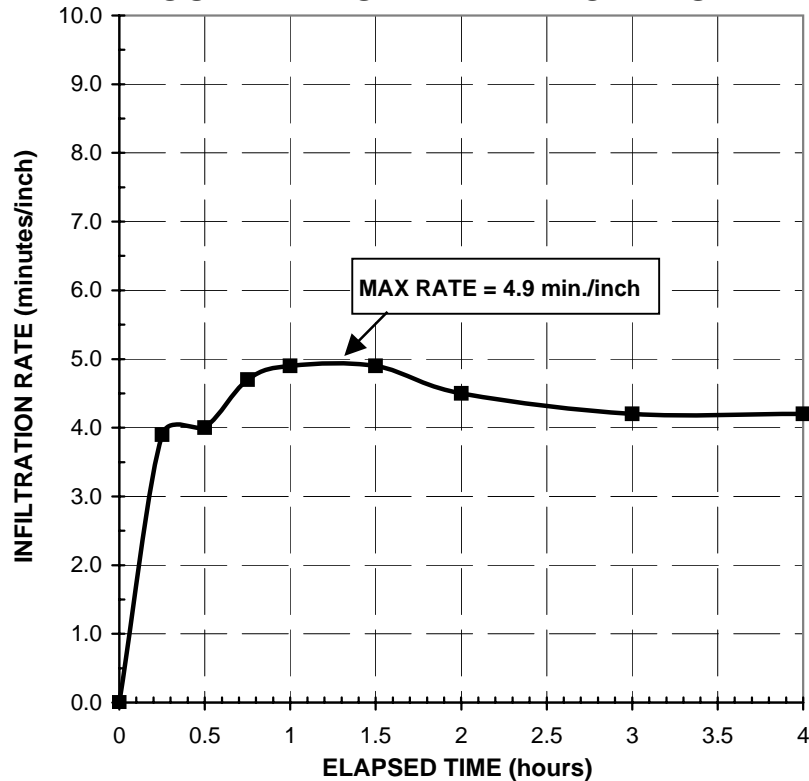
DOUBLE RING INFILTRATION TEST

DOUBLE RING INFILTRATION DATA

Test Location: **DRI-1**
 Test Elevation: **1.5 feet below existing land surface**
 Test Date: **November 14, 2022**

Depth (ft.)	Munsel No.	Description
0.0 to 0.5	10YR 5/1	Gray fine sand
0.5 to 1.7	10YR 7/1	Light gray fine sand
1.7 to 6.0	10YR 7/3	Very pale brown fine sand w/shell

Maximum Infiltration Rate (min./in.): 4.9

WATER TABLE AT TIME OF TEST (BLS): EST. **2.5'**
 EST. SEASONAL HIGH WATER TABLE **Tidal (2.5')**

The maximum infiltration rate at DRI-1 was determined to be a fairly rapid 4.9 minutes per inch (12.2 inches/hr.) after 4 hours of testing with the test apparatus seated approximately 1.5 feet below the ground surface or 1 foot above the static water table level.
