SHEET 1 OF 2
 LOTS 2,3,4,6,7 & 9, BLOCK 29, N.C.B. 18076
 AMENDING PLAT OF
 CULEBRA CROSSING SHOPPING CENTER SUBDIVISION
 VOL. 9510, PAGE 110, D.P.R.B.C.T.
 LOT 11, BLOCK 29, N.C.B. 18076
 REPLAT OF A PORTION OF
 CULEBRA CROSSING SHOPPING CENTER SUBDIVISION
 VOL. 9512, PAGE 161, D.P.R.B.C.T.
 CITY OF SAN ANTONIO, TEXAS

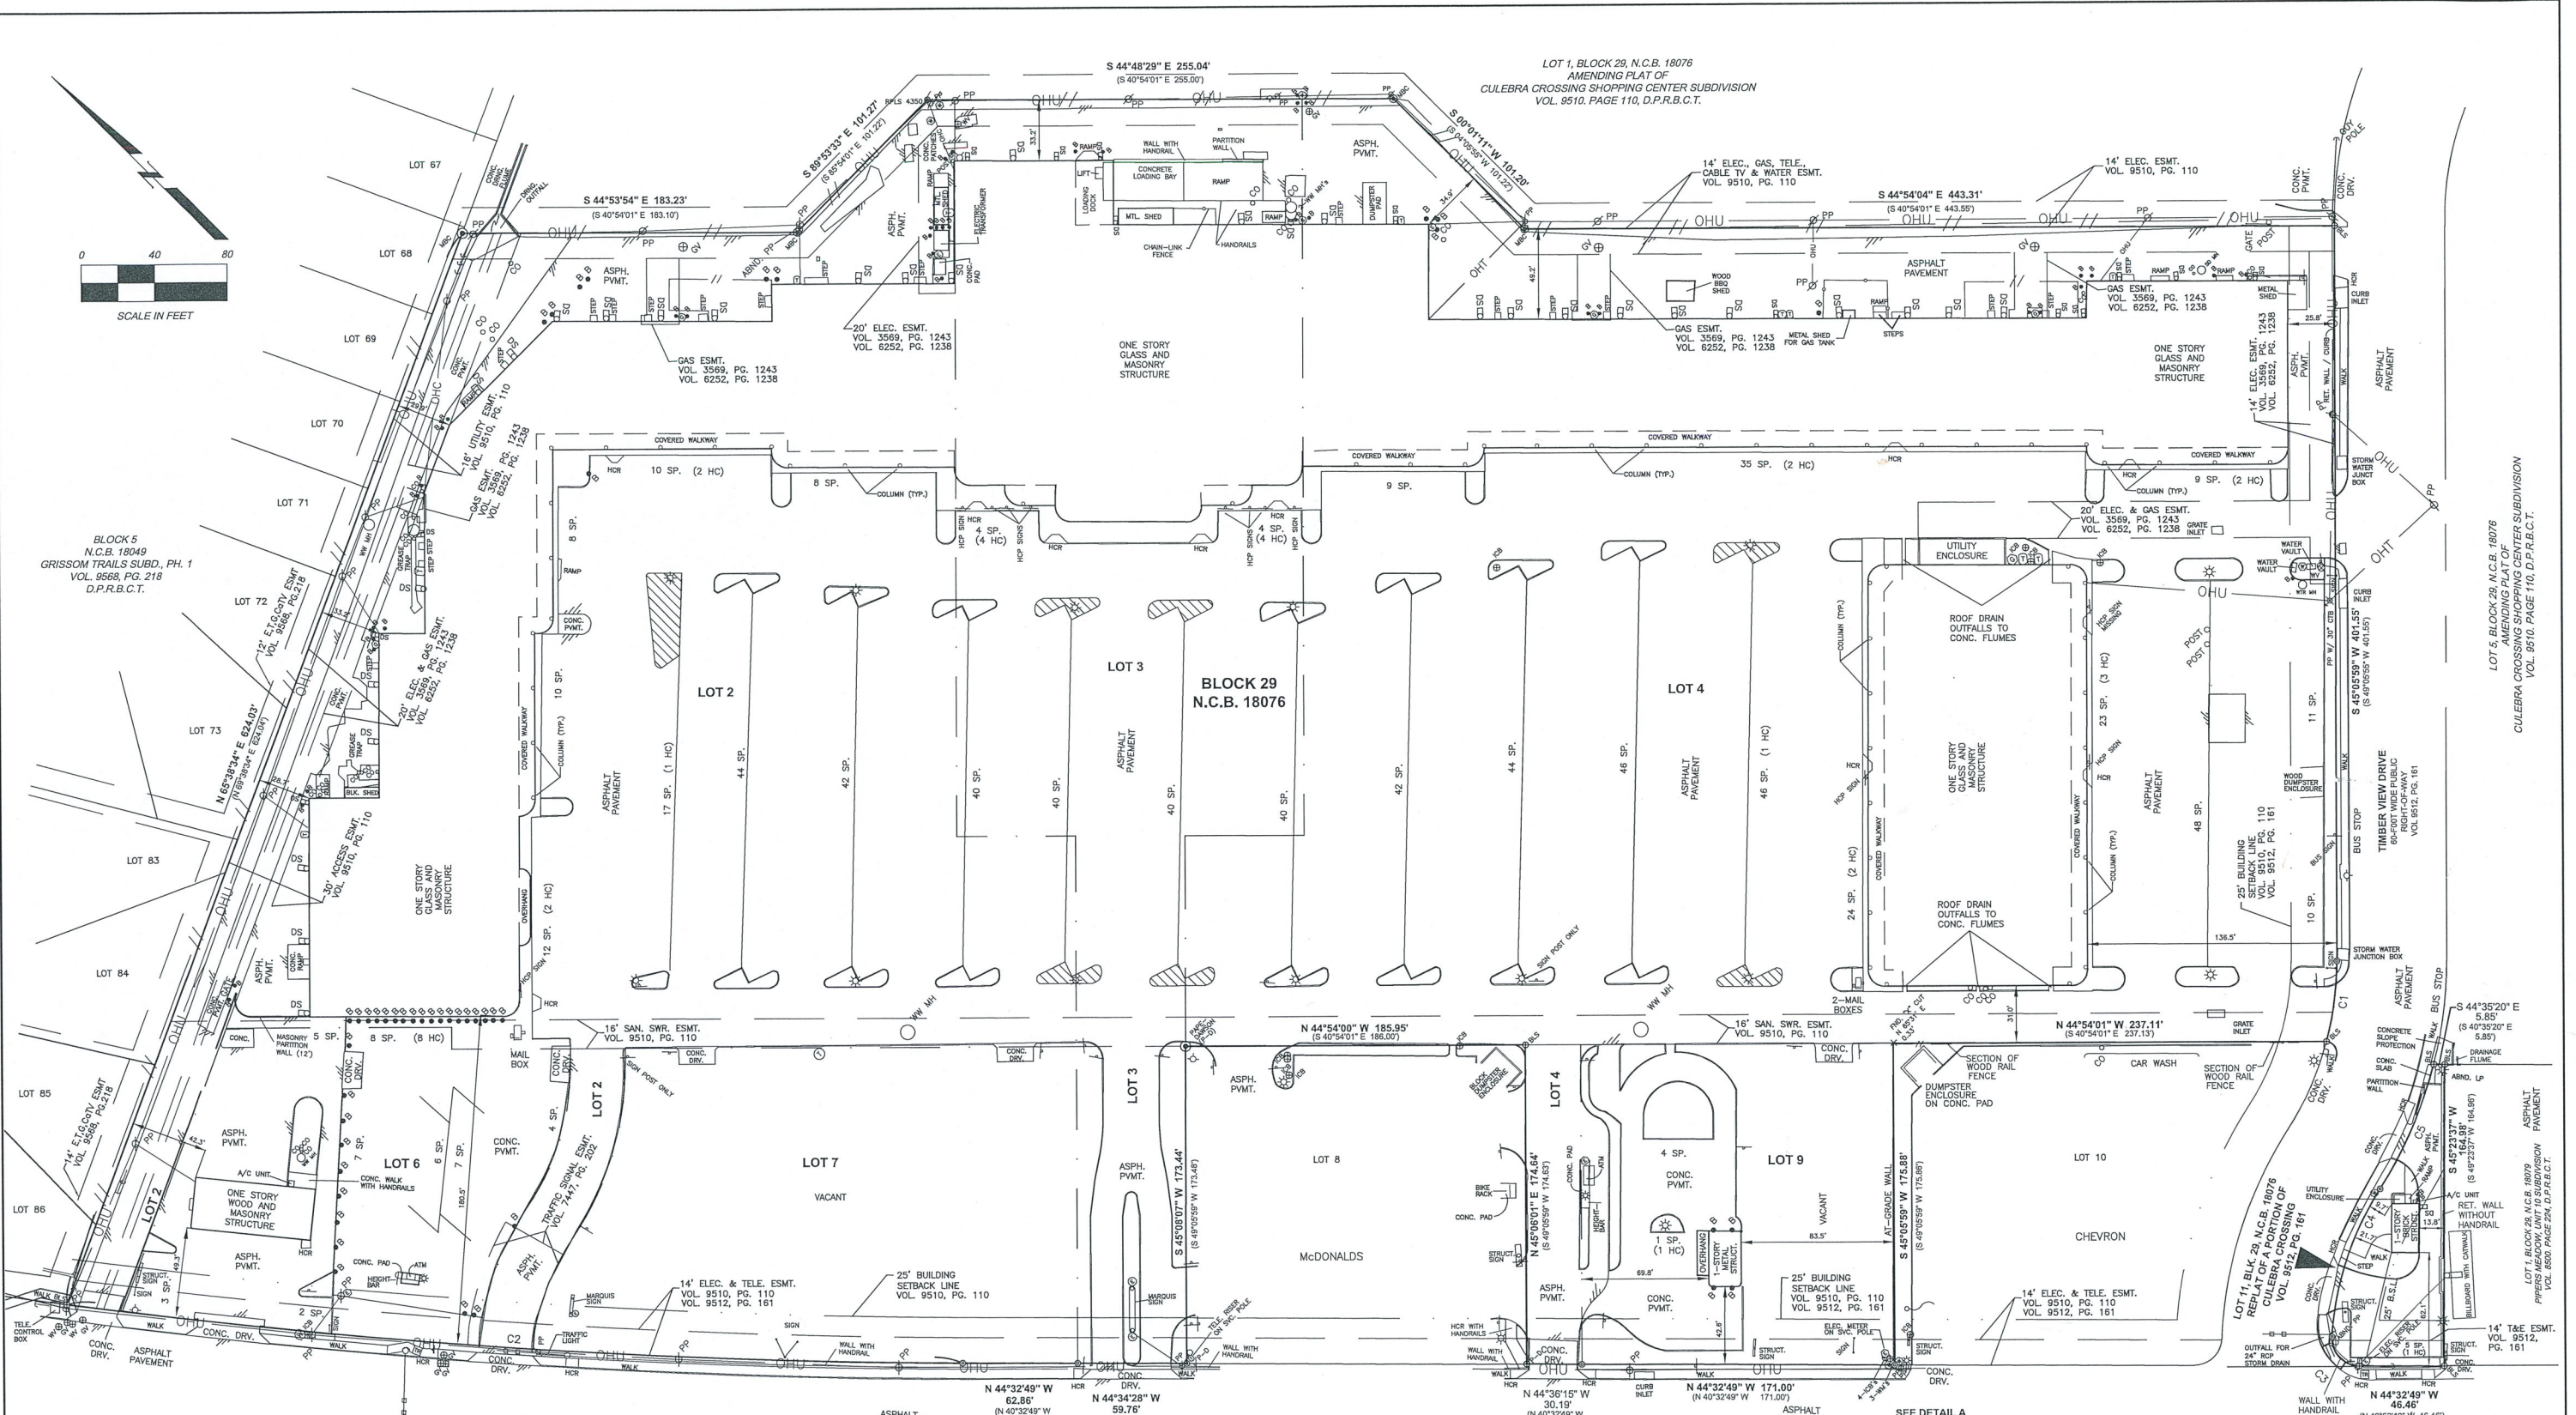
CURVE	RADIUS	DELTA	ARC LEN	CHD BRNG	CHD LEN
C1	170.00'	15°00'30"	44.53'	S 52°36'14" W	44.40'
C2	3912.00'	7°12'37"	492.29'	N 40°56'31" W	491.97'
C3	15.00'	93°28'07"	24.47'	N 02°10'13" E	21.85'
C4	170.00'	29°00'31"	86.07'	N 63°24'32" E	85.15'
C5	230.00'	18°31'45"	74.38'	N 68°38'54" E	74.06'
