Reference: **Test Pit Evaluation**
St. Augustine - Golf
St. Augustine, Florida
UES Project No. 0930.2100209.0000 and Report No. 1905298

GEOTECHNICAL EXPLORATION
 ST. AUGUSTINE GOLF
 ST. AUGUSTINE, FLORIDA
 TEST PIT / BORING LOCATION PLAN

TEST PIT PROFILES

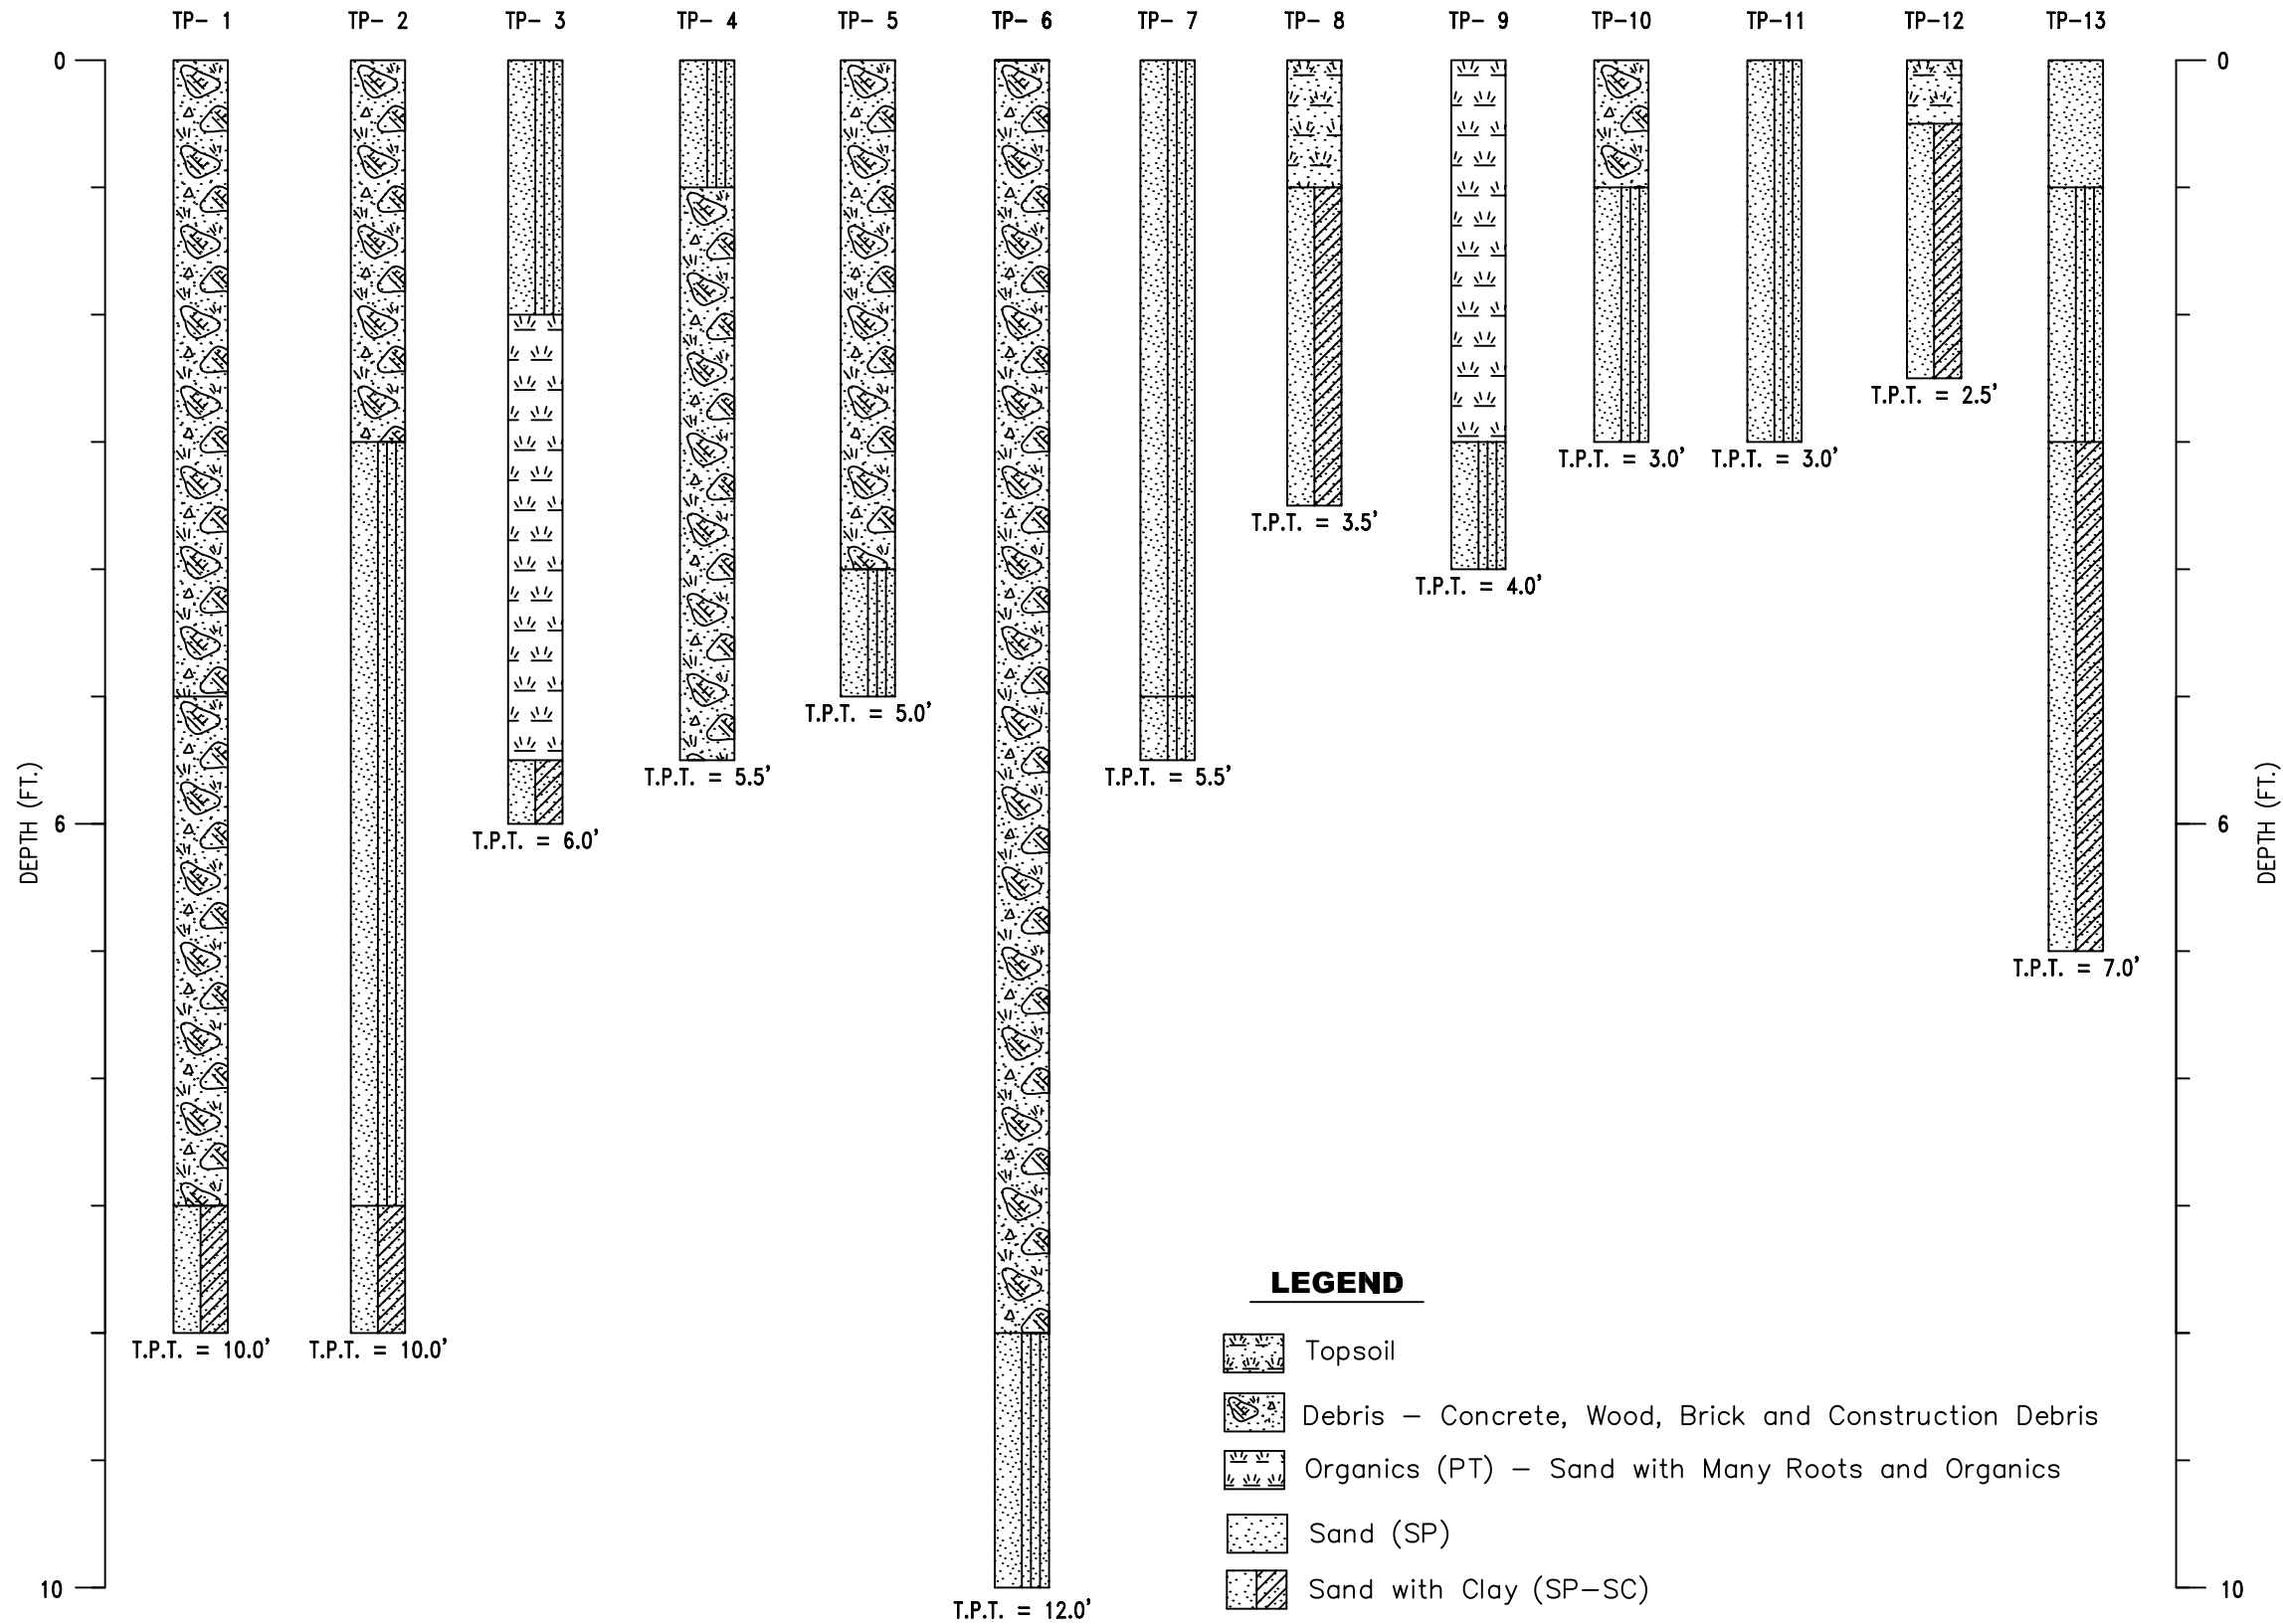
We observed thirteen (13) test pit excavations on October 5, 2021 to depths of approximately 2.5 to 12.0 feet below the existing ground surface. The Test Pits generally encountered a thin layer of topsoil underlain with fine sand with silt and many organics/ pieces of wood/ concrete debris (PT, DEBRIS) and extending to 1.0 to 8.0 feet. These materials were underlain by fine sand with silt (SP-SM) and fine sand with clay (SP-SC) extending to the maximum depth explored of 2.5 to 12.0 feet below the existing grade at the time of our exploration. As an exception test pit locations 8, and 11 through 13 generally encountered a thin layer of topsoil underlain with fine sand (SP), fine sand with clay (SP-SC) and fine sand with silt (SP-SM) to the maximum depth explored of 7.0 feet below the existing ground surface at these locations. It should be understood that the soil conditions will vary away from and between the test pit locations. The Test Pit locations and detailed subsurface conditions are illustrated in the Appendix. The following Table presents the encountered depths of unsuitable materials.

Table 1 Depths of Encountered Unsuitable Materials	
Test Pit	Depth of Encountered Unsuitable Materials (ft)
TP-1	0-9.0
TP-2	0-3.0
TP-3	2-5.5
TP-4	1.0-5.5*
TP-5	0-4.0
TP-6	0-10.0
TP-7	--
TP-8	--
TP-9	0-3.0
TP-10	0-1.0
TP-11	--
TP-12	--
TP-13	--

Depths are below the existing grade at the time of our evaluation. In areas where unsuitable materials were not encountered surficial topsoils should be anticipated.
*Test Pit TP-4 did not penetrate the debris due to large concrete debris

Based on the results of the test pits, the soils with pieces of wood, concrete and other construction debris and soils with many organics (PT/ DEBRIS) are not suitable to remain in place below the proposed building and pavement areas. These materials should be removed and replaced with properly compacted structural fill. Over excavation of debris and placement of structural fill should be performed in accordance with our report July 27, 2021.

Within the proposed pavement areas a geosynthetic (such as Mirafi RS380I or equivalent) can be incorporated into the subgrade in lieu of full overexcavation of debris to the depths encountered. A minimum separation of 3 feet is recommended below the bottom of the base and any organics/ debris. A more detailed design incorporating a geosynthetic into the pavement section design can be formulated once more detailed site grading information is available. Although this option can be used in lieu of overexcavation of debris to the depths encountered, some periodic pavement maintenance may be necessary.
