# WOOD DESTROYING PESTS AND ORGANISMS INSPECTION REPORT

Building No.	Street	City	Zip	Date of Inspection	Number of Pages
2005	9th Street	Los Osos	93402	08/08/2024	1 of 7

**Report #: 108611**

General Description: Two story; Commercial; Stucco and wood shake exterior; Composition shingle roof; Furnished and occupied.	Inspection Tag Posted: Electrical room.
Other Tags Posted:

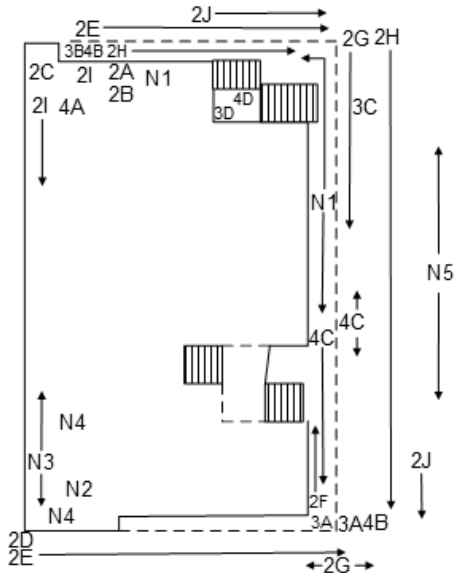
**\*\*\*Complete Inspection Report\*\*\***  
 Diagram not to scale-Finding locations approximate

Key: 1 = Subterranean Termites   
 2 = Drywood Termites   
 3 = Fungus/Dryrot   
 4 = Other Findings   
 5 = Unknown Further Inspection
