900 NORTHWEST 2nd STREET, FORT LAUDERDALE, FL. 33311

SHEET 1 OF 2 (SKETCH OF SURVEY) - SEE SHEET 2 OF 2 FOR LEGAL DESCRIPTION, AND OTHER SURVEY RELATED DATA. SURVEY IS NOT COMPLETE WITHOUT ALL SHEETS

Last Revision Date: 12-13-2019 Boundary Survey prepared by: LB8111

LEGAL DESCRIPTION OF: 900 NW 2 ST, FT. LAUDERDALE, FL, 33311

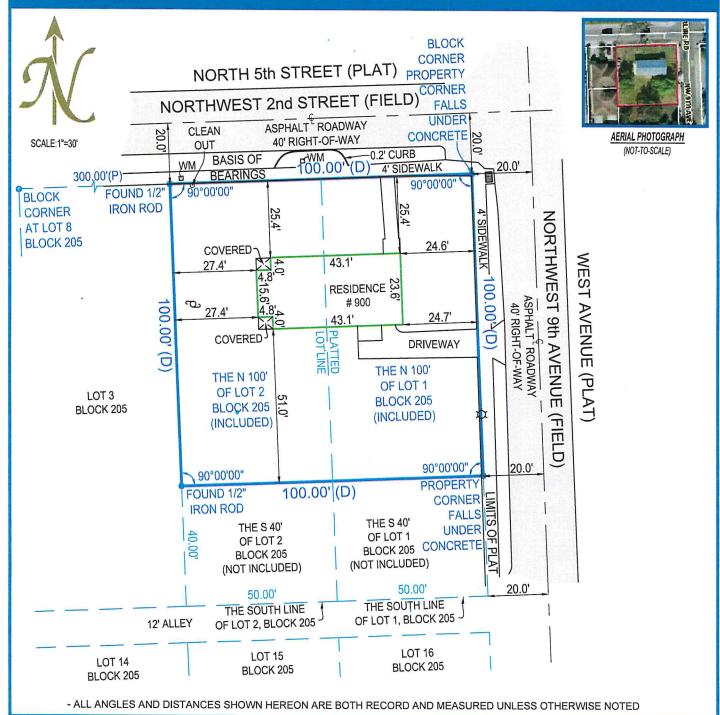
- DRIVEWAY CROSSES THE BOUNDARY LINE ON EASTERLY SIDE OF LOT AS SHOWN.
- CONCRETE WALK CROSSES THE BOUNDARY LINE ON NORTHERLY SIDE OF LOT AS SHOWN.
