Pentz Appliance :: 13 - 15 S Center

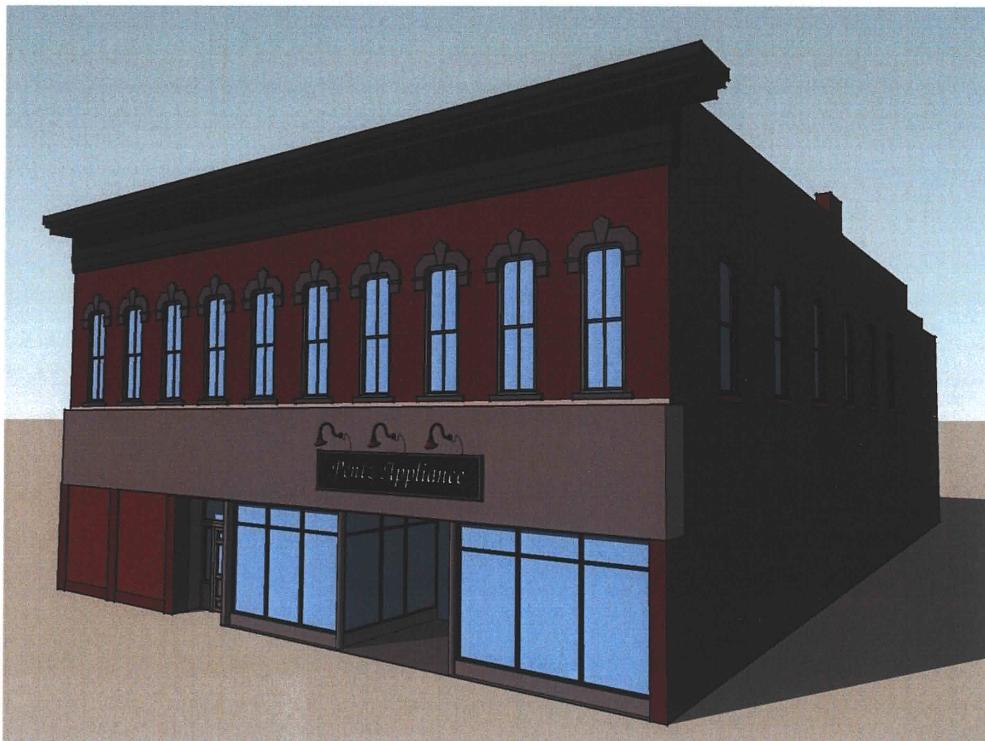
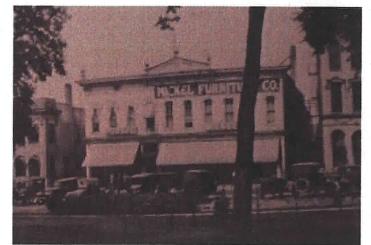
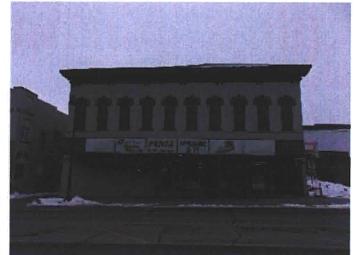
ABOVE LEFT: PROPOSED RENDERING
 ABOVE RIGHT: HISTORIC PHOTO
 BELOW: EXISTING CONDITION

Work Proposed	
Windows (2nd Floor)	Remove stucco from window openings to reveal historic windows. Repair and rehabilitate ten (10) existing historic wood windows at primary façade. Paint colors will be chosen from a palette sensitive and compatible to the historic district. Repairs shall conform to Preservation Brief 9 - The Repair of Historic Wooden Windows. Alternates to include providing operable storm windows to provide protection for historic window and increased energy efficiency. Repair and rehabilitate six (6) existing historic wood windows at north façade; provide operable storm windows.
Doors	Remove stucco from historic door opening at first floor. Rehabilitate and restore original entryway. Repair or replace existing door hardware with commercial grade hardware.
Exterior Walls	Remove stucco from primary façade. Assume all masonry to be repointed and 100 square feet of masonry repairs. Analyze existing historic mortar to determine appropriate strength, color, texture and tooling for the replacement mortar. Repairs shall conform to Preservation Brief 2 - Repointing Mortar Joints in Historic Masonry Buildings. Alternate work to include removing stucco from secondary (north) facade. Assume an additional 800 square feet of repointing.

Porch / Stairs / Deck / Ramp	N/A
Foundation	No work.
Storefront / signage	Alternate work to include removing existing signage. Make repairs to transom area and paint. Provide new signage that is complimentary or compatible to the historic district.
