## **ASBESTOS INSPECTION REPORT**

**James Wayne Properties**

3505 Houston Highway  
Victoria, Texas

one story commercial/industrial

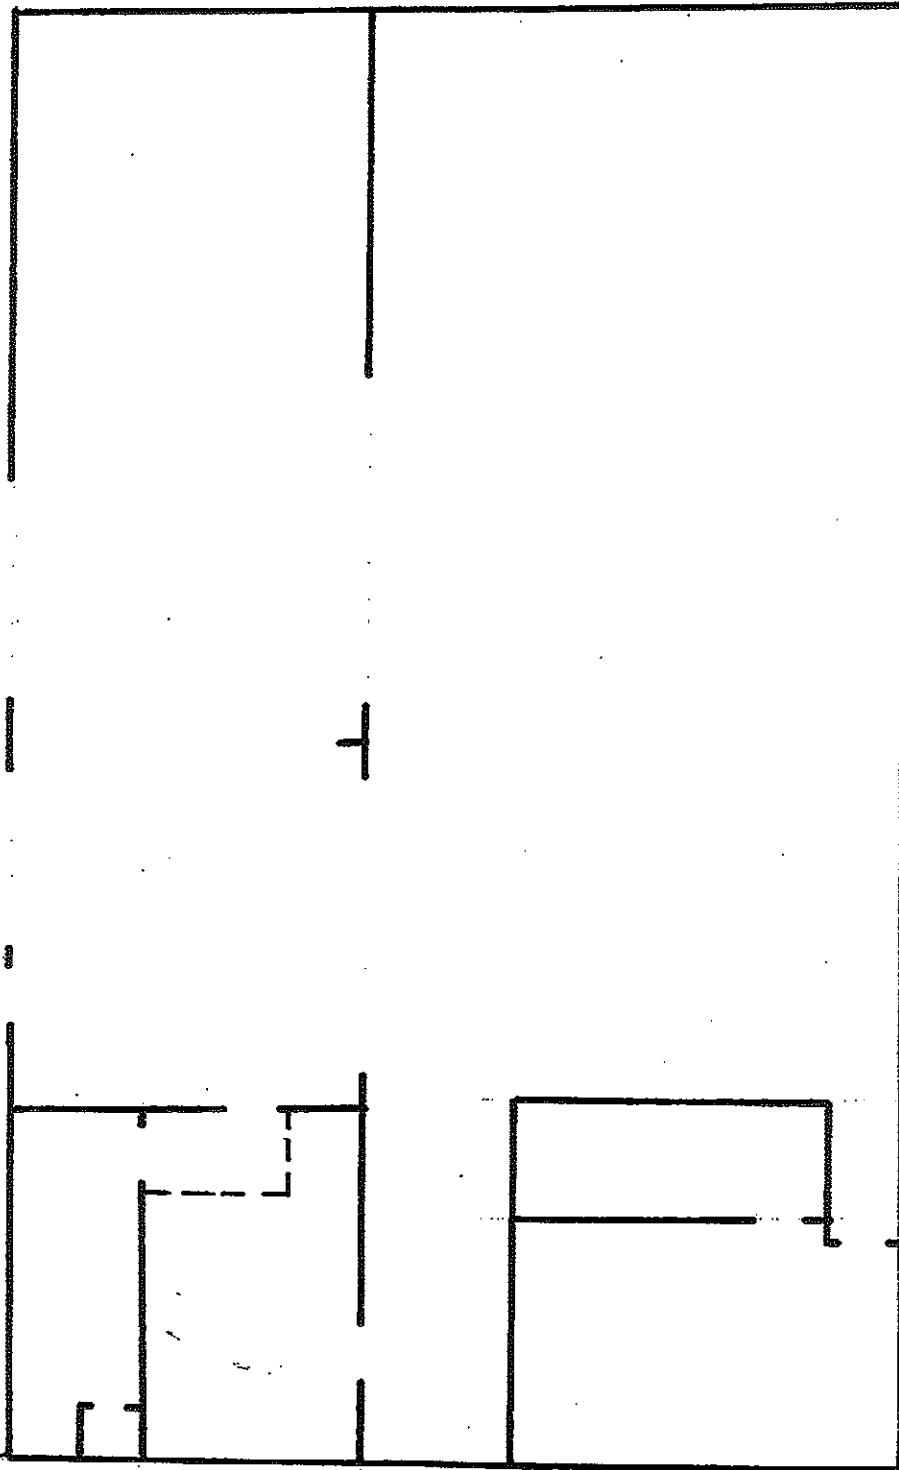
BUILDING A  
3505 HOUSTON HIGHWAY

Bldg. A (lab/work bldg. faces highway)

| 01-03 | floor tile/mastic (office) |
| 04-06 | 2x2 ceiling tile (office) |
| 07-09 | wall plaster |

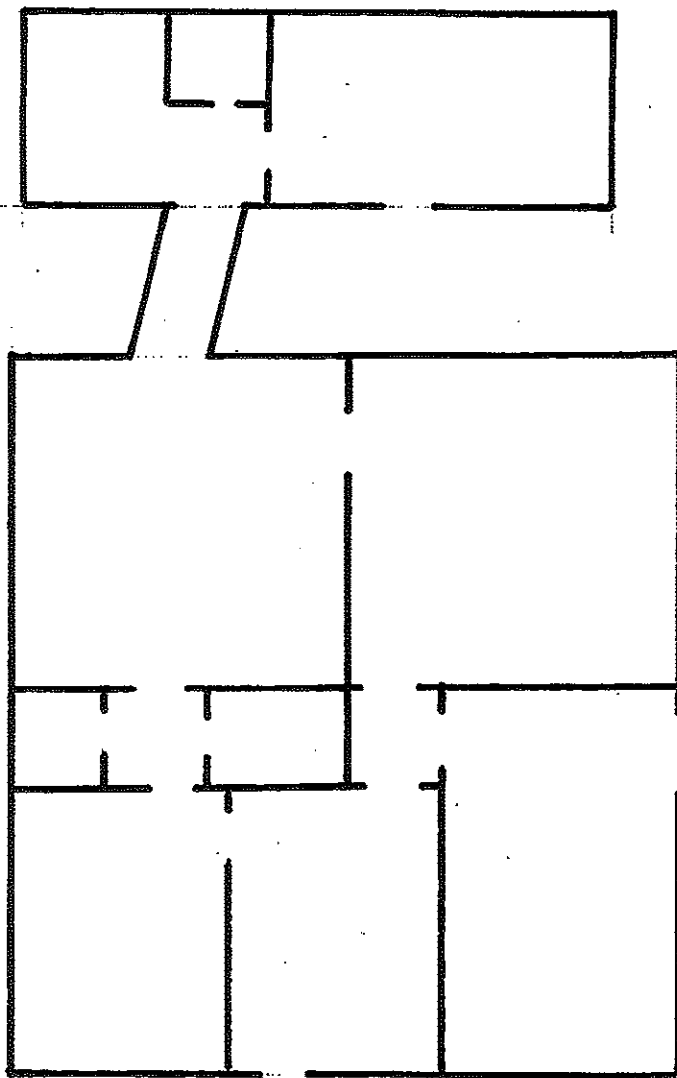
BUILDING B  
3505 HOUSTON HIGHWAY

Bldg. B (office bldg. closest to highway)

| 10-12 | 9x9 red floor tile/mastic (entrance room and rear utility closet) |
| 13-15 | 12x12 floor tile/mastic (attached portable bldg.) |

9x9 red floor tile/mastic (10-12)  
floor tile/mastic (13-15 in attached portable)

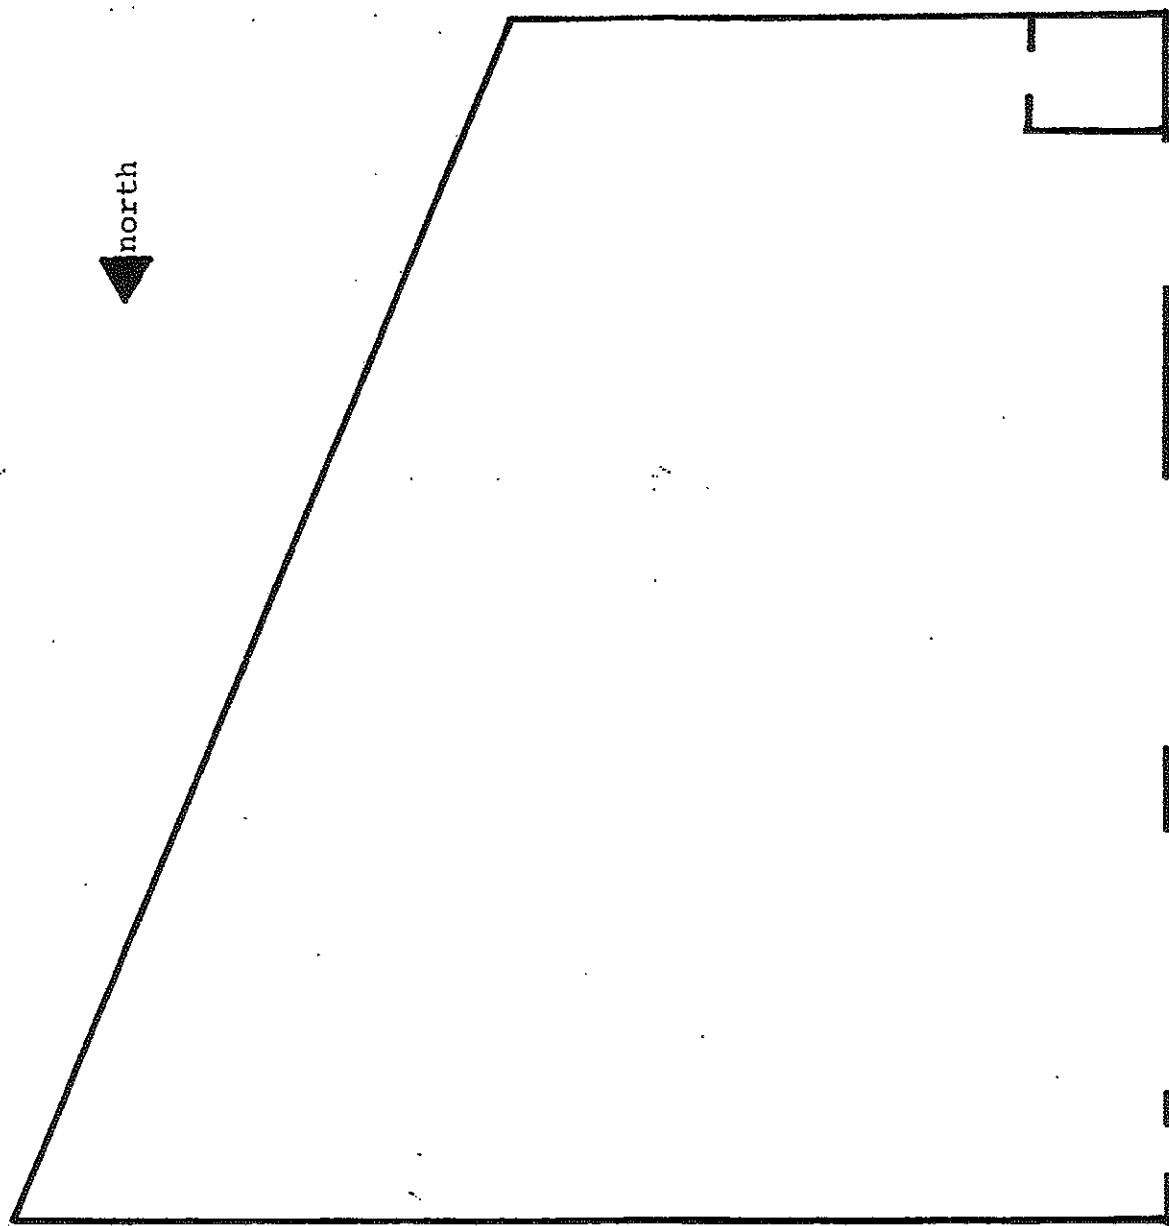
BUILDING C  
3505 HOUSTON HIGHWAY

Bldg. C (warehouse at rear)

| 43-45 | floor tile/mastic (office) |
