WOOD DESTROYING PESTS AND ORGANISMS INSPECTION REPORT

BUILDING NO. 3735-41	STREET, CITY, STATE, ZIP Madison Ave & 4548 38th St., San Diego CA 92116	Date of Inspection 2/5/2025	No. of Pages 7
--------------------------------	----------------------------------------------------------------------------------------	---------------------------------------	--------------------------

General Description: Three one story four family structures, frame and stucco construction, composition roofs, attached and detached garages.

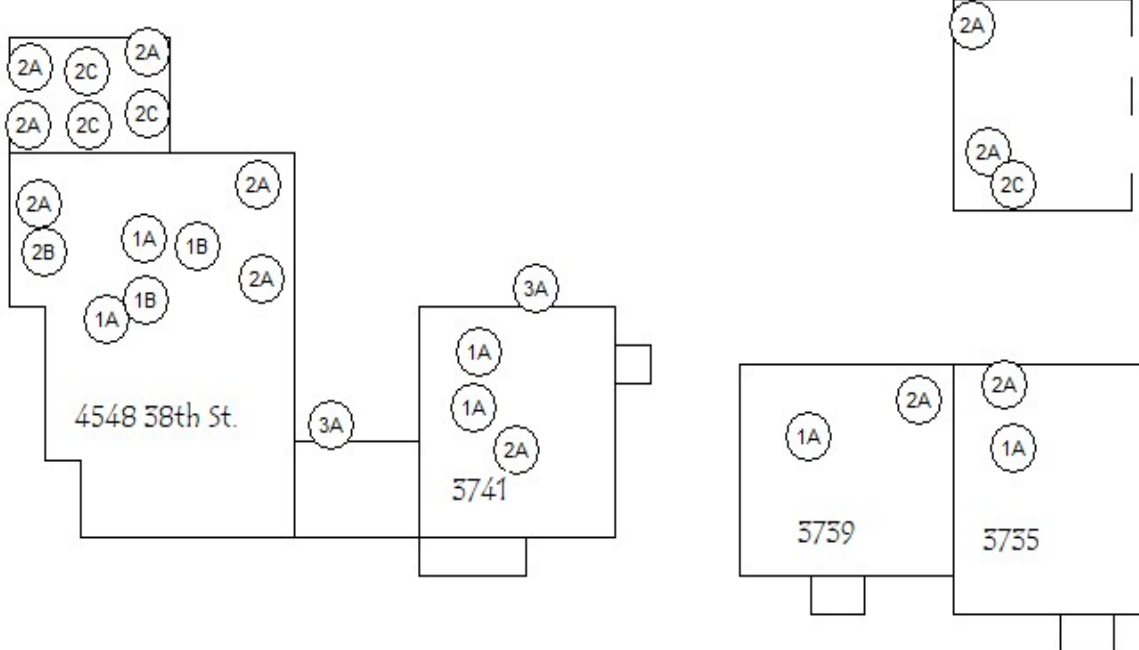
NOTE: Diagram not to scale. Findings in approximate locations.

FINDING: Evidence of subterranean termites and cellulose debris noted in subareas, see 1A on diagram.

FINDING: Evidence of subterranean termites noted in attic of 4548 38th Street, see 1B on diagram.

FINDING: Evidence of drywood termites noted in sub areas, attics, garages and hardwood flooring, see 2A on diagram.

FINDING: Evidence of drywood termite damage noted in 4548 38th Street hardwood flooring, see 2B on diagram.

FINDING: Evidence of drywood termite damage noted in garage framing, see 2C on diagram.

FINDING: Fungus damage noted in window moulding and eaves, see 3A on diagram.

RECOMMENDATION: Remove and dispose of all loose cellulose debris, chemically treat (Termidor) soil of infested areas by trench method as needed for control of subterranean termites. Treatment guaranteed for one year.

RECOMMENDATION: Remove and dispose of all loose cellulose debris, chemically treat (Termidor) soil of infested areas by trench method as needed for control of subterranean termites break down subterranean termite tubes as needed. Treatment guaranteed for one year.

RECOMMENDATION: Fumigate entire structure with lethal fumigant Sulfuryl Fluoride (VIKANE) Introduce Chloropicrin (tear gas) as needed as a warning agent. Fumigation will assure complete elimination of drywood termites, cover or clean up all visible and accessible pellets as needed. Fumigation notice and pesticide disclosure MUST be read and signed prior to injection of fumigant. Fumigation guaranteed for two years. **ALL FUMIGATIONS CANCELED LESS THAN 72 HOURS PRIOR TO SCHEDULED DATE WILL BE SUBJECT TO A CANCELLATION FEE OF 25% OF THE FUMIGATION COST.**

RECOMMENDATION: Remove and replace or repair drywood termite damage as needed. Work completed by D&S Termite guaranteed for one year. If certification is required D&S Termite must re inspect work completed by others. D&S Termite does not guarantee work completed by others. D&S Termite & Pest Control will apply primer coat, but cannot be responsible for match of color. If during the course of repair work, fungus and/or termite damage extends into inaccessible areas, there may be an additional charge for repairs. D&S Termite & Pest Control will contact you about additional charges if any.

RECOMMENDATION: Remove and replace or repair fungus damaged wood as needed. Work completed by D&S Termite guaranteed for one year. If certification is required D&S Termite must re inspect work completed by others. D&S Termite does not guarantee work completed by others. D&S Termite & Pest Control will apply primer coat, but cannot be responsible for match of color. If during the course of repair work, fungus and/or termite damage extends into inaccessible areas, there may be an additional charge for repairs. D&S Termite & Pest Control will contact you about additional charges if any.
