THE ALLIED REPORT

Inspection # **031224-1456**

Inspection Date: **3/12/2024**

Property Address: **14560 NE 3rd Court**

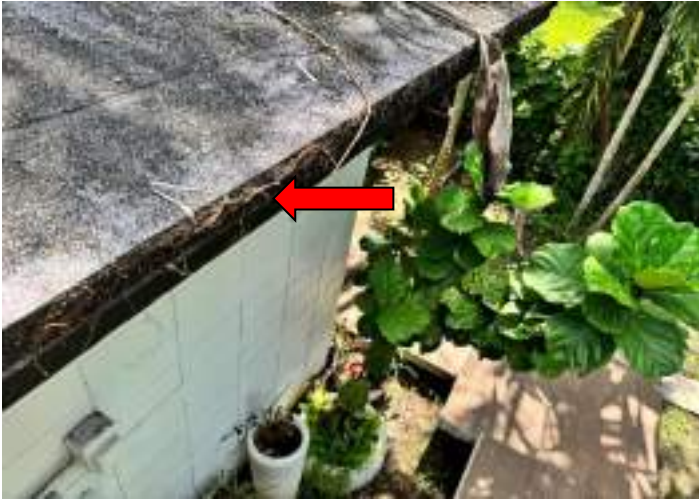
DISCOLORATION

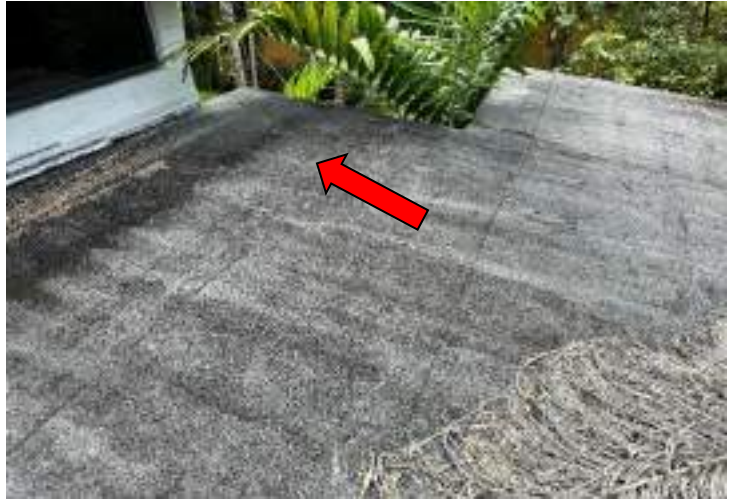
DISCOLORATION

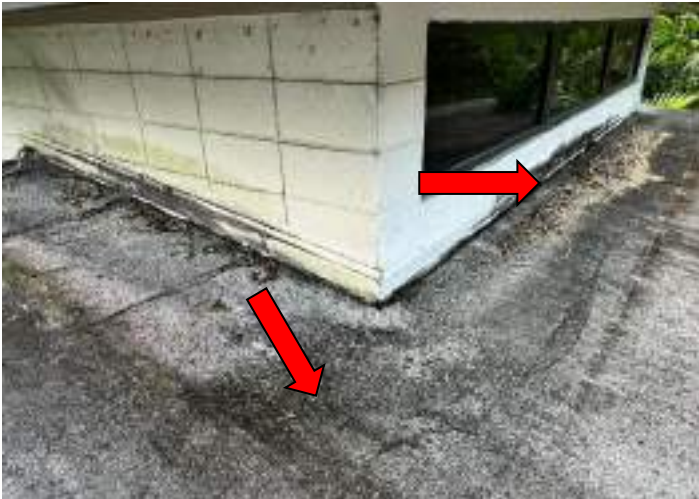
DISCOLORATION/DETERIORATED MEMBRANE

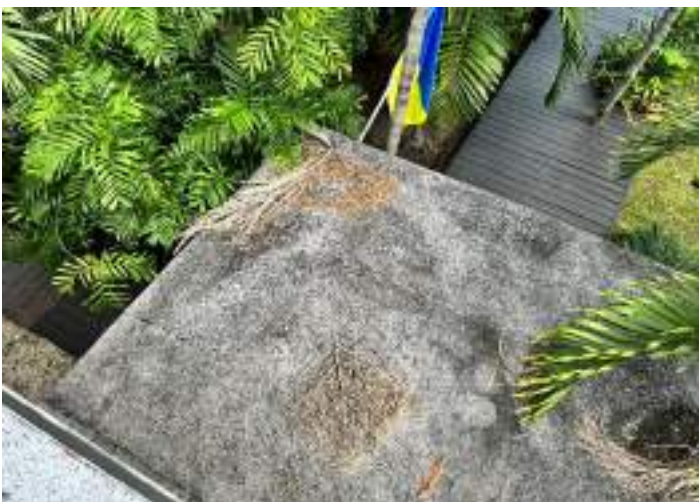
DISCOLORATION/DETERIORATED MEMBRANE

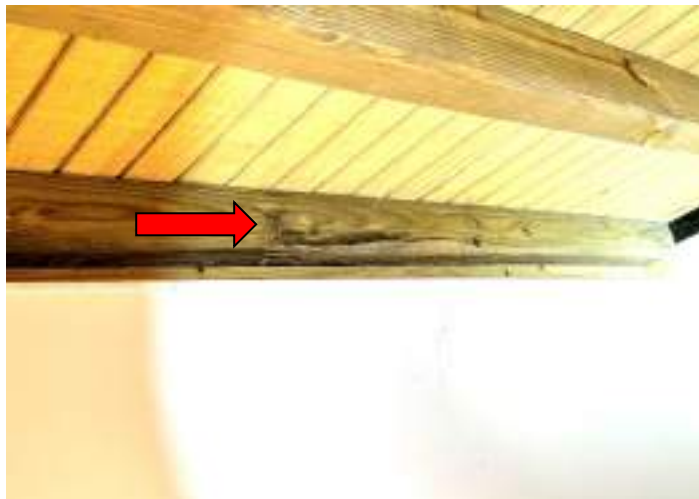
DAMAGED RAFTER

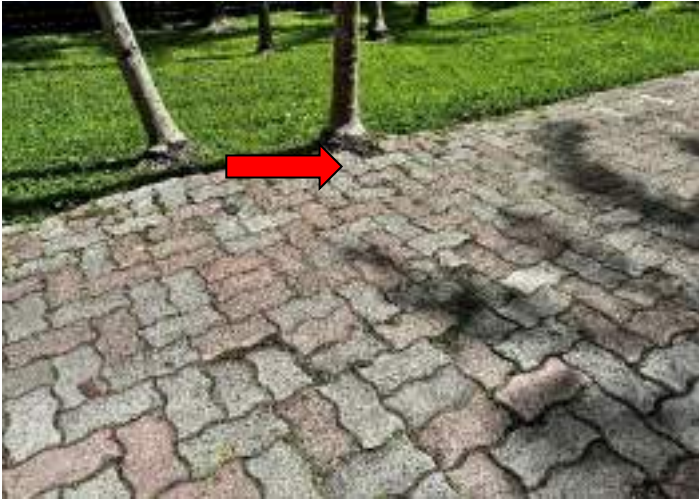
SETTLEMENT MOVEMENT

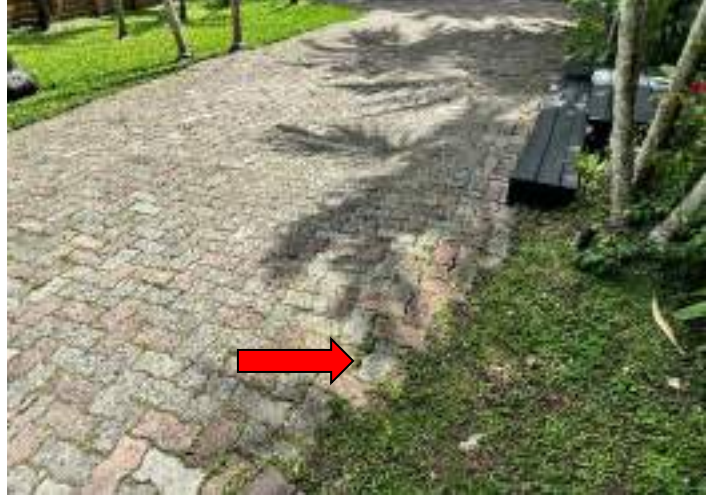
SETTLEMENT MOVEMENT

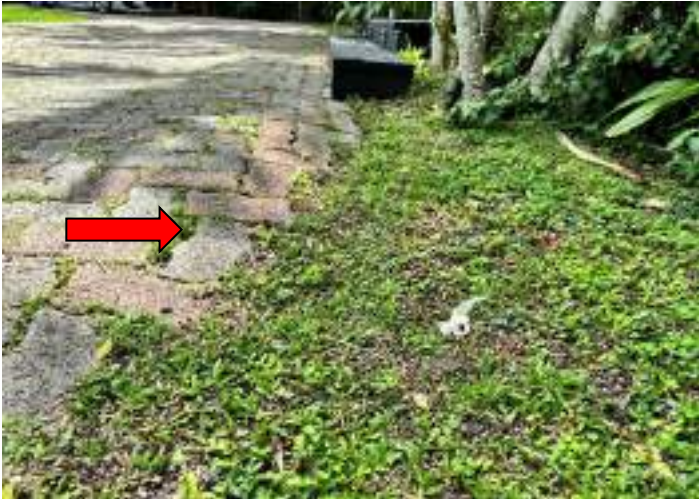
SETTLEMENT MOVEMENT

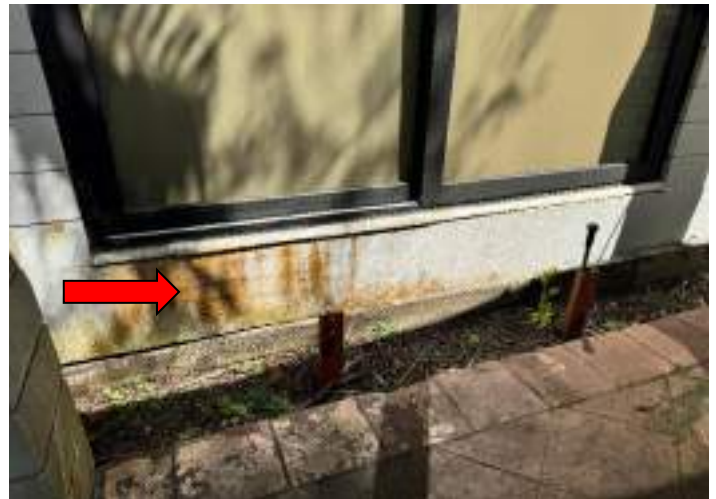
DISCOLORATION

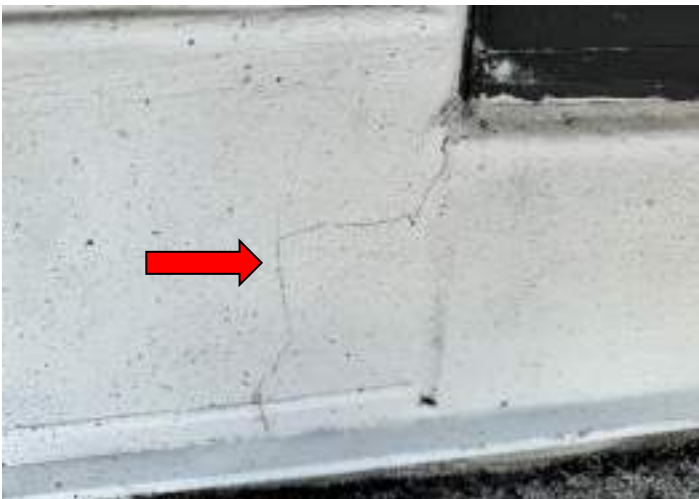
HAIRLINE CRACKS

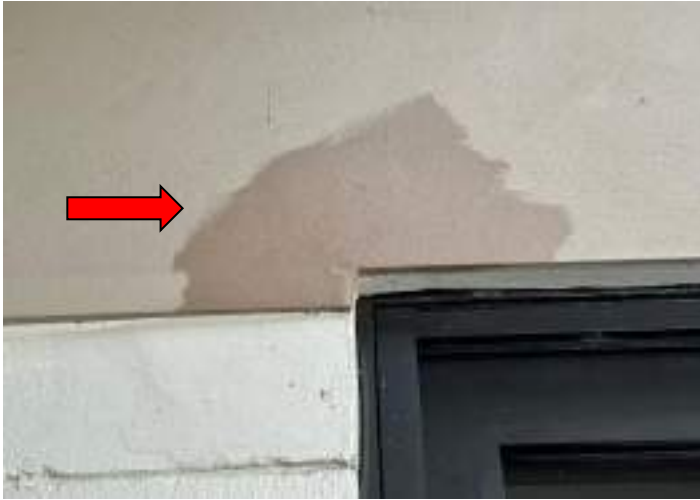
PREVIOUS REPAIRS

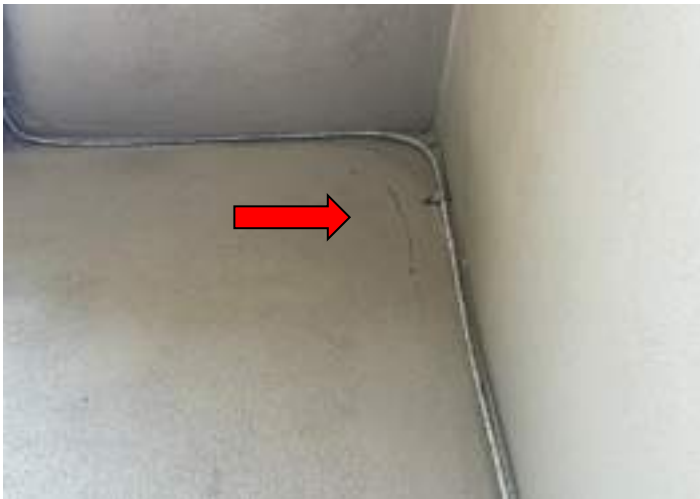
HAIRLINE CRACKS

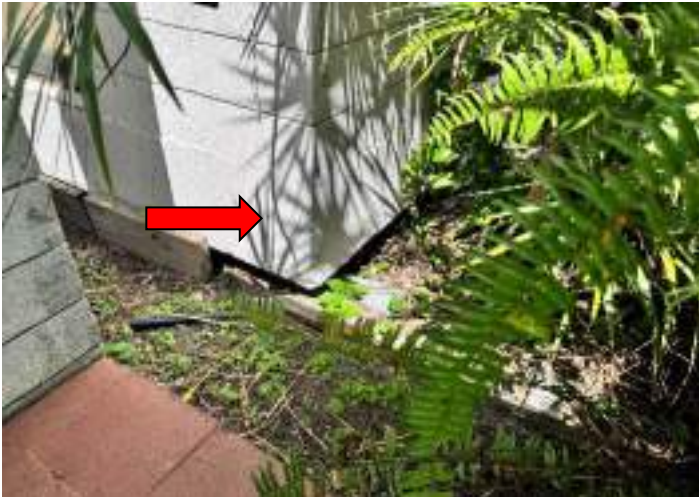
STRUCTURAL SETTLEMENT/CRACKING

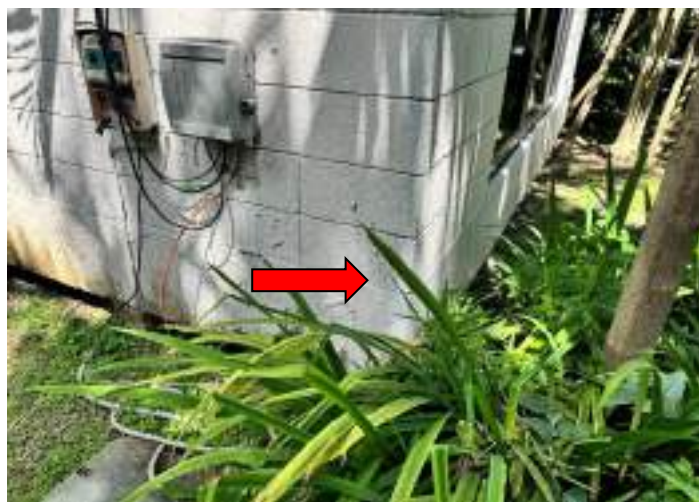
STRUCTURAL SETTLEMENT/CRACKING

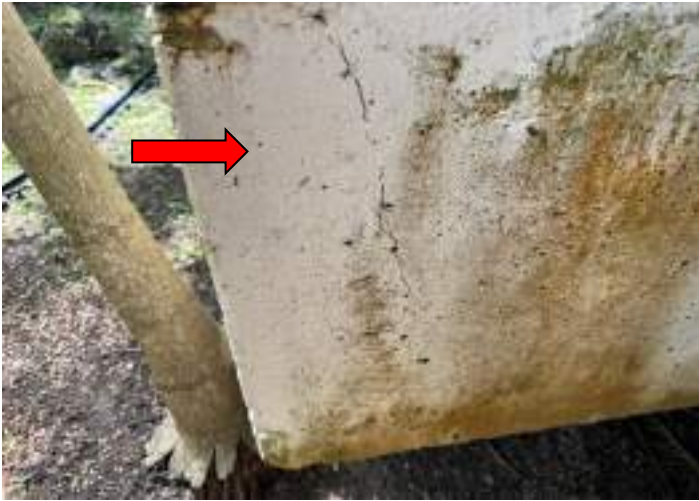
STRUCTURAL SETTLEMENT/CRACKING

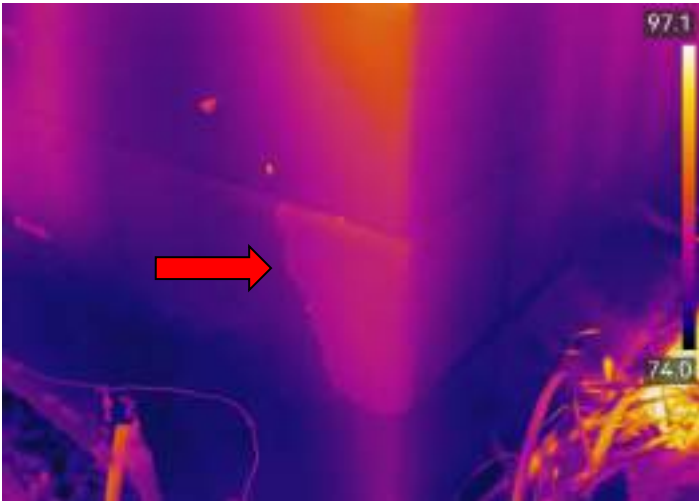
STRUCTURAL SETTLEMENT/CRACKING

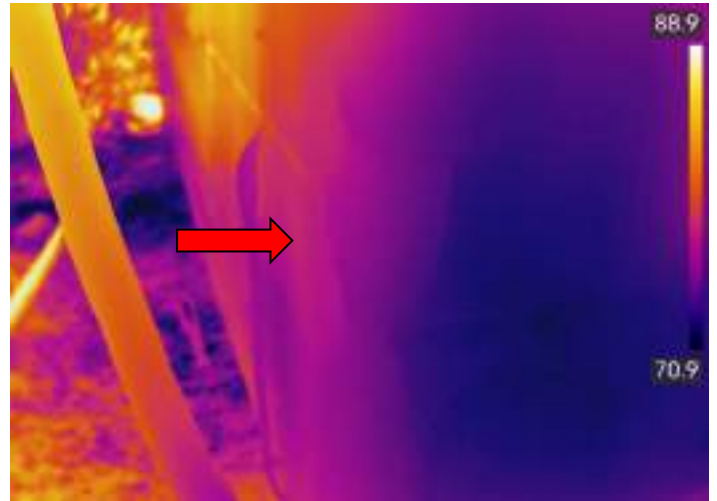
THERMAL ANOMALY

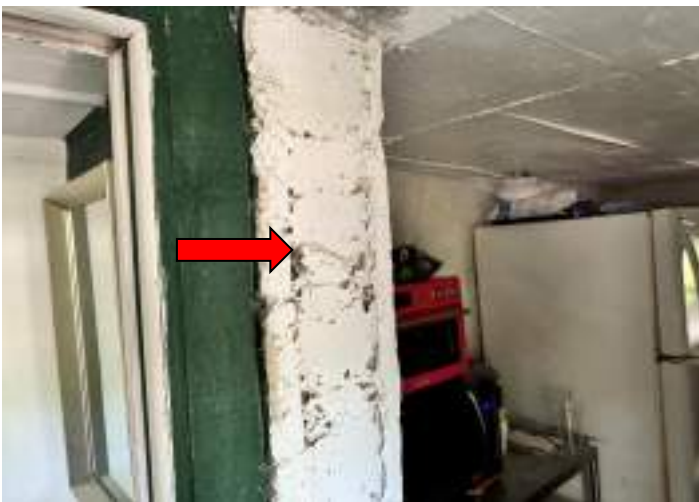
THERMAL ANOMALY

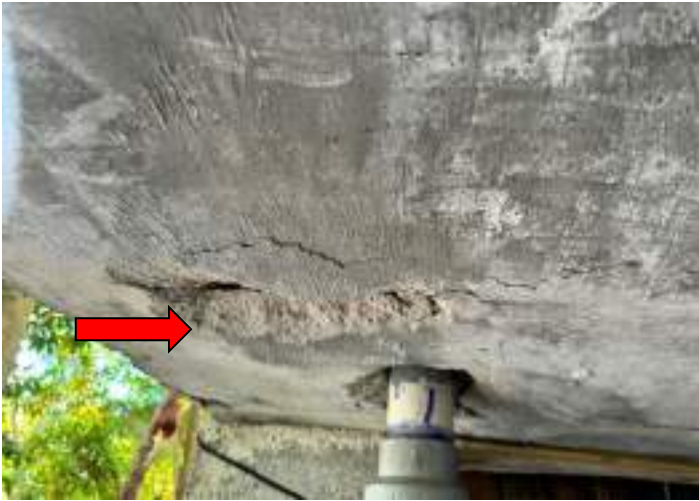
SPALLING/EXPOSED REBAR

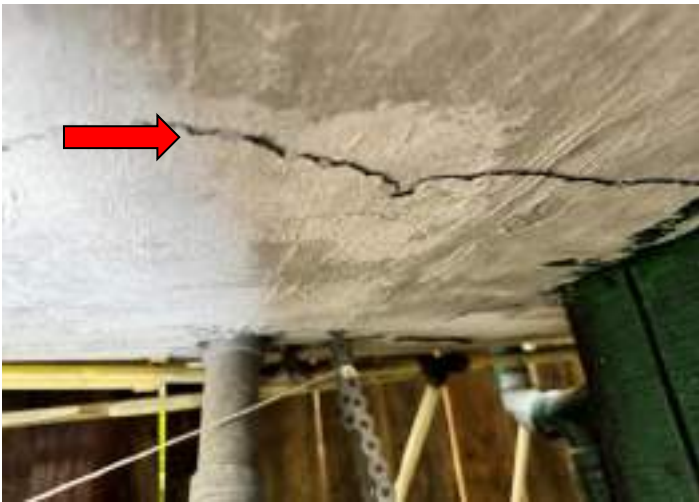
SPALLING/EXPOSED REBAR

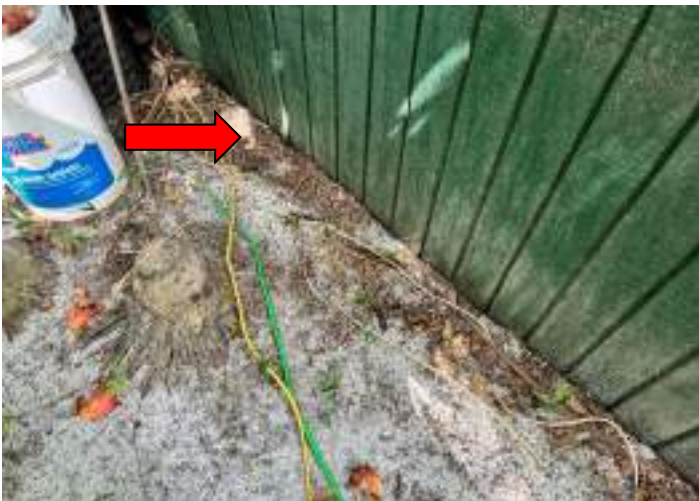
SPALLING/EXPOSED REBAR

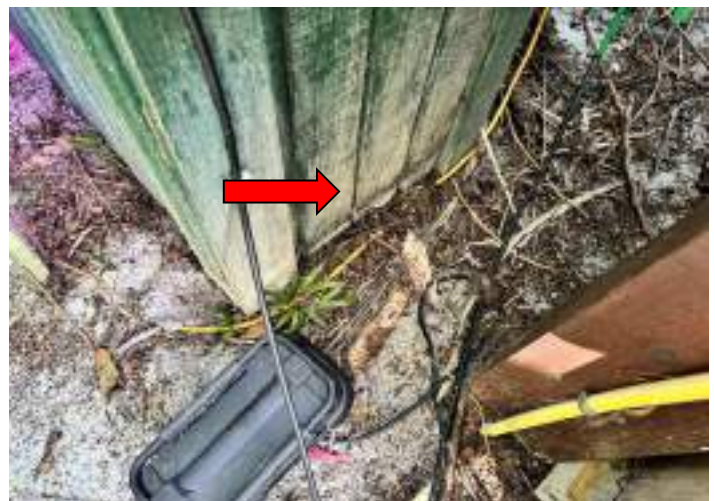
GROUND CONTACT

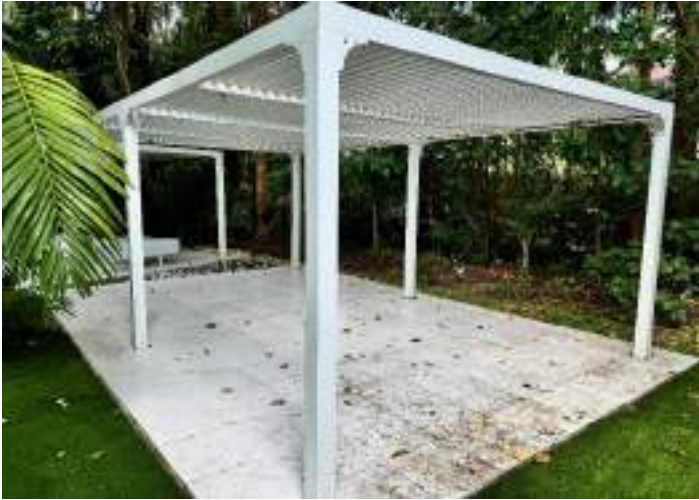
GROUND CONTACT

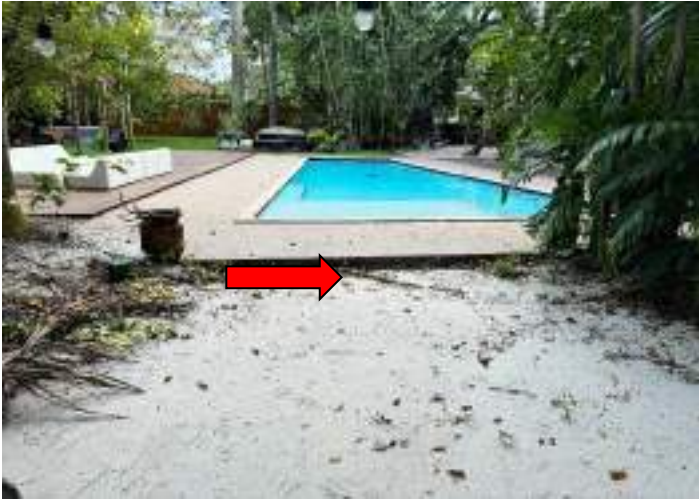
CRACKED/DAMAGED TILE

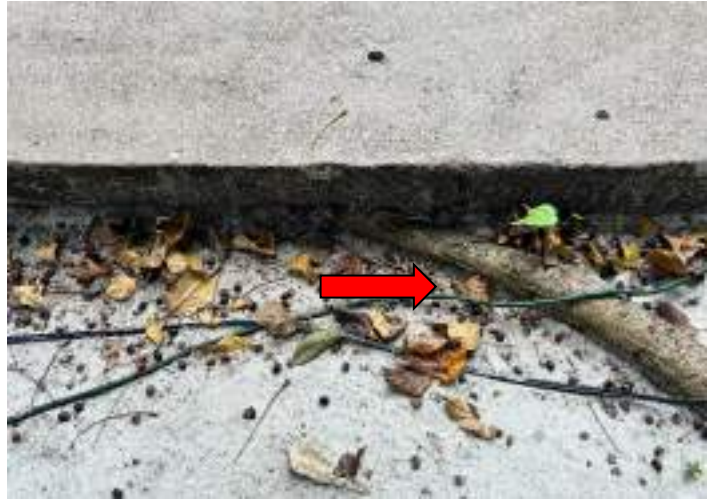
POOL DECK

5. Pool valves/piping were not labeled properly.
6. Two (2) of the jets were not operational at the time of the inspection.
7. Settlement cracks were noted on multiple areas of the pool deck.

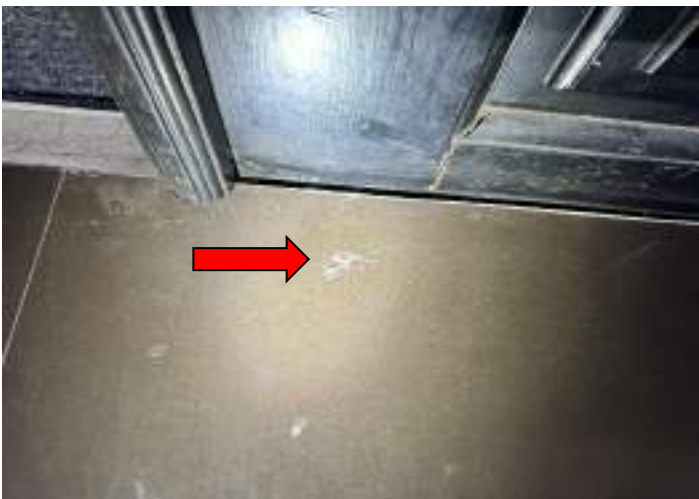
DETERIORATED/MISSING GROUT

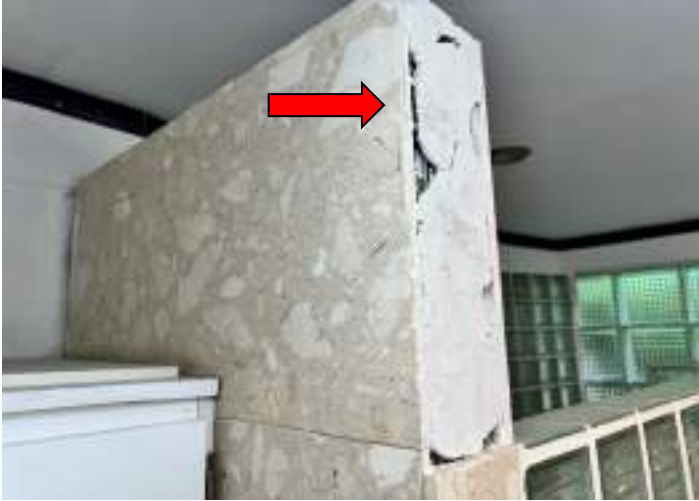
CRACKED/DAMAGED TILE

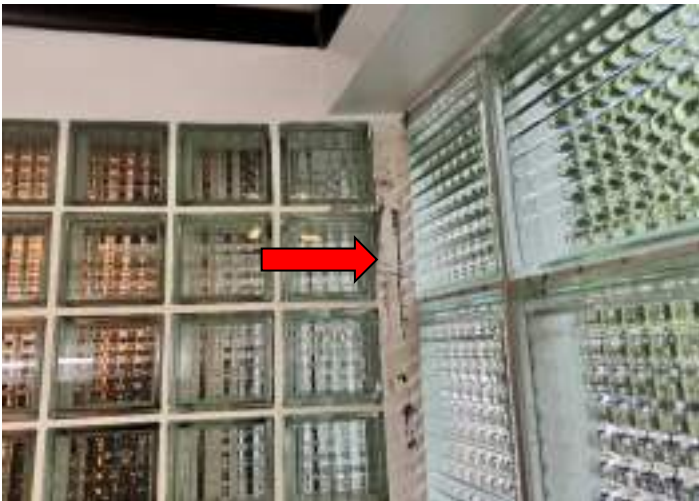
UNWORKMANLIKE REPAIR

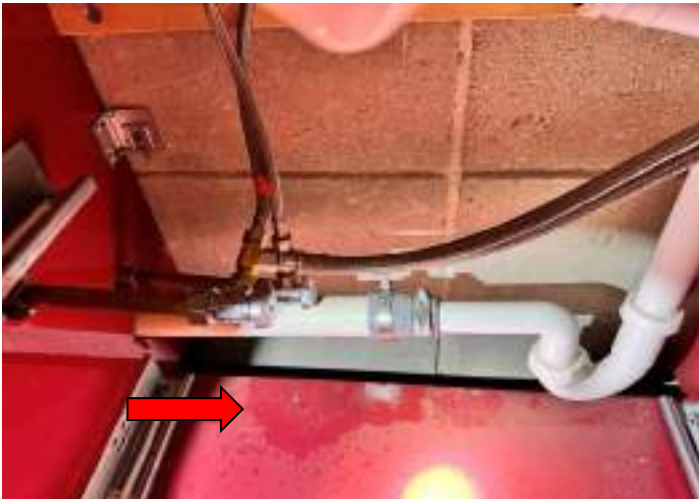
IMPROPERLY INSTALLED VANITY CABINET

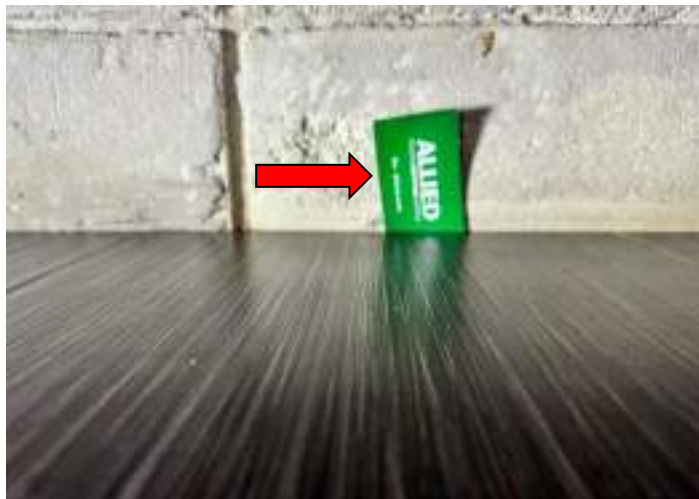
NO ELEVATED MOISTURE LEVEL

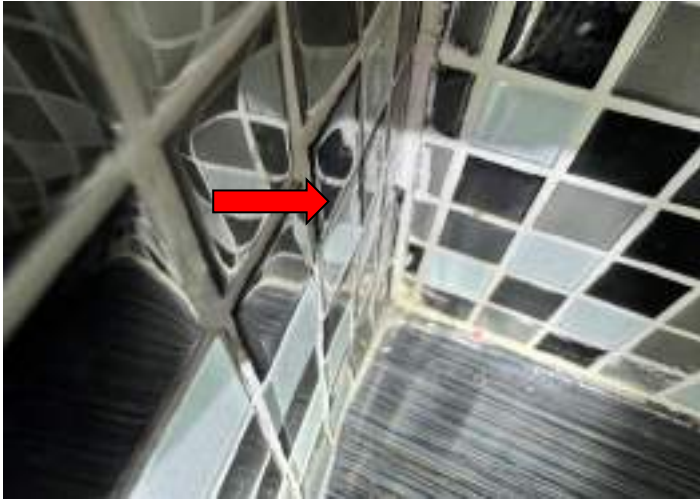
MISSING/DETERIORATED CAULK

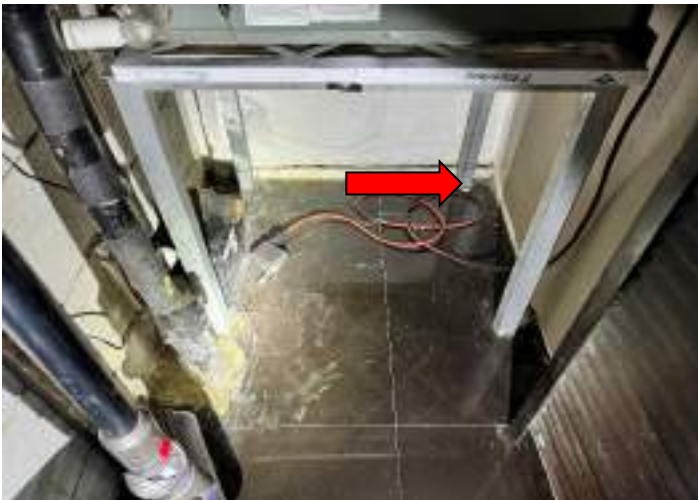
MOLD-LIKE SUBSTANCE/STAIN MARKS

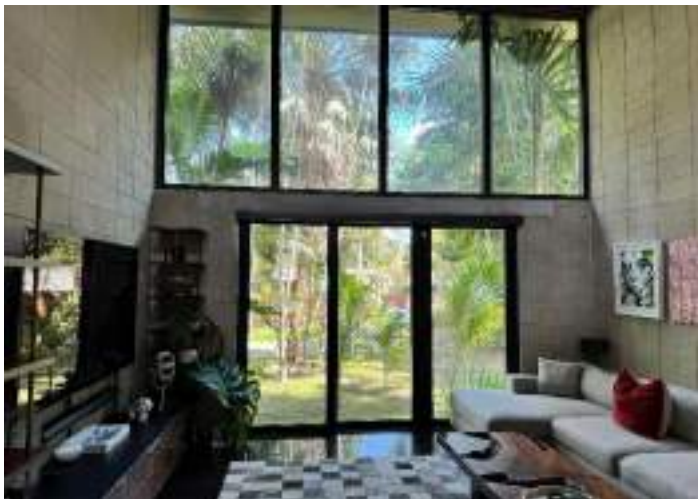
NO ELEVATED MOISTURE LEVEL

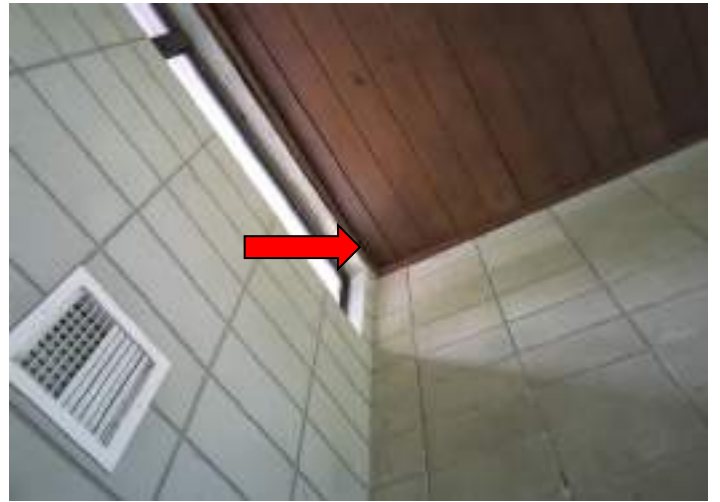
NO THERMAL ANOMALY

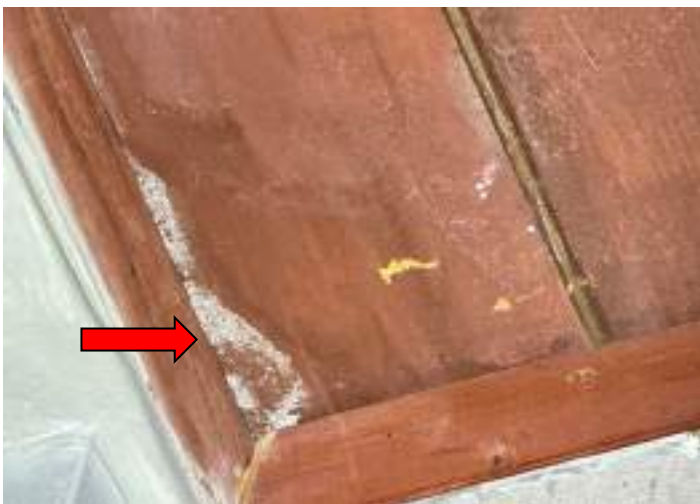
MOISTURE STAIN

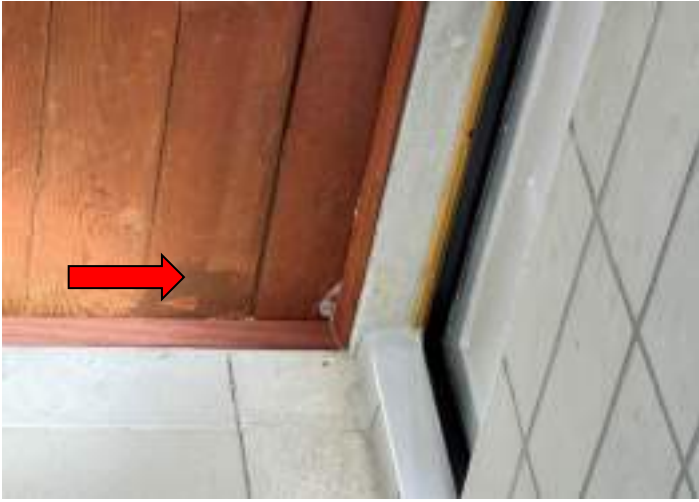
MOISTURE STAIN

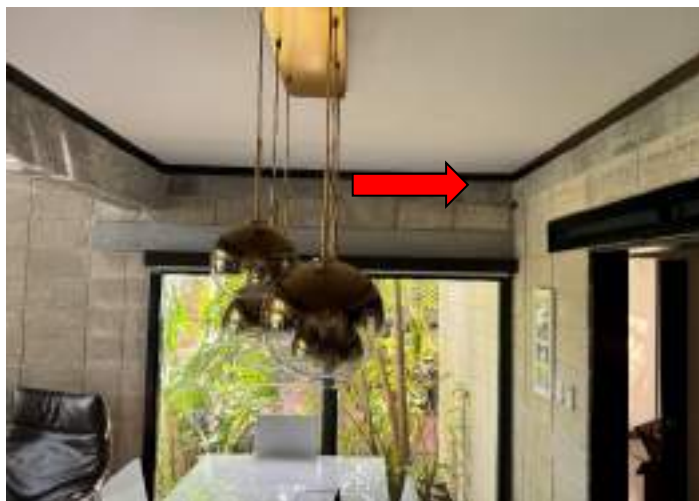
DAMAGED/CRACKED CONCRETE BLOCK

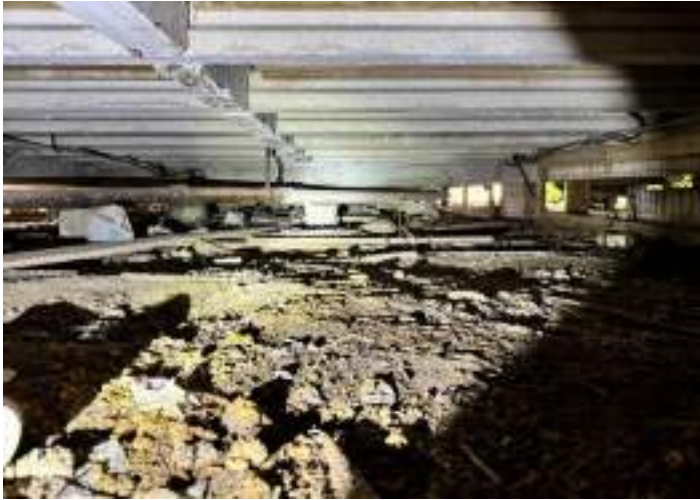
CHIPPED CONCRETE/ EXPOSED EMT CONDUIT

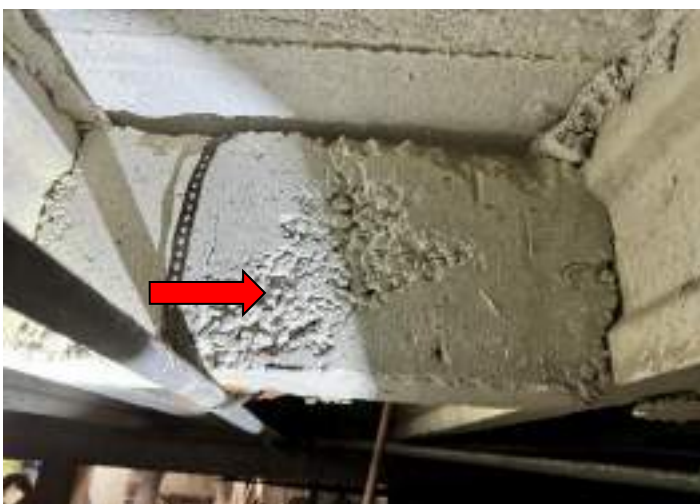
SPALLING/EXPOSED REBAR/BULGES/SETTLEMENT

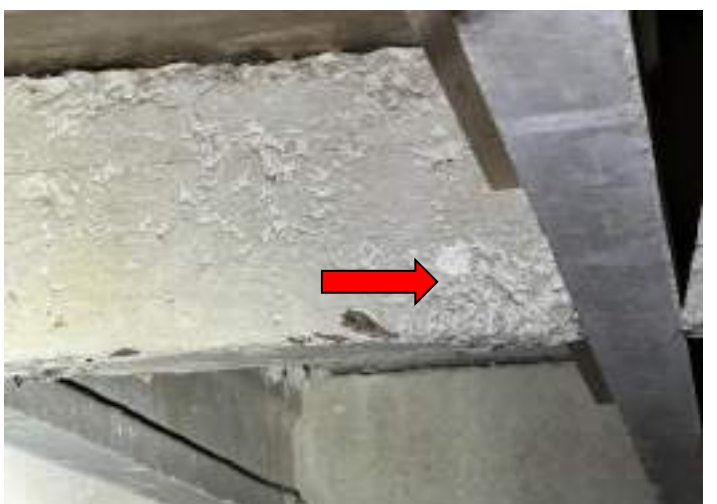
HONEYCOMBING

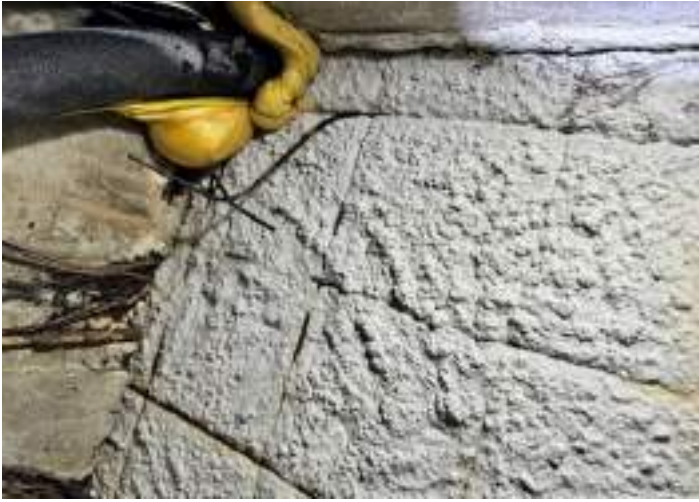
HONEYCOMBING

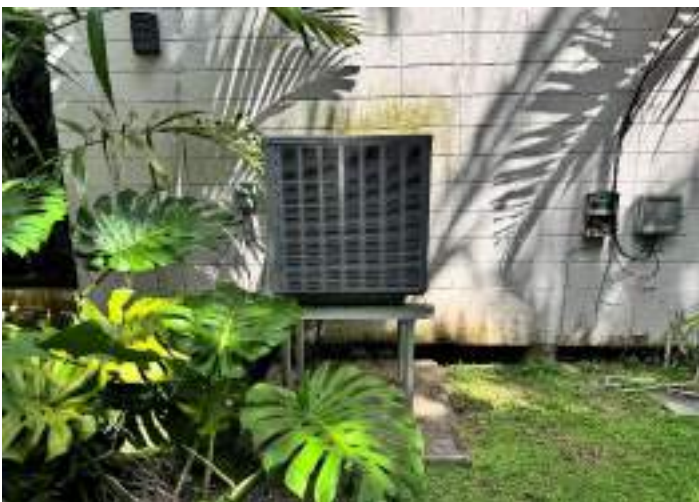
SPALLING/EXPOSED REBAR

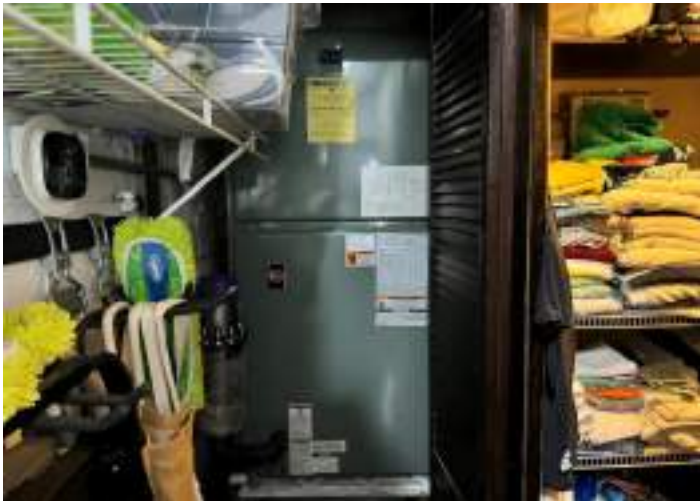
DAMAGED COIL

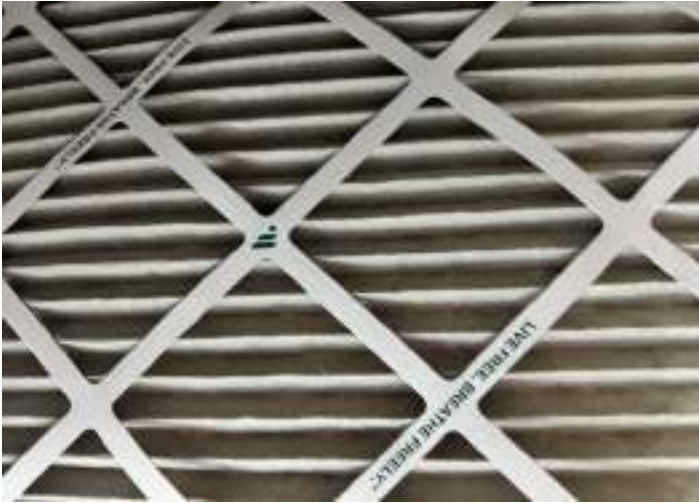
MOLD-LIKE SUBSTANCE

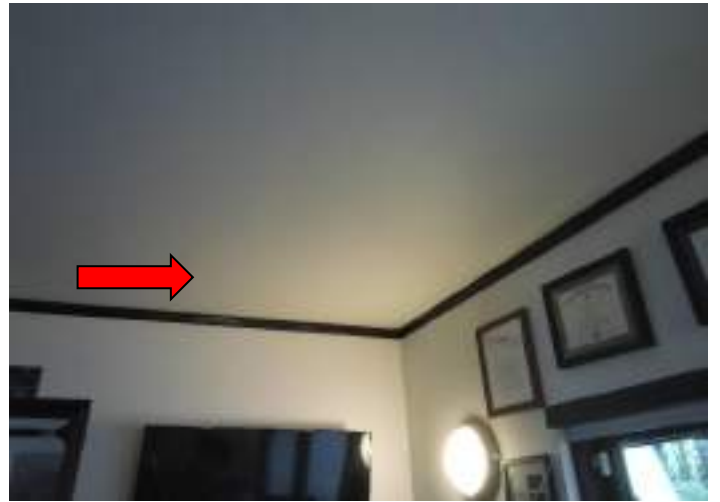
THERMAL ANOMALY

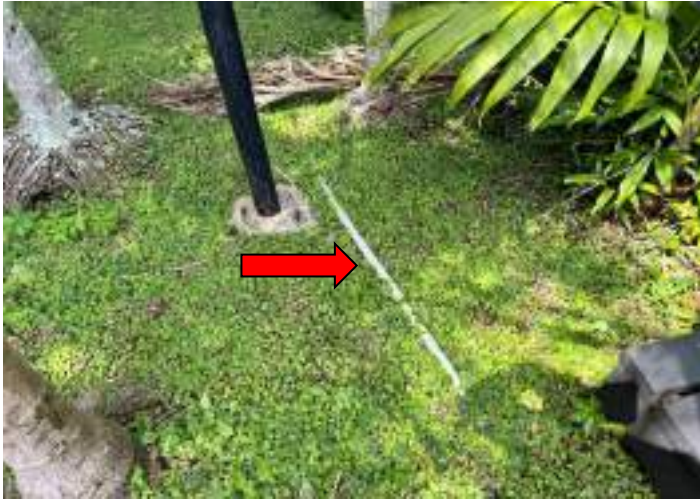
EXPOSED CONDUIT

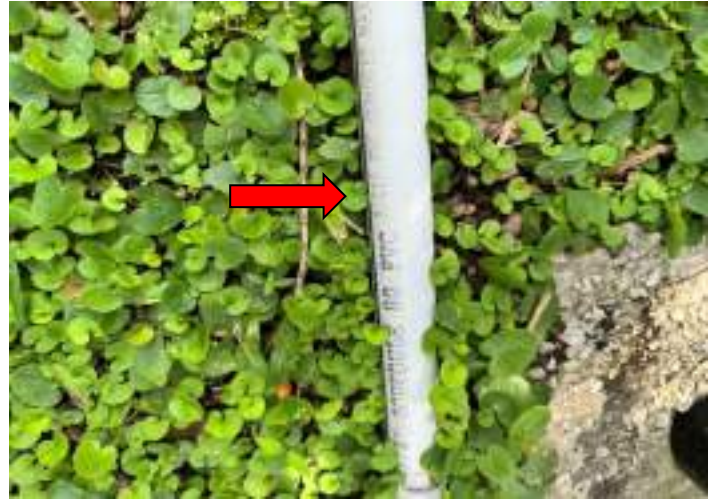
EXPOSED CONDUIT

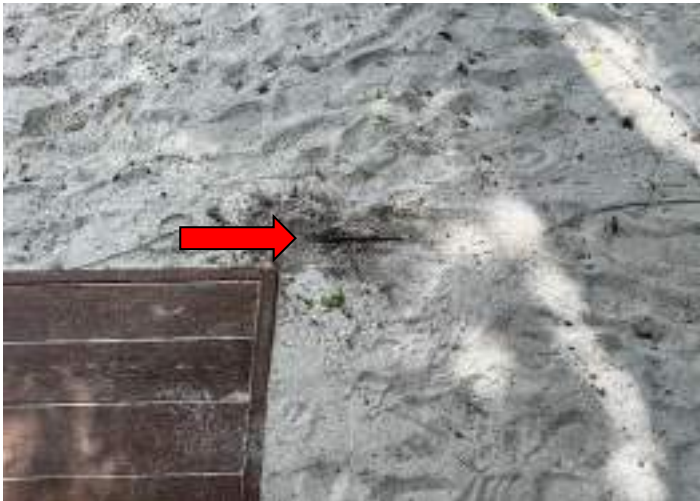
EXPOSED WIRES

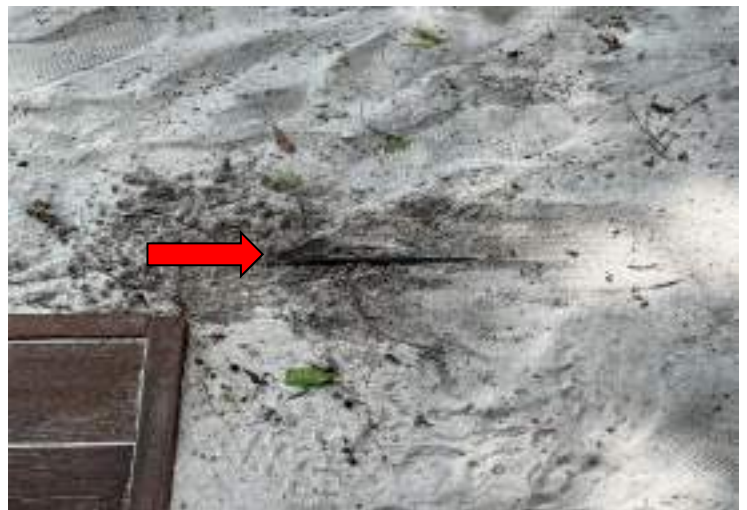
EXPOSED WIRES

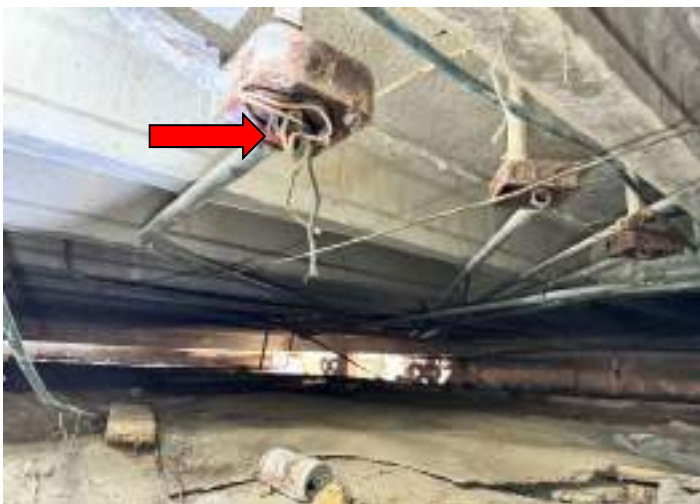
EXPOSED WIRES

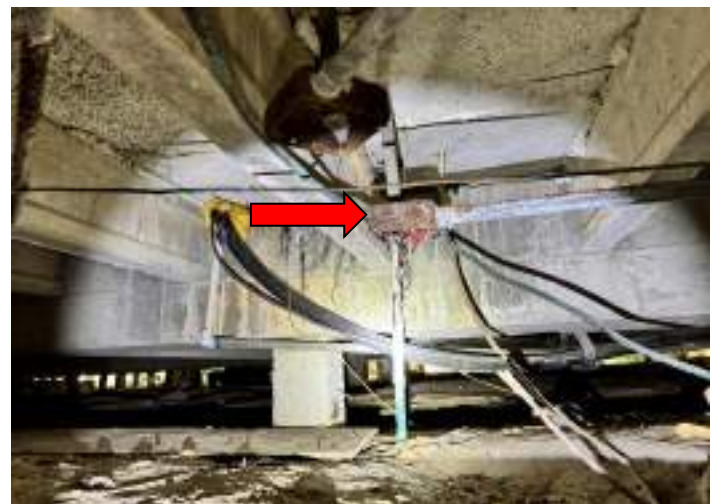
EXPOSED WIRES

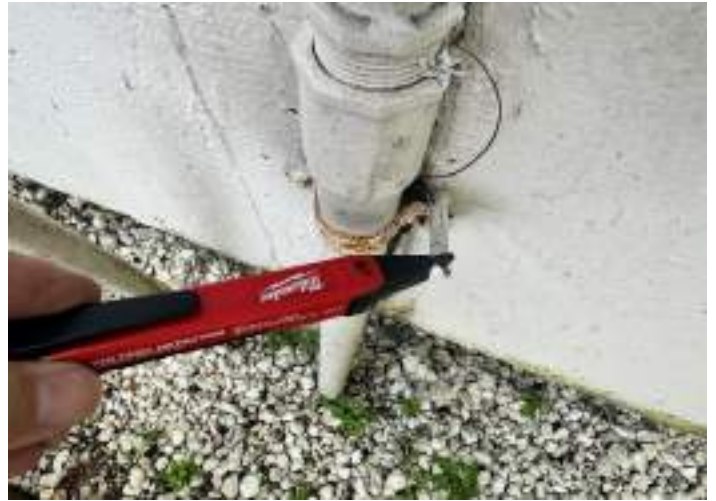
EXPOSED WIRES

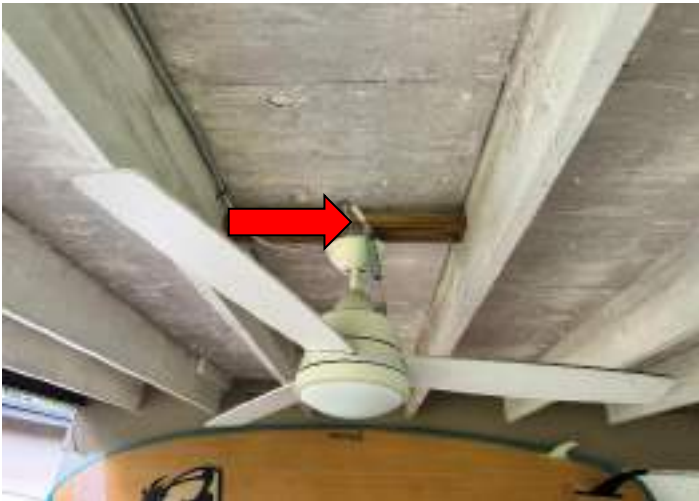
EXPOSED WIRES

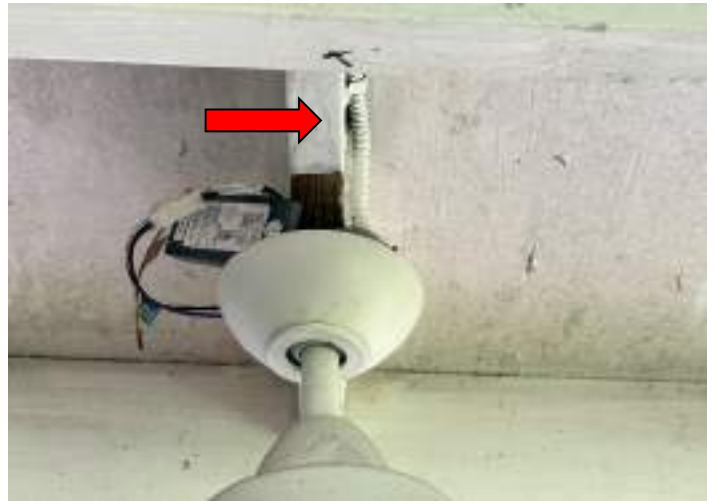
EXPOSED WIRES

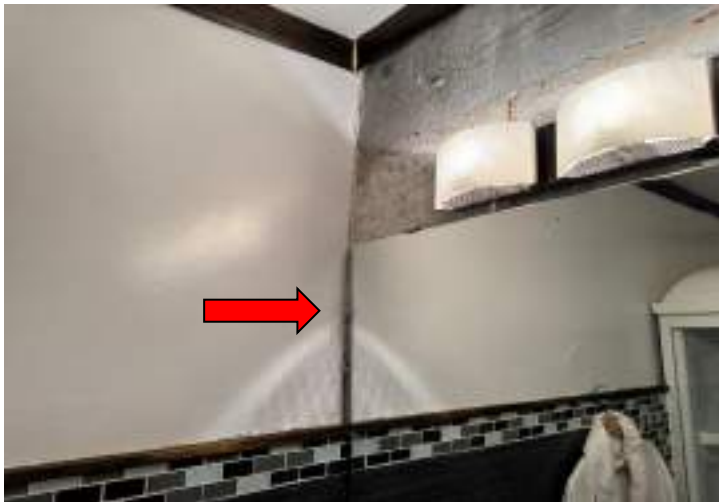
EXPOSED WIRES

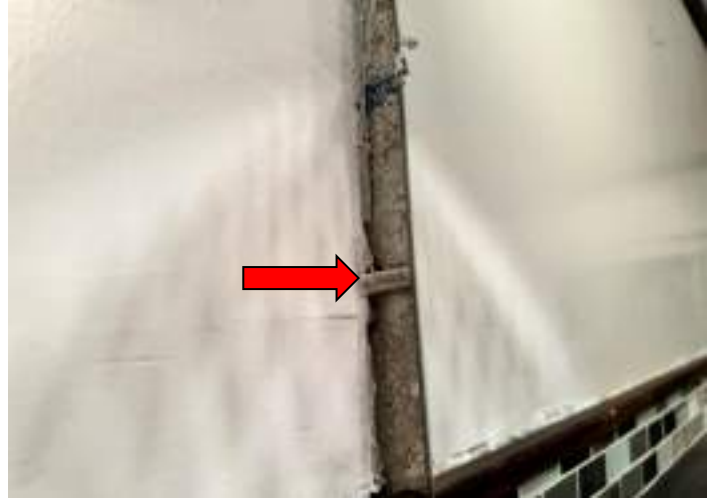
EXPOSED WIRES

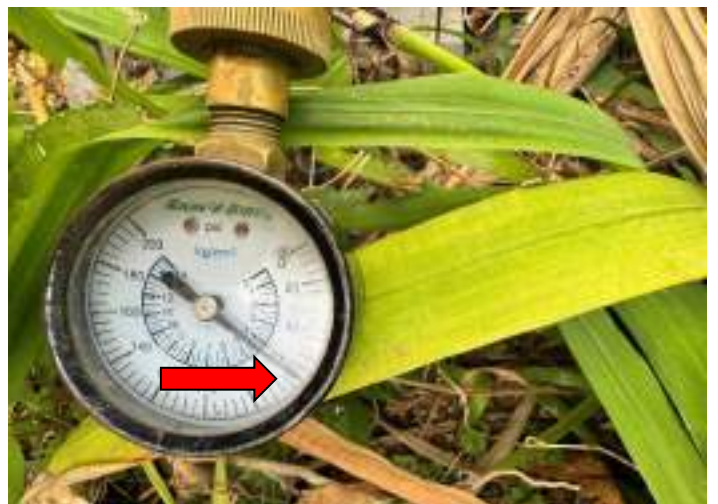
WATER PRESSURE 60 PSI +/-

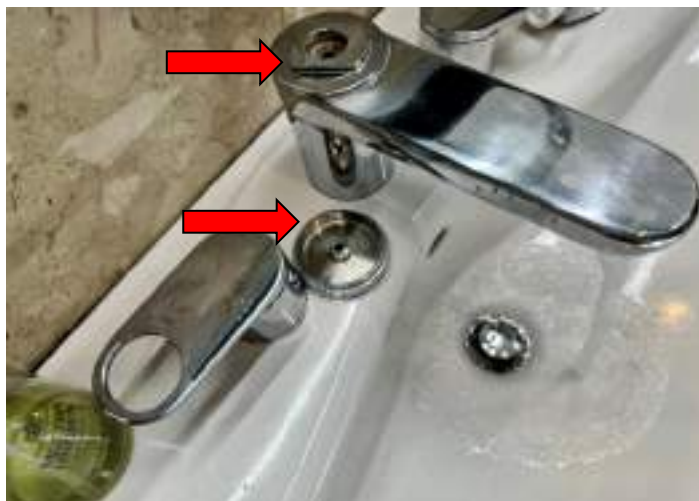
DAMAGED FAUCET

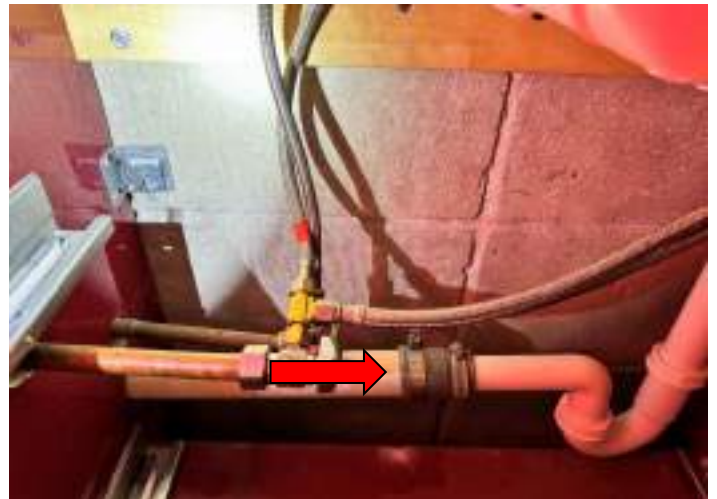
PLUMBING DETAIL/RUBBER HUB CONNECTOR

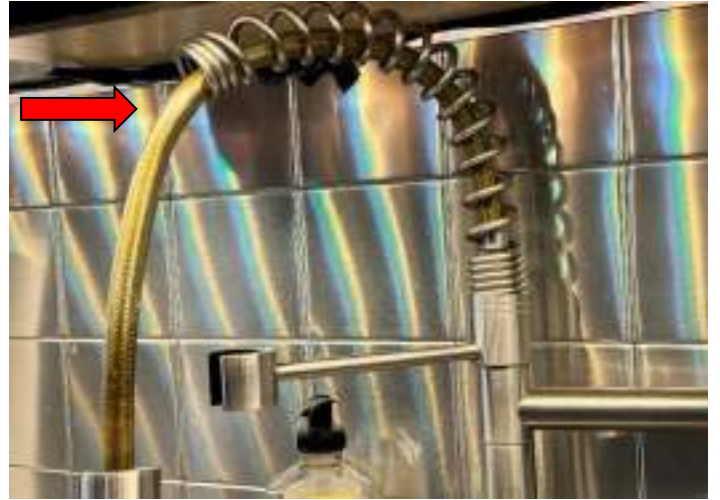
RETRACTOR NOT PULLING

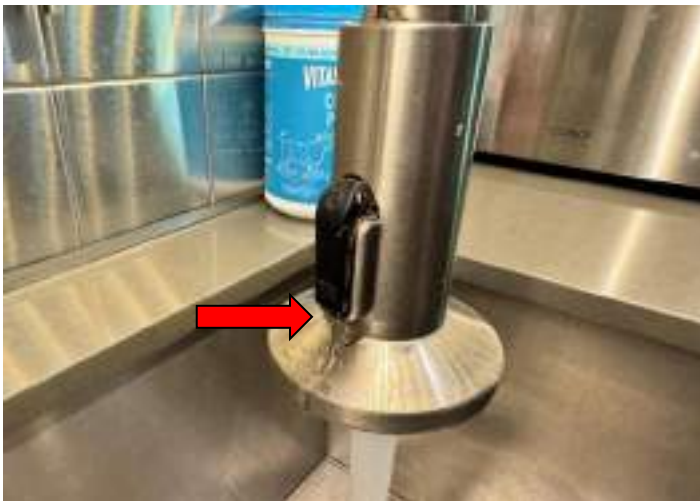
LEAKING FAUCET

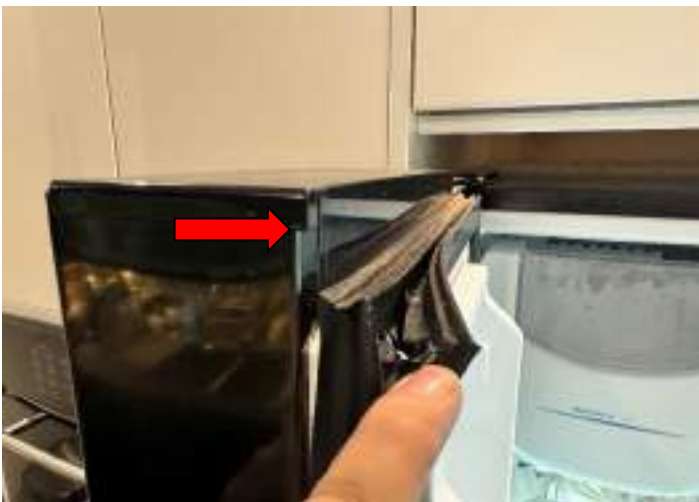
DAMAGED GASKET

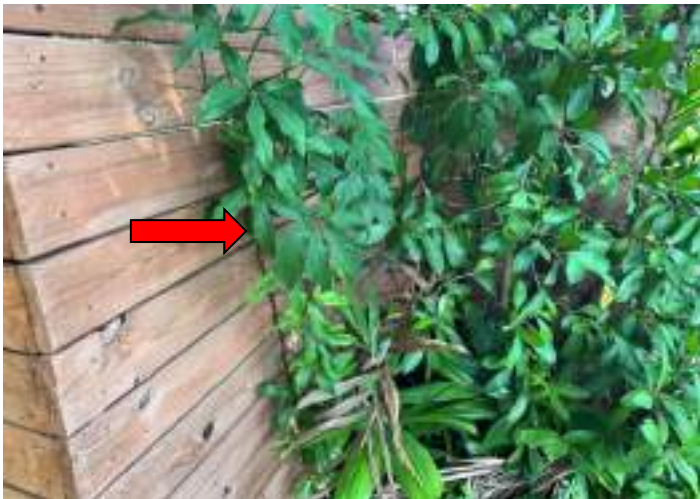
FENCE NOT ALIGNED

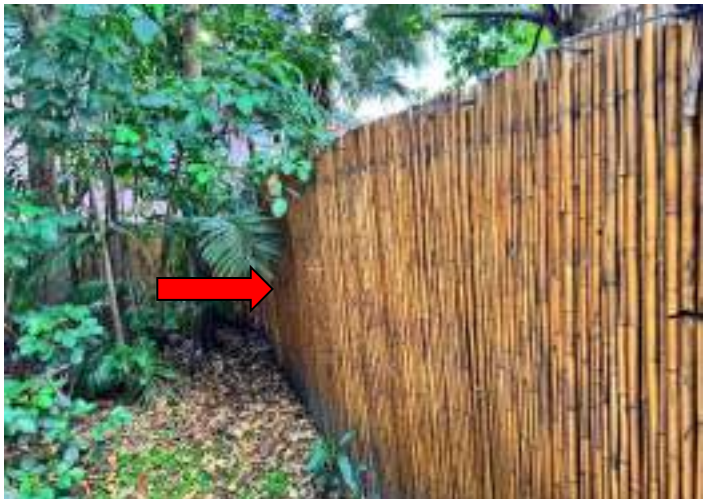
FENCE OVERGROWN
