THE ALLIED REPORT

Inspection # **031224-1456**

Inspection Date: **3/12/2024**

Property Address: **14560 NE 3rd Court**

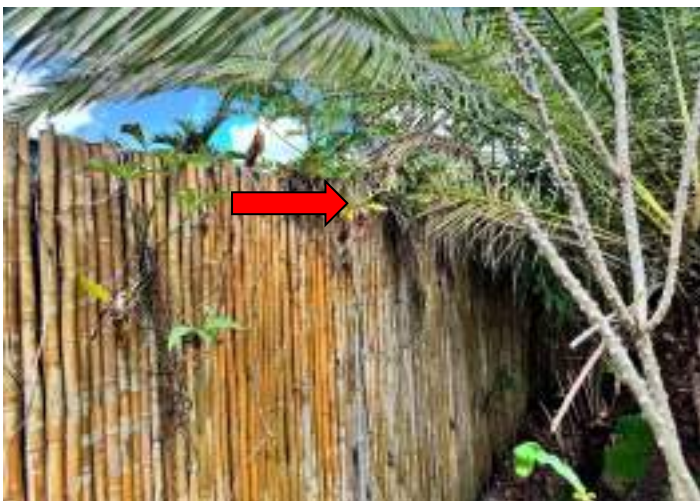
FENCE OVERGROWN

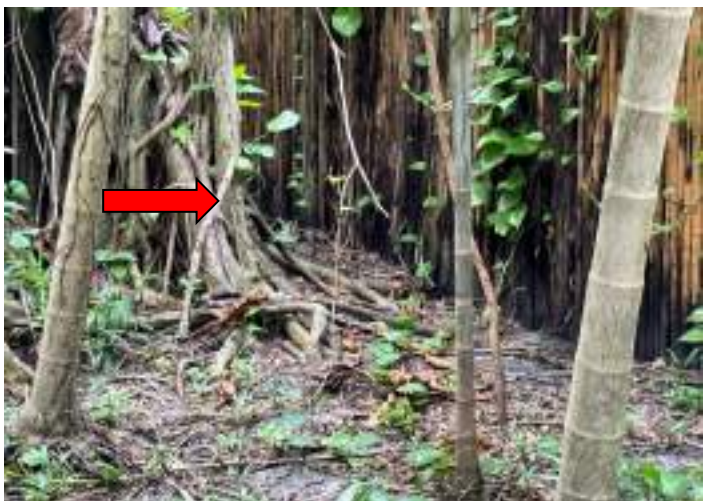
FENCE OVERGROWN

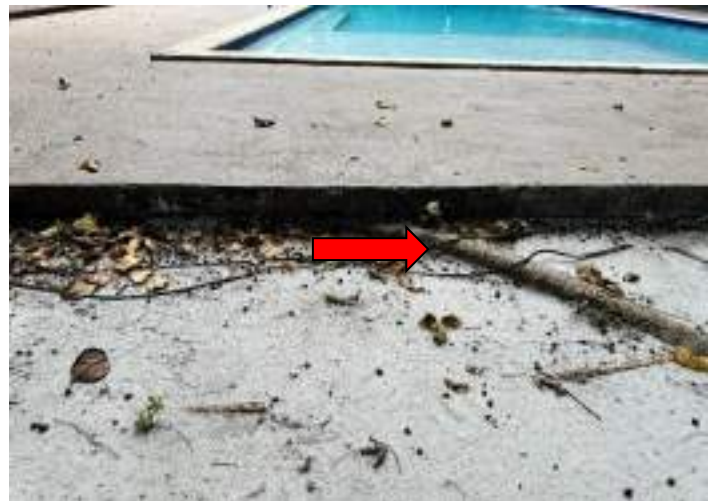
EXCESSIVE ROOT GROWTH

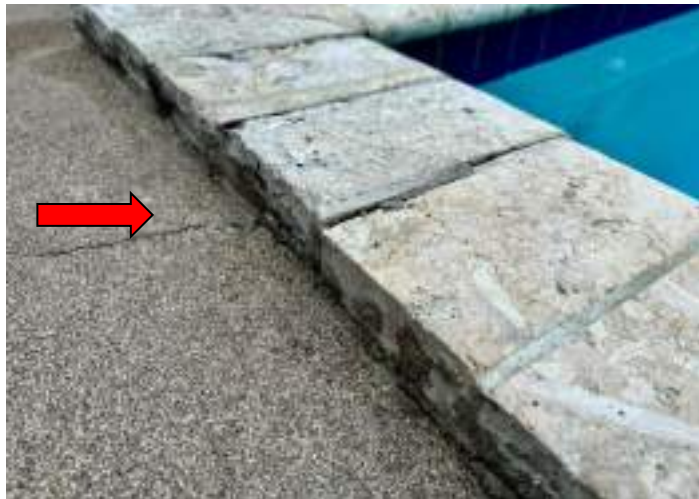
SETTLEMENT CRACKS
