INSPECTION REPORT

For the Property at:
4090 CLEVELAND AVENUE
COLUMBUS, OH 43224

RE: Report No. 8437, v.2
4090 Cleveland Avenue
Columbus, OH
43224

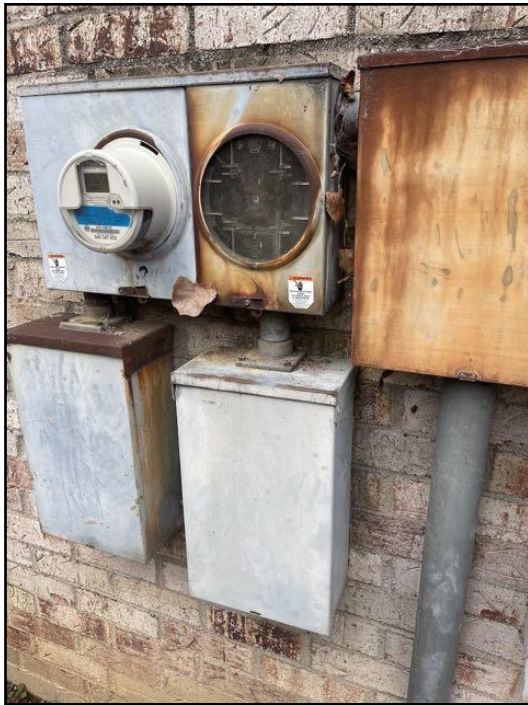
5. Condition: • The service has been abandoned to this unit. I recommend consulting the current owner to again a better understanding of the condition of the unit and why the utility company would pull the service.

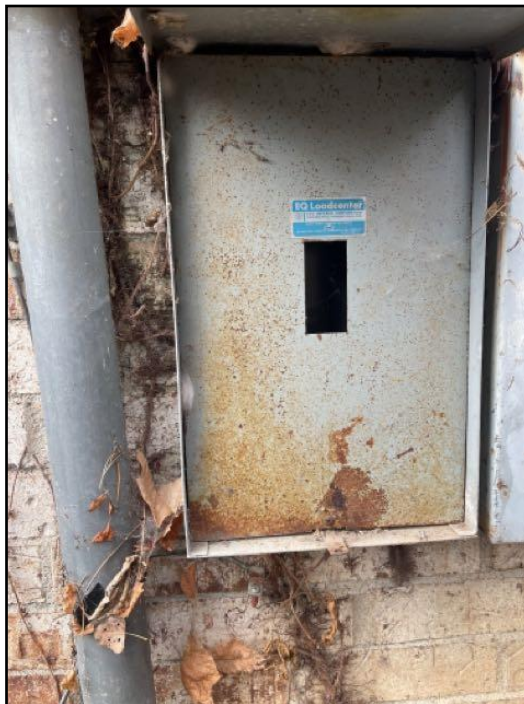
19. Unprotected openings

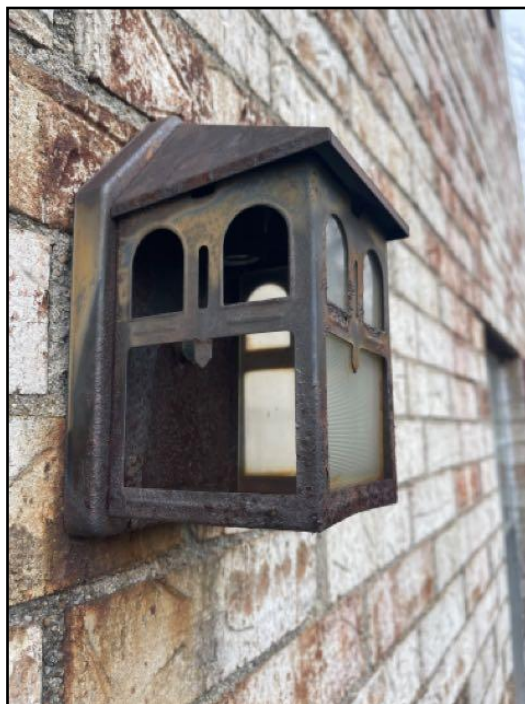
32. Damaged

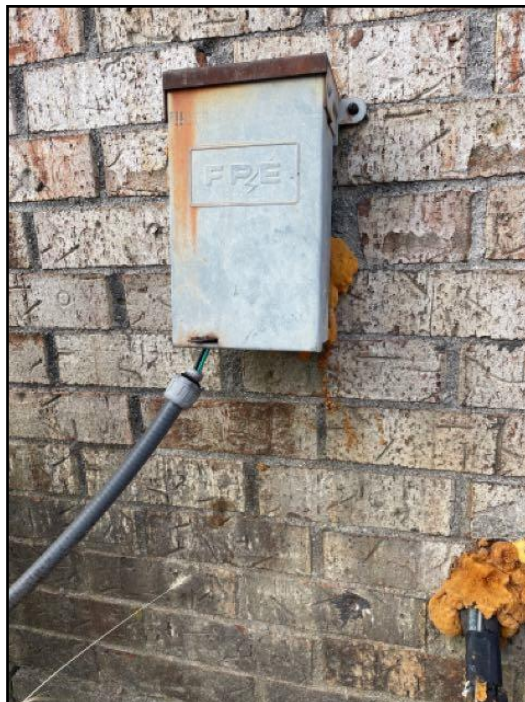
44.

26. Condition: • The exterior disconnect whip is under stress. I recommend contacting a qualified contractor to make the necessary repairs

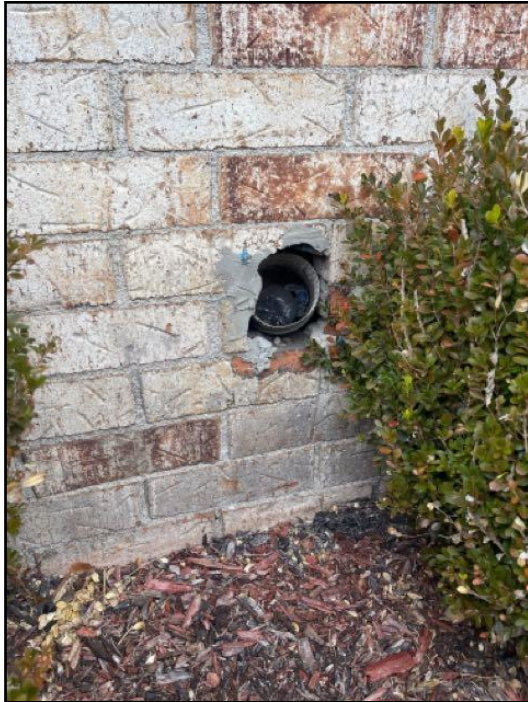
47. Damaged

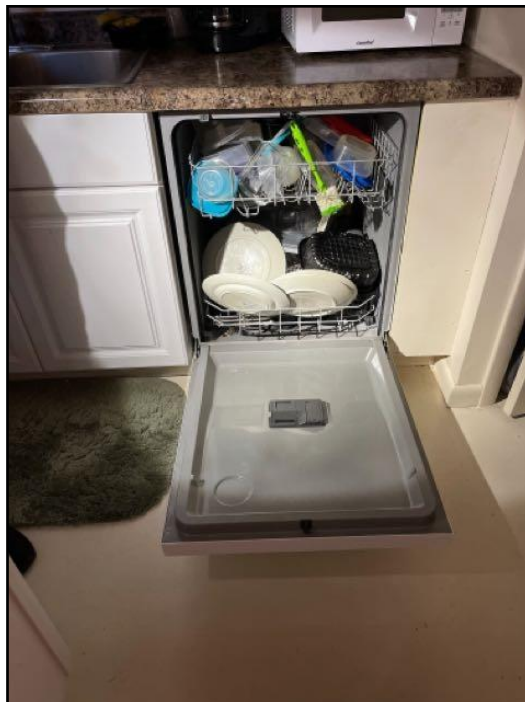
52.

31. Condition: • Dishwasher the heating element is inoperative. I recommend her head qualified appliance repair technician to service the unit.

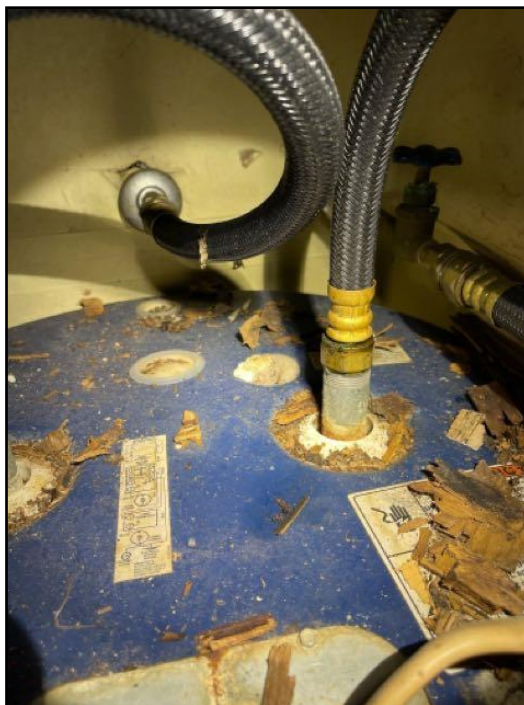
53. Equipment leaking

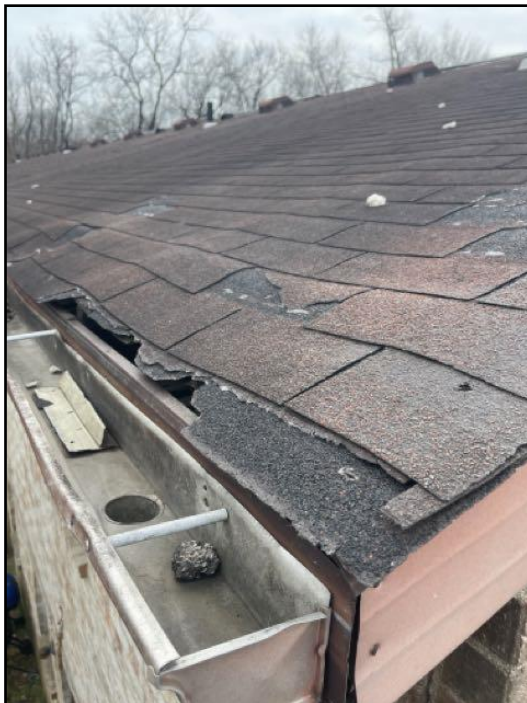
55. Beyond typical life expectancy

Cost: Re-Roof (\$365 x Sqft 1 layer) (\$21 2 layer)

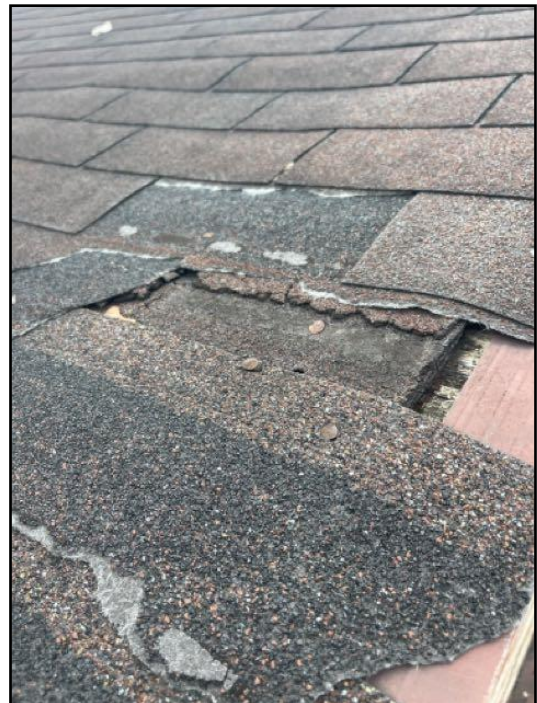
56. Beyond typical life expectancy

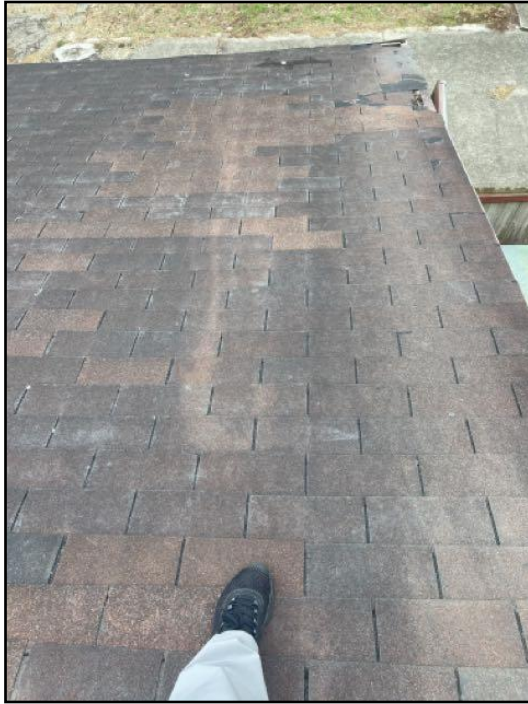
57. Beyond typical life expectancy

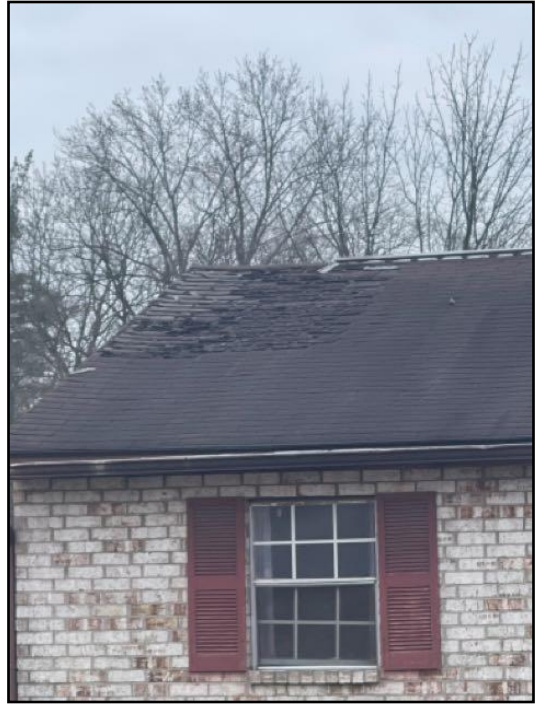
58. Beyond typical life expectancy

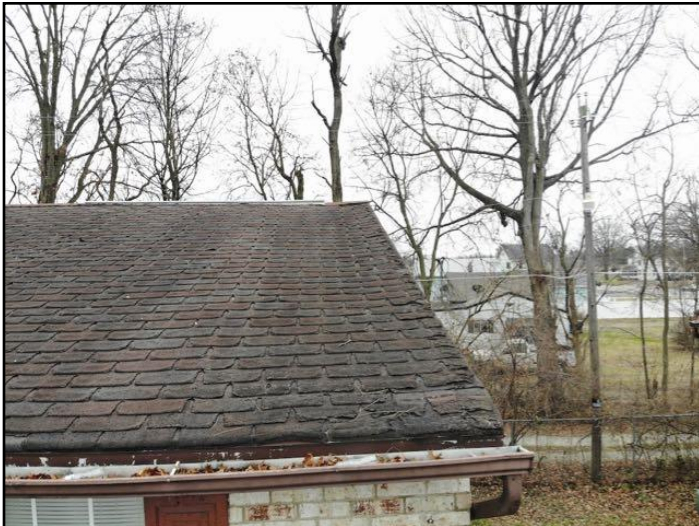
59. Beyond typical life expectancy

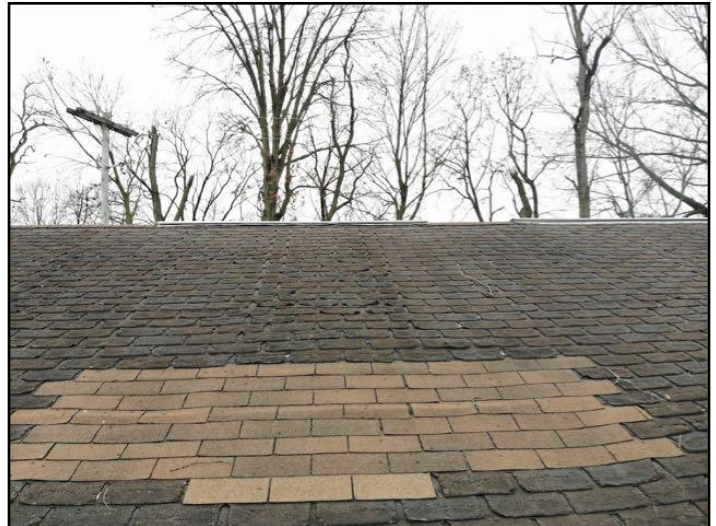
60. Beyond typical life expectancy

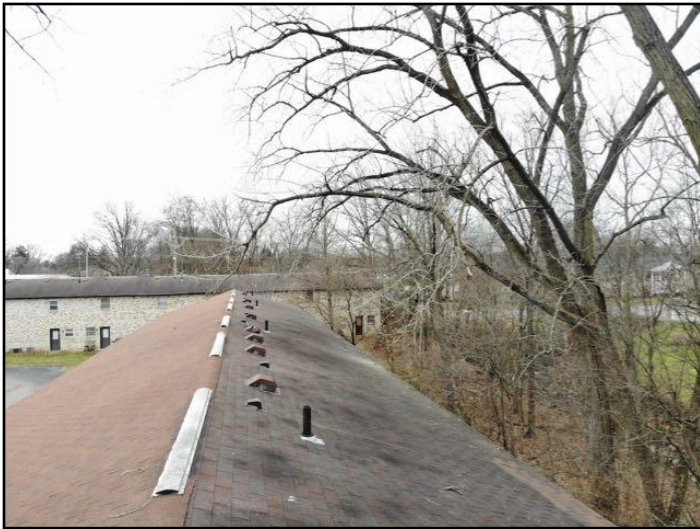
61. *Beyond typical life expectancy*

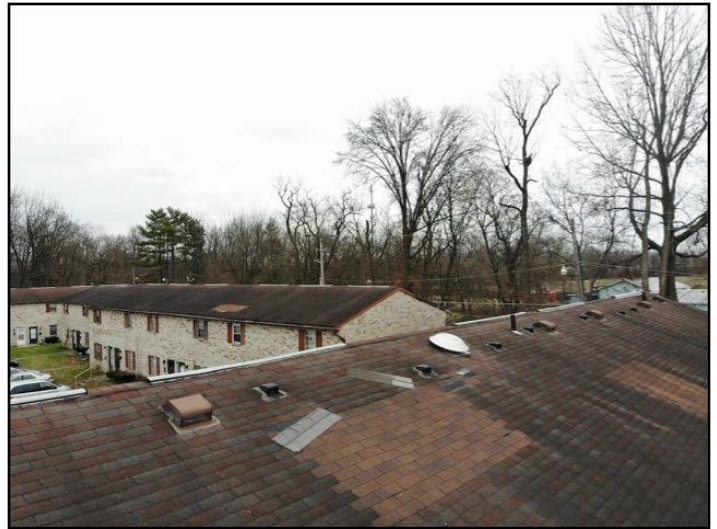
62. *Beyond typical life expectancy*

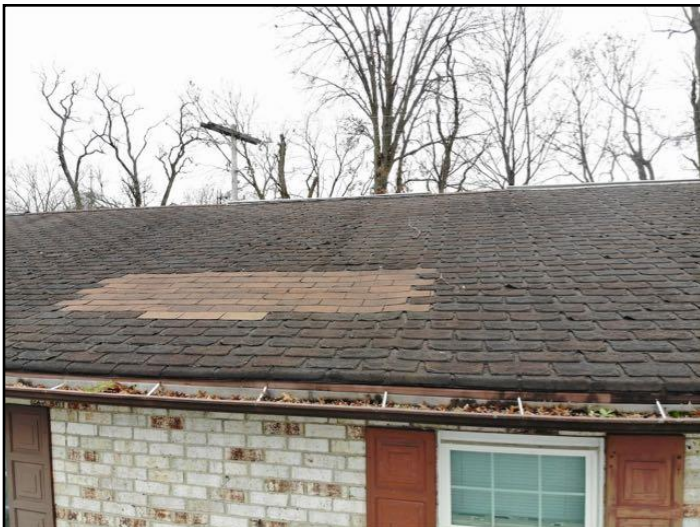
63. *Beyond typical life expectancy*

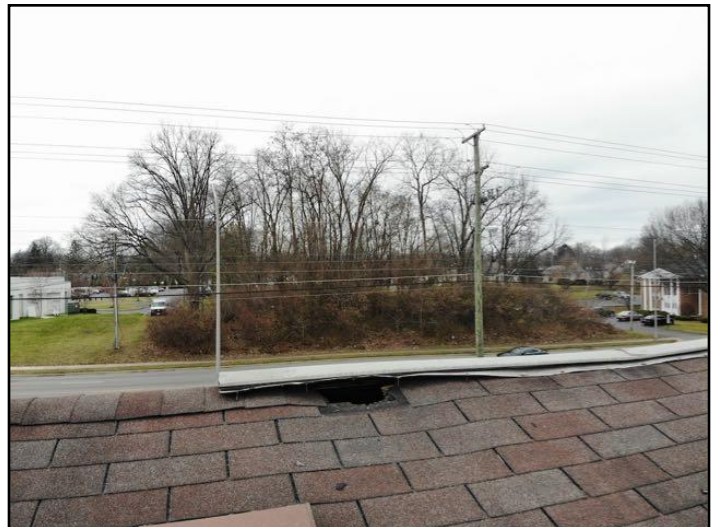
64. *Beyond typical life expectancy*

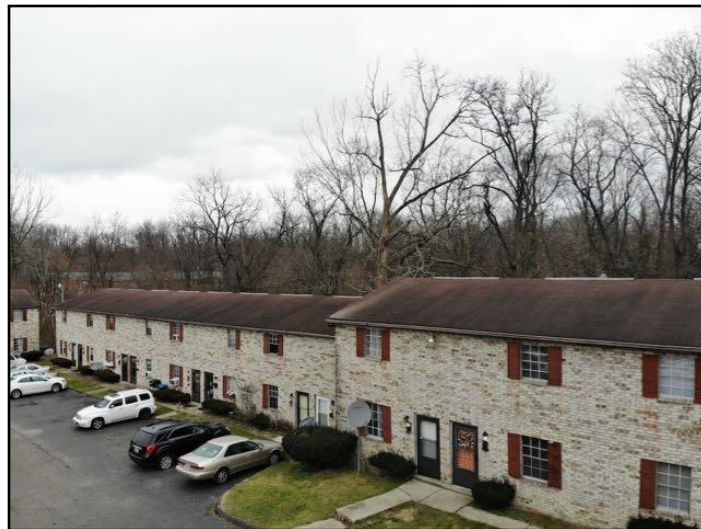
66. Beyond typical life expectancy

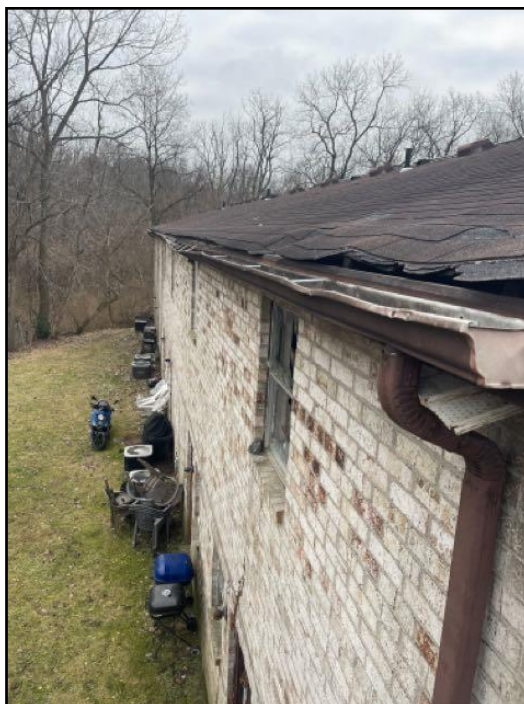
37. Condition: • Poor condition

Runoff/leakage from gutters and downspouts was present and could be causing water intrusion on the interior structure

in various locations. The gutters have loose or missing, spikes or straps and damaged connections. All of the connections should be examined and repair or replace as needed. The most common issue with spouting is perimeter drains involves the system becoming clogged with dirt, roots and other underground debris. Structures that use clay or concrete weeping tiles to drain water are prone to more problems as they age, and will often become unusable over time. PVC perimeter drains on new structures can become disconnected due to common settlement of the structure. Underground drainage is excluded from the property inspection and are out of the view of the inspector. It is impossible to predict issues with site drainage from a one time noninvasive visit to the property.

70. Poor condition

Task: Replace

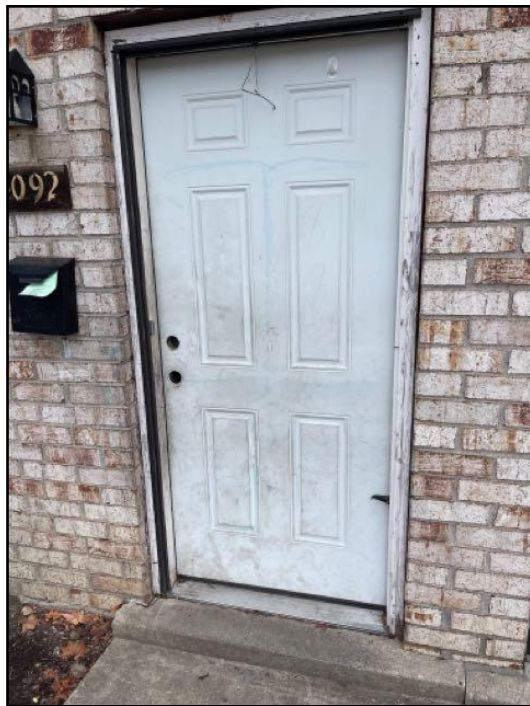
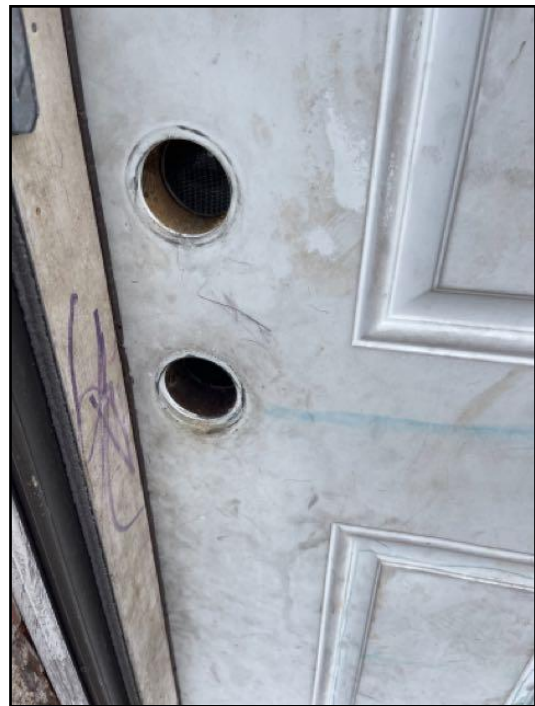
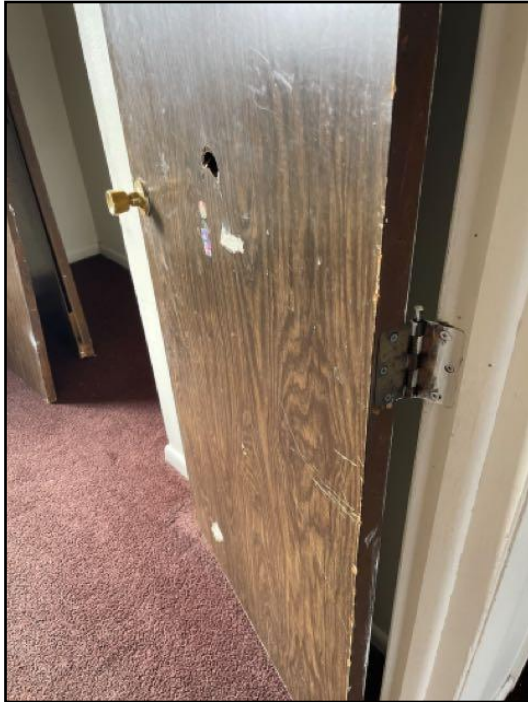
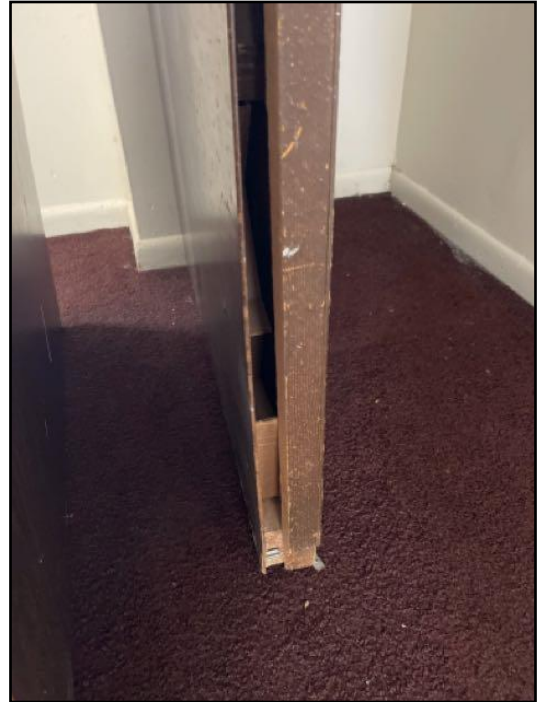
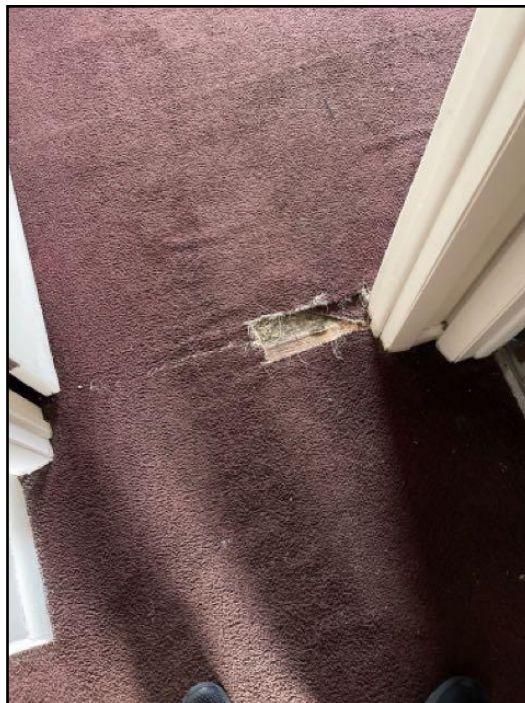
39. Condition: • Rental Property receive high abuse from tenants. Property condition consultants considers this while inspecting. It is common to have areas that no longer comply with current code. This is not a new structure and this building cannot be expected to meet current code standards. While this inspection makes every effort to point out safety issues, it does not inspect for code. It is common that buildings of any age will have had repairs performed and some repairs may not be in a workmanlike manner. Some areas may appear less than standard. This inspection looks for items that are not functioning as intended. It does no grade the repair. It is common to see old plumbing or mixed materials. Sometimes water signs in crawlspaces or basement could be years old from a problem that no longer exists. Or, it may still need further attention and repair. Determining this can be difficult on an older structures. Sometimes in older buildings there are signs of damage to wood from wood destroying organisms. Having this is typical and fairly common. If the building inspection reveals signs of damage you should have a pest control company inspect further for activity and possible hidden damage. The home inspection does not look for possible manufacturer recalls on components that could be in this structure. Always consider hiring the appropriate expert for any repairs or further inspection.

72. Rental Property receive high abuse from...

73. Rental Property receive high abuse from...

74. Rental Property receive high abuse from...

75. Rental Property receive high abuse from...

76. Rental Property receive high abuse from...

Task: Renovate when necessary

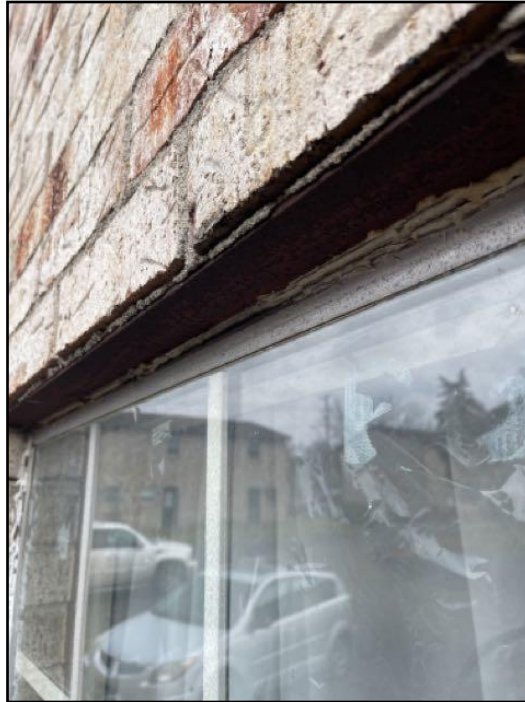
46. Condition: • Corroded

Lintels transfer the structural loads over the opening. Rusted lintels can cause structural movement and allow water

91. Corroded

intrusion, I recommend contacting a masonry contractor for the necessary repairs before you close.

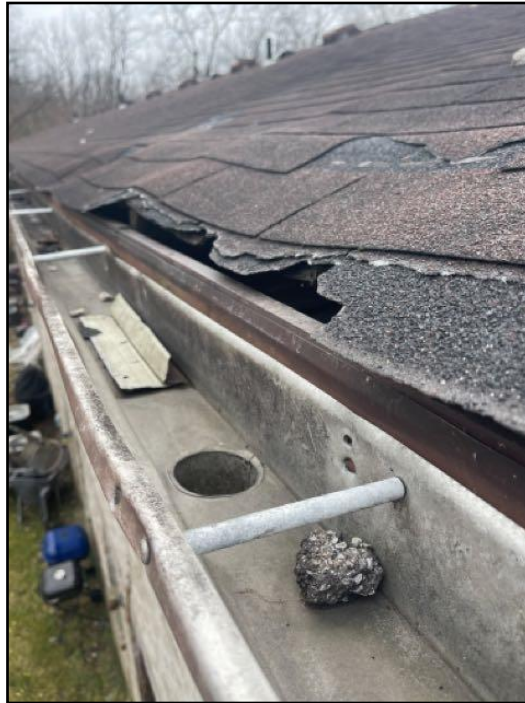
49. Condition: • Rot

The roof decking is rotted in various locations. I recommend contacting a qualified contractor to make the necessary repairs.

101. *Rot*

Task: Replace

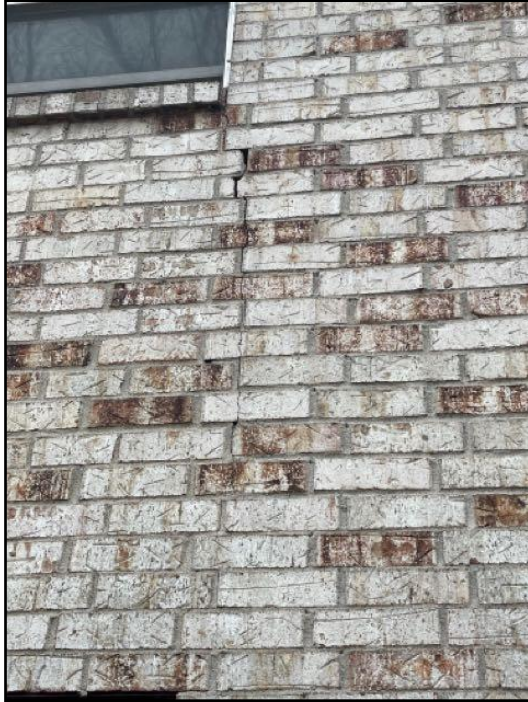
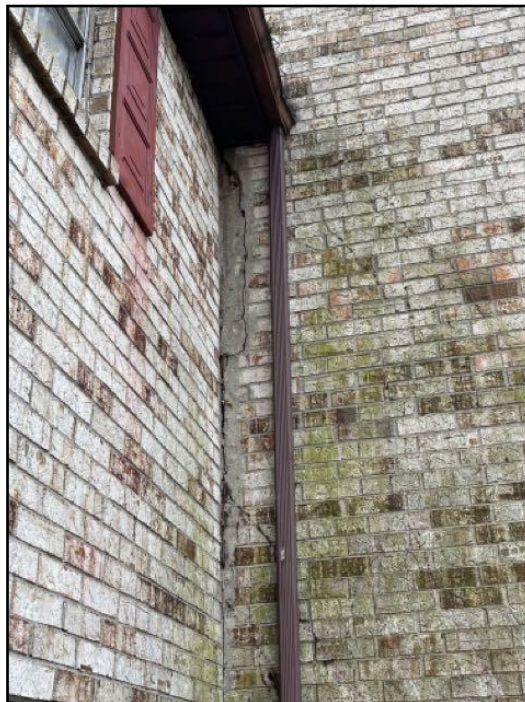
107. Cracks

109. Cracks

Task: Repair

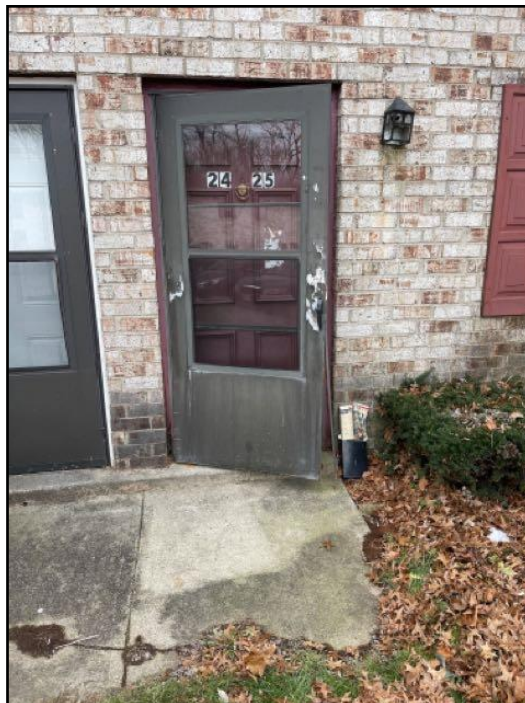
120.

55. Condition: • Storm doors have standard wear & tear, screens are torn, door sweeps are broken, the screen door panel is rotted and the hardware is suffering from high abuse. I recommend replacement 70% development wide.

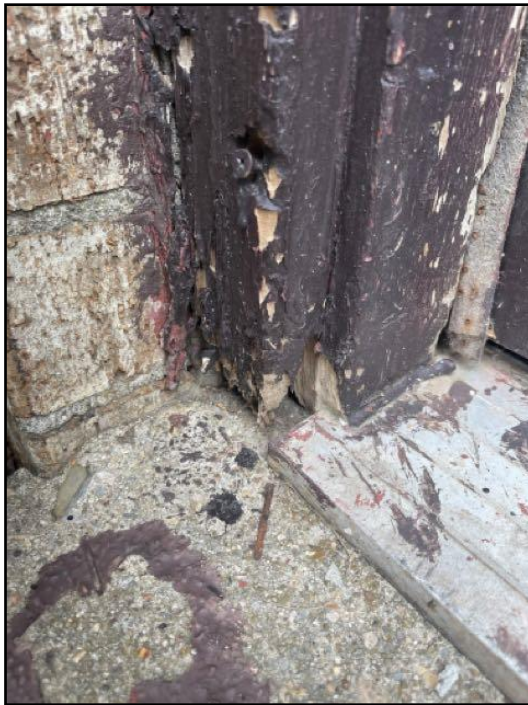
56. Condition: • Rotted

123. Rotted

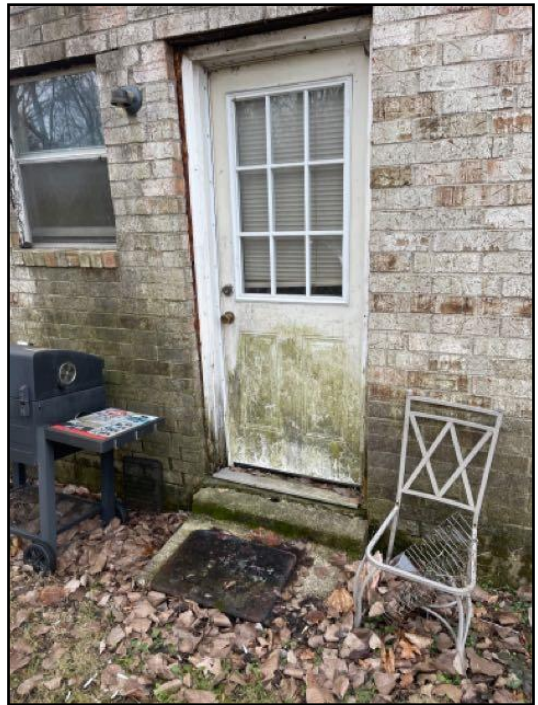
124. Rotted

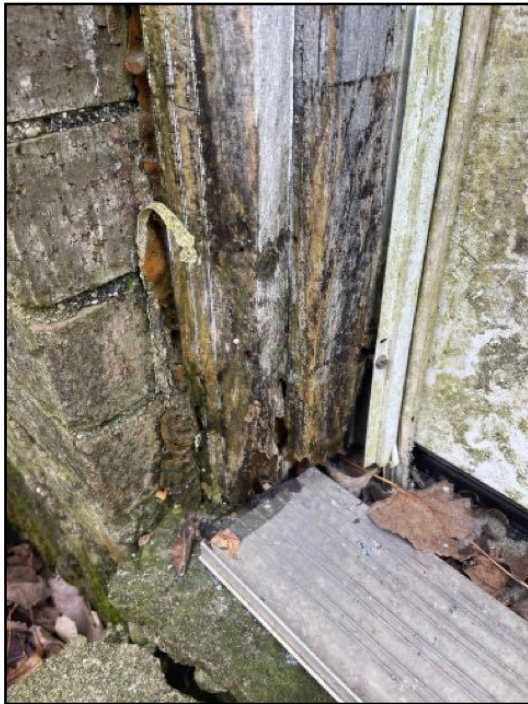
125. Rotted

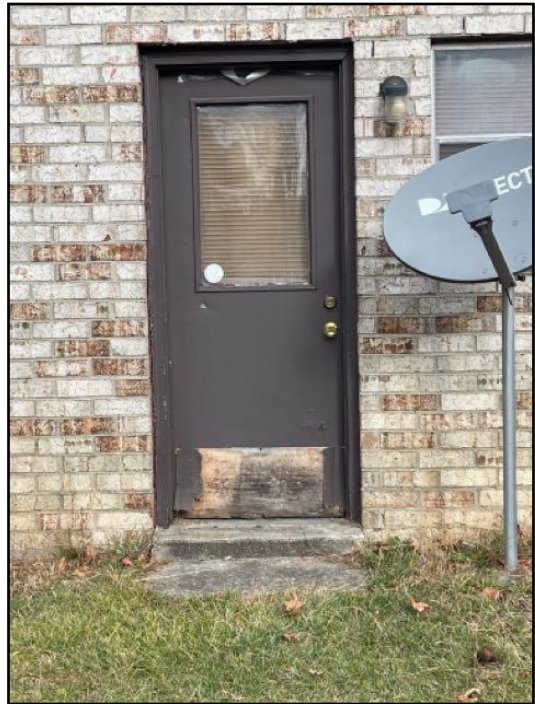
126. Rotted

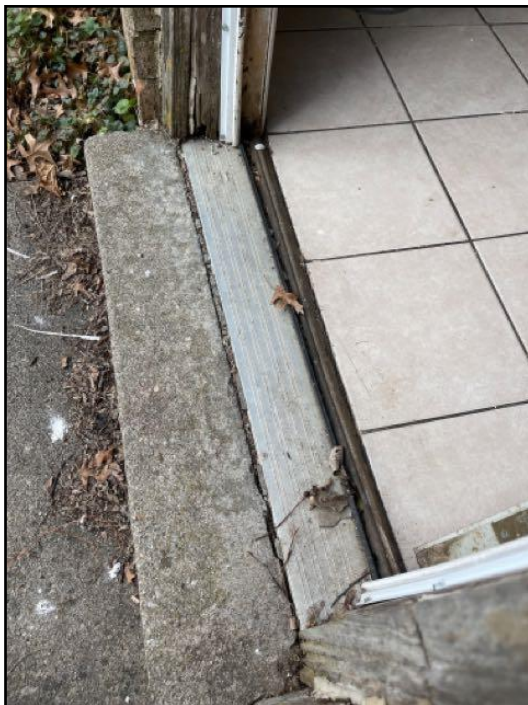
127. Rotted

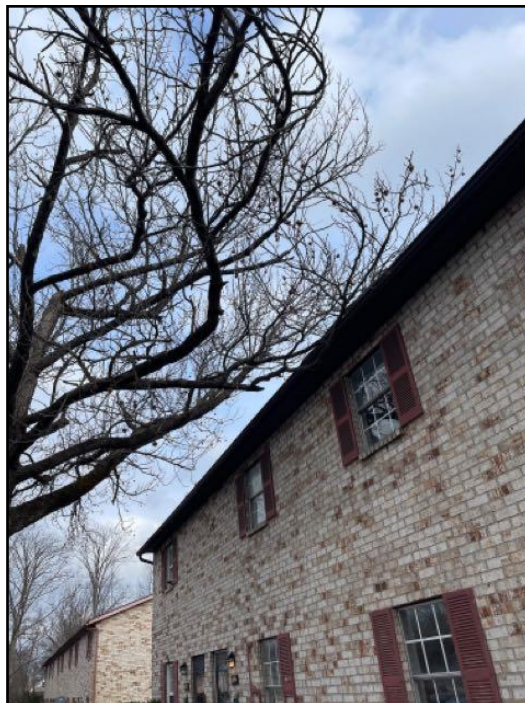
141. I recommend all vegetation be cut back from...

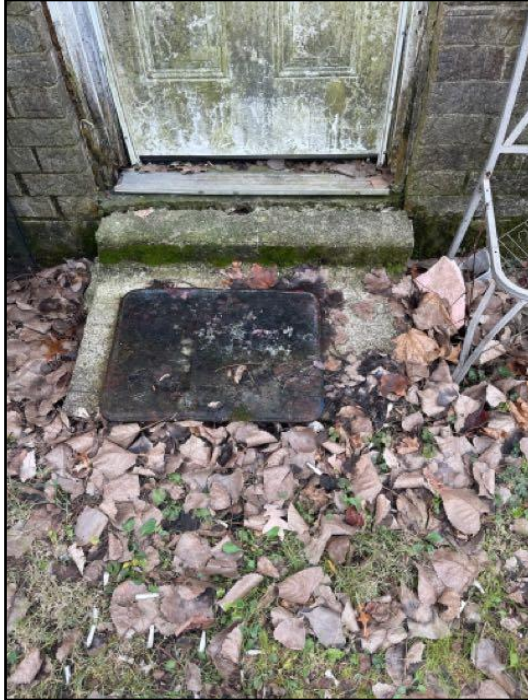
142.

60. Condition: • The concrete landings, stairs, and walkways are settling and spalling. I recommend consulting a qualified contractor who specializes in flat work for a cost analysis.
