1362 SW 2nd Street, Miami, FL 33135

Reference: 40 Year Re-Certification
Two-Story Residential Building
Folio No.: 01-4102-006-2220
1362 SW 2 ST, MIAMI, FL 33135
Bldg. No.: 1 / Sq. Ft.: 3,811

James Hanskat, P.E., has performed structural and electrical inspections of the above-referenced property located in Miami-Dade County, Florida.

Structural Photolog

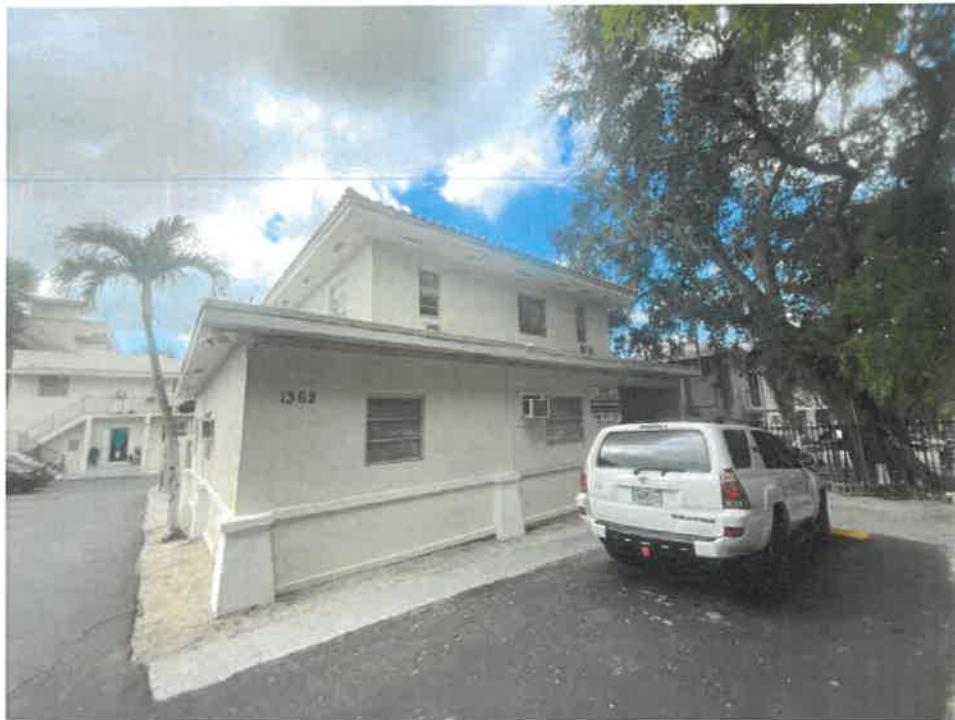
Building Elevation (North)

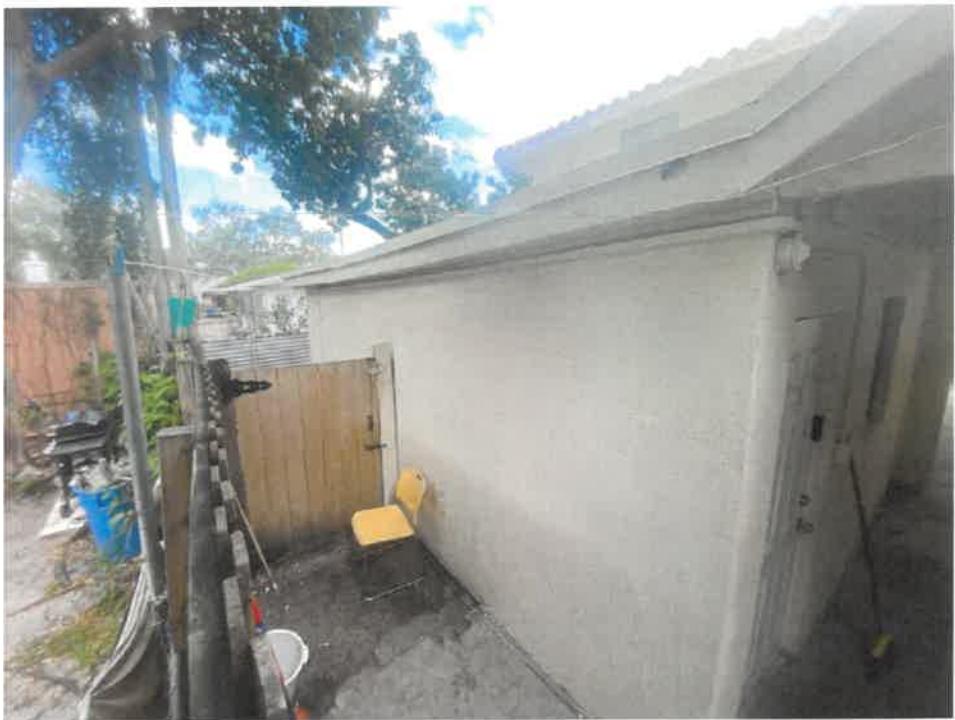
Building Elevation (South)

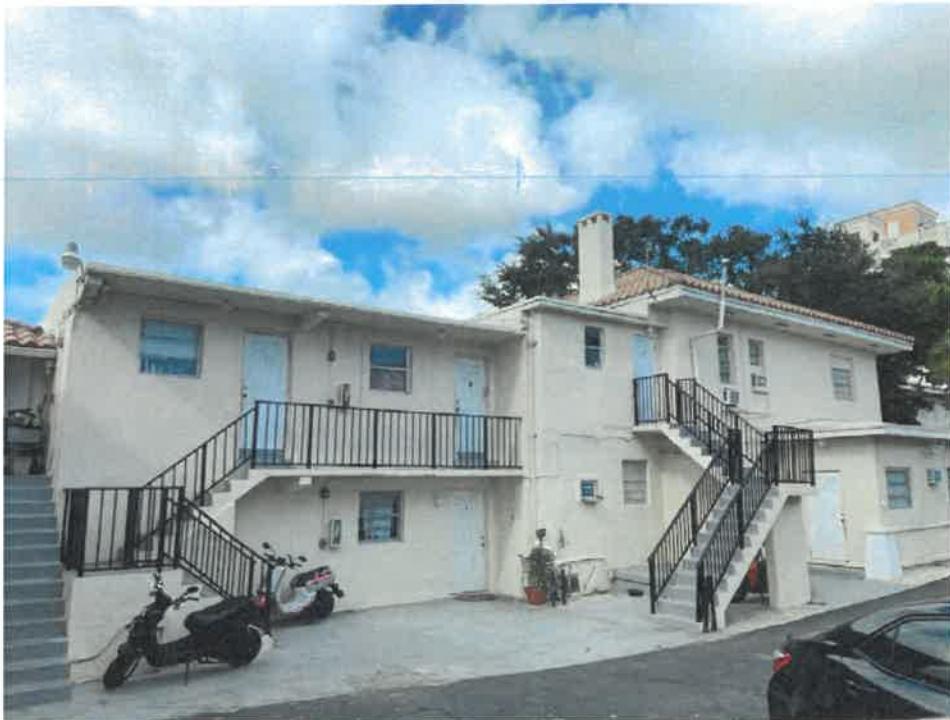
Building Elevation (East)

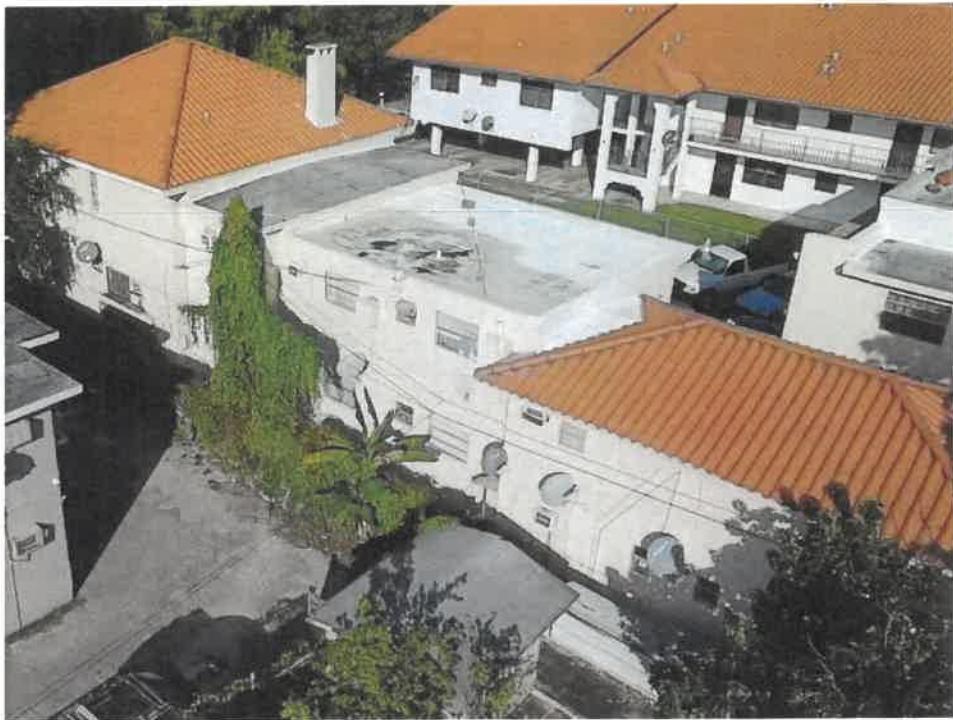
Building Elevation (West)
