COMMERCIAL MULTI-UNIT INSPECTION REPORT

4468 Reinbeau Dr
Columbus, OH 43232

09/09/2024

- This document is a Property Condition Report (PCR) of the property located at: 4468 Reinbeau Dr Columbus OH 43232
- This PCR was prepared by: Russell Allen
- This PCR was prepared for: Gerard Tema
- User's position with the property: Buyer
- The property habitable square footage is: 12390 sq. ft.
- Type of real estate transaction: Commercial Investment, Multi-Family
- Date of site visit: 09/09/2024

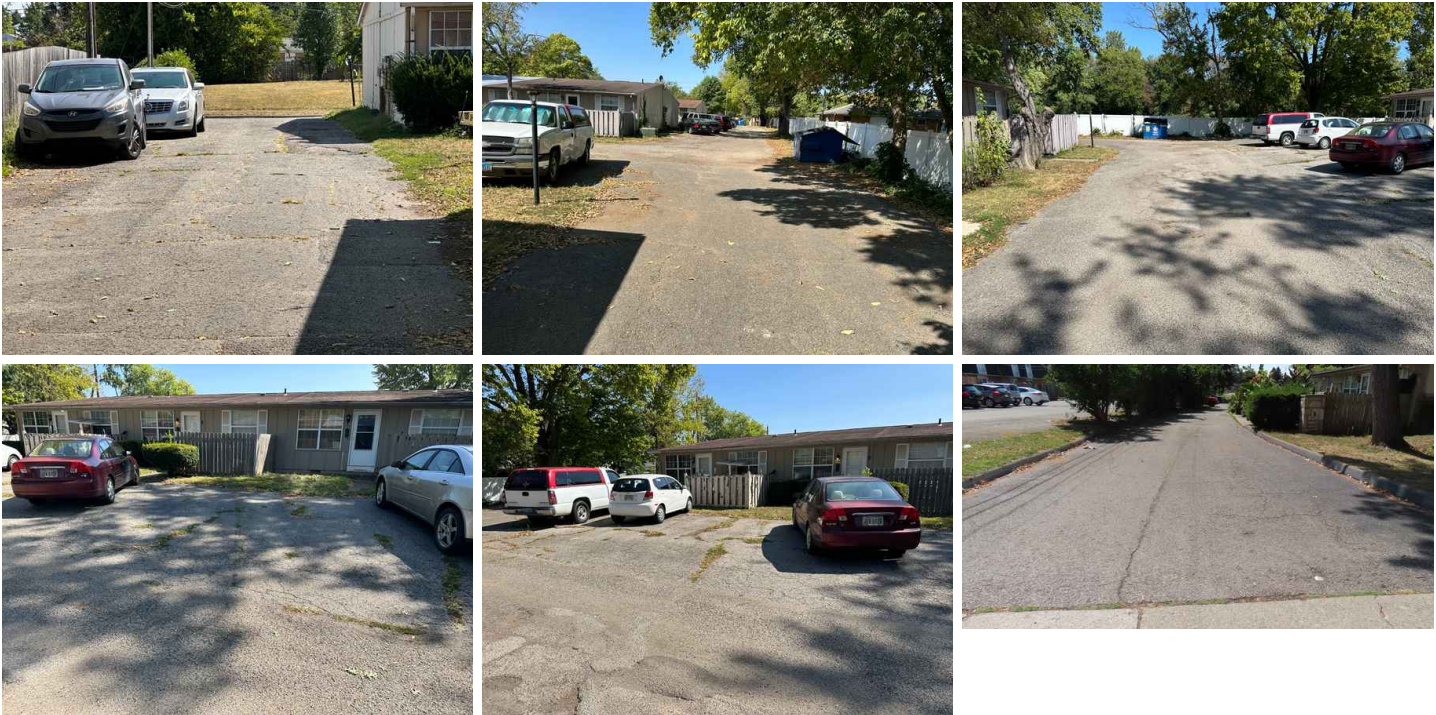
6.3.1 Lighting: Parking Lot

INADEQUATE LIGHTING

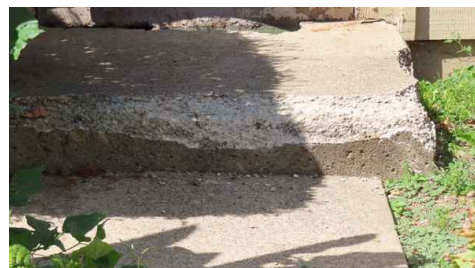
7.1.2 Walkways and Steps

CRUMBLING CONCRETE ON STEPS

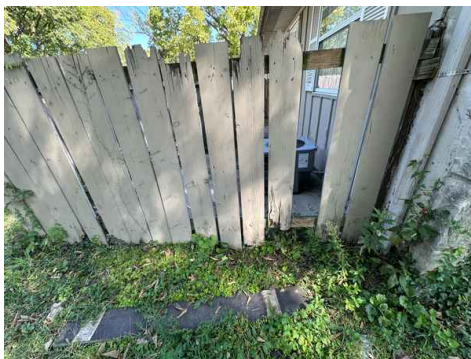
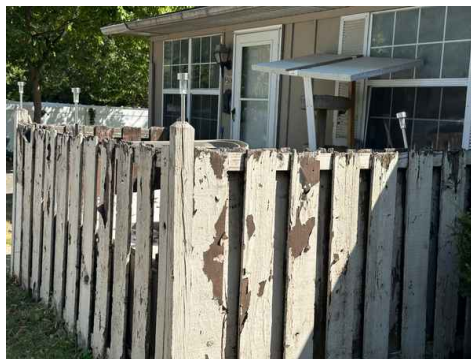
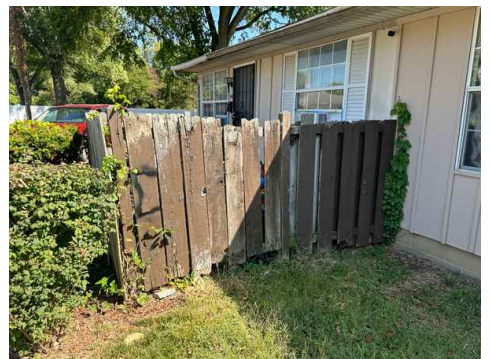
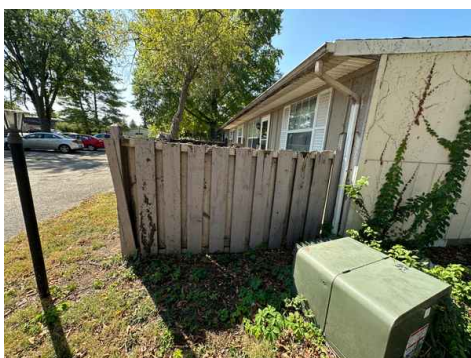
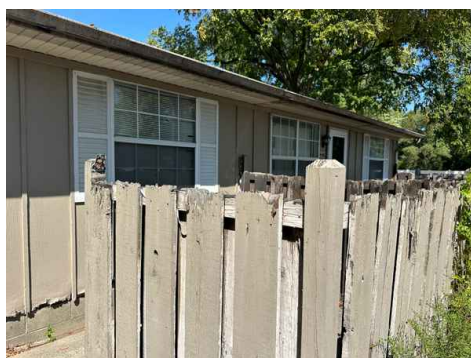
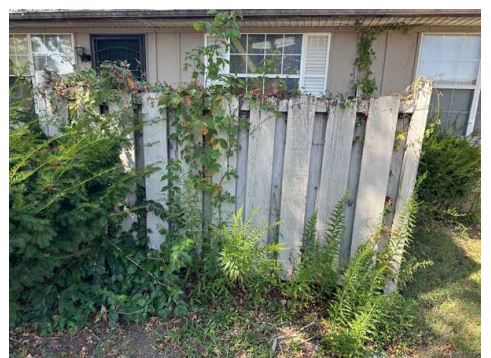
10.3.1 Fencing

DETERIORATION: MODERATE TO SEVERE

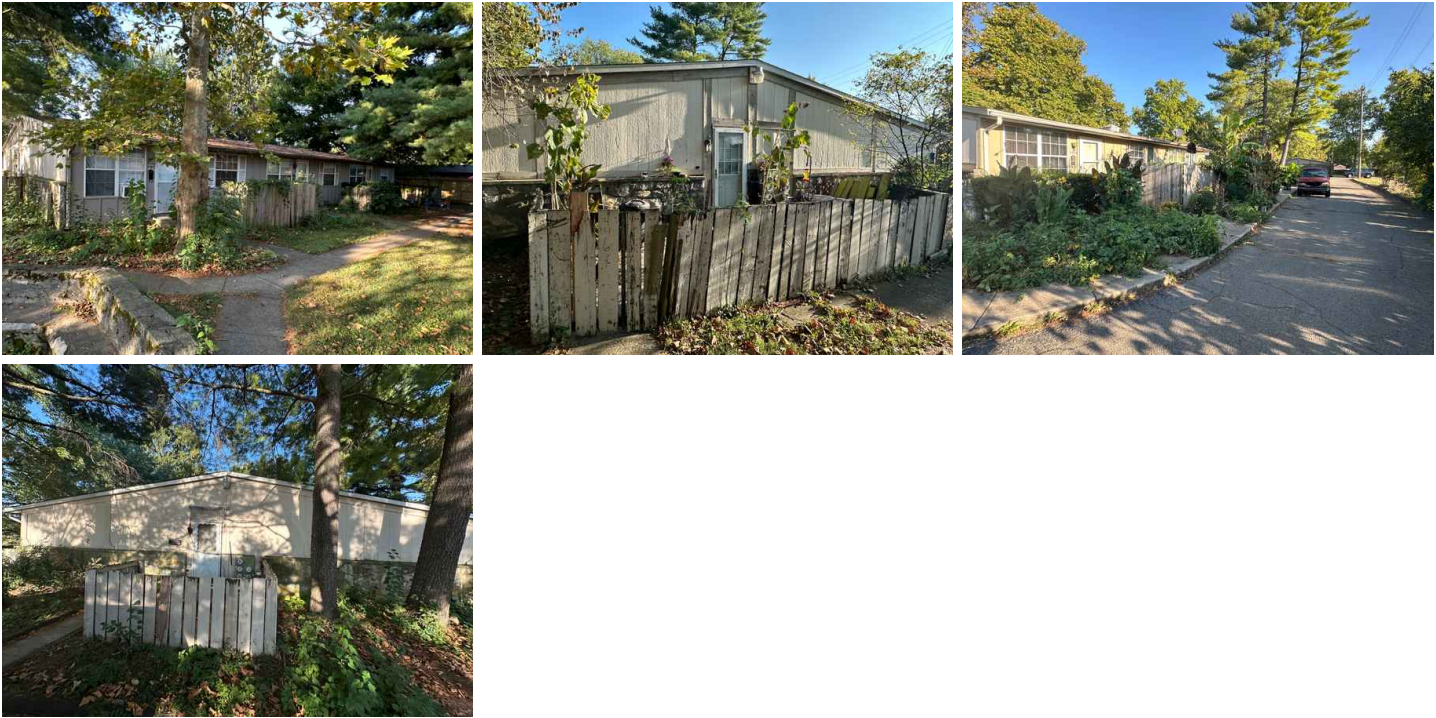
10.4.1 Trees

TREES: TRIMMING NEEDED

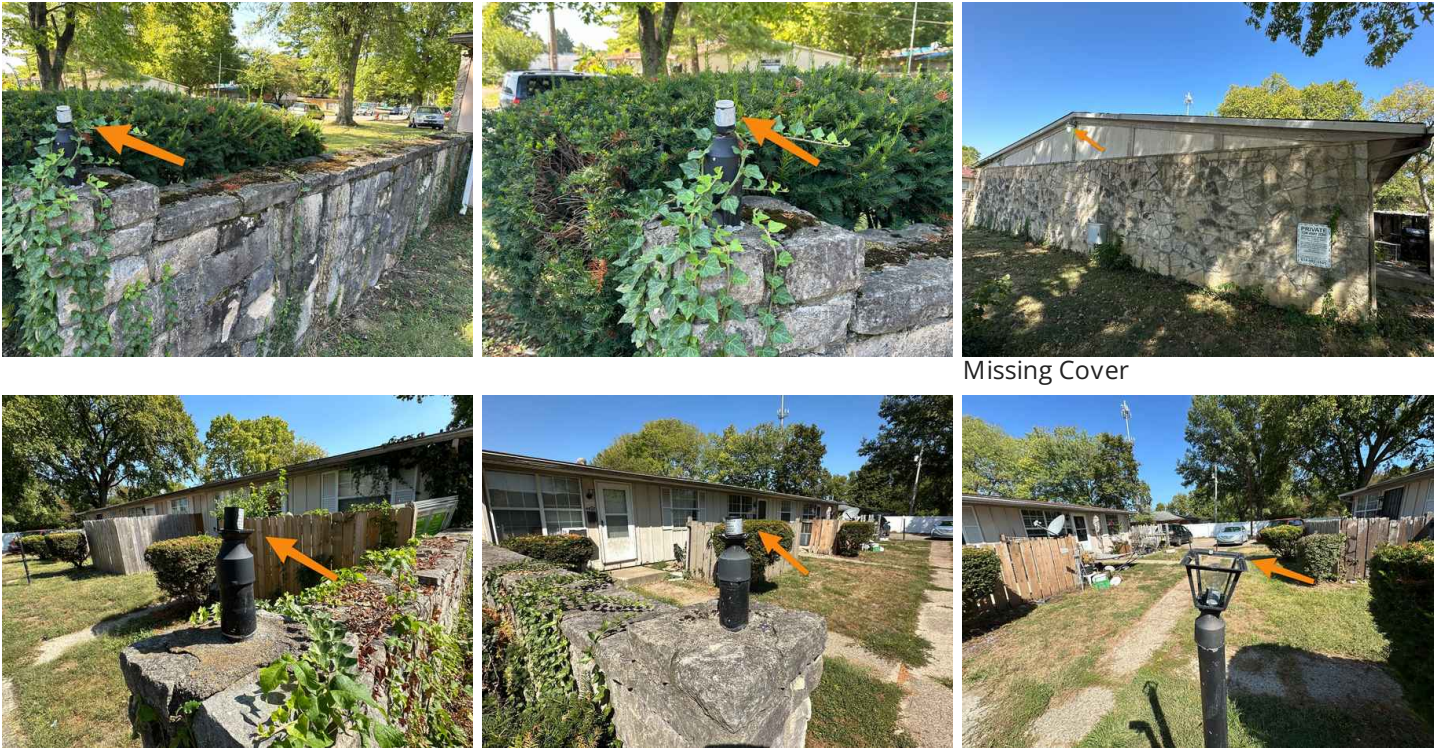
10.5.1 Exterior Lighting

WALKWAY LIGHTS: REPAIR/REPLACE

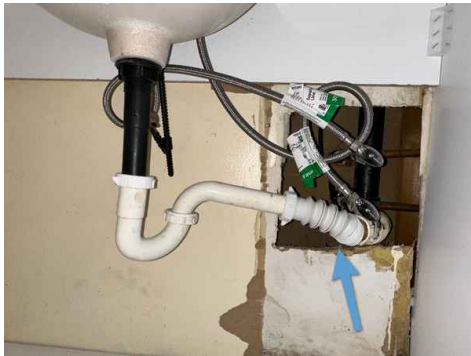
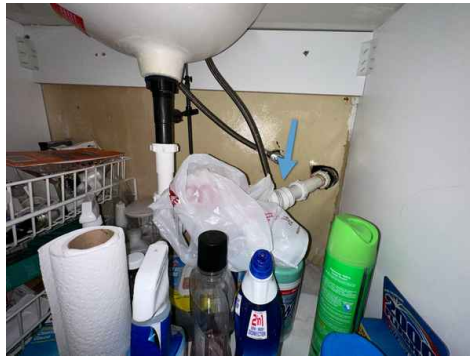
14.4.1 Undersink Plumbing - Bathroom

DRAIN PIPES - FLEX DRAIN PIPE PRESENT

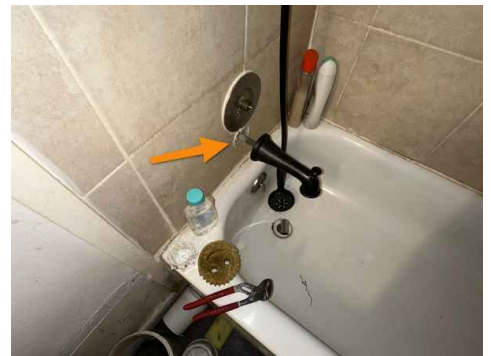
14.5.2 Bathtub(s)

FAUCET/VALVES - NOT FLUSH WITH WALL

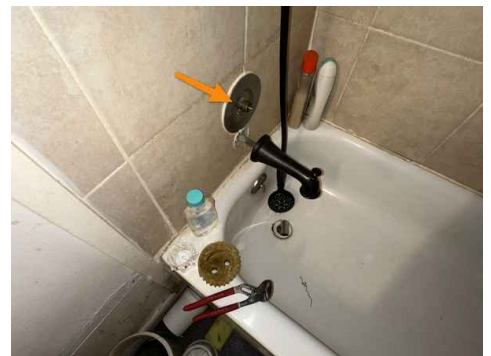
14.5.3 Bathtub(s)

FAUCET/VALVES - VALVE HANDLE MISSING

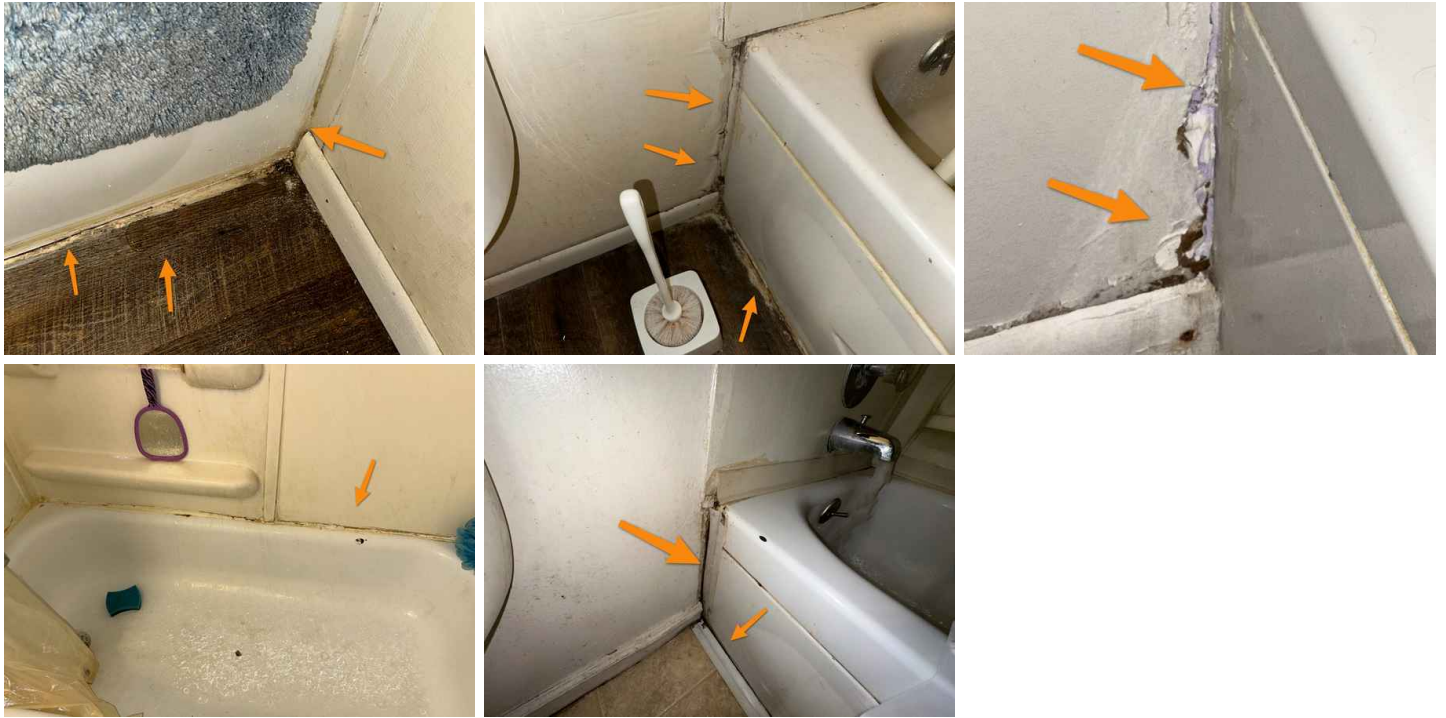
14.7.1 Shower Walls

SEALANT - CRACKED/GAPS PRESENT

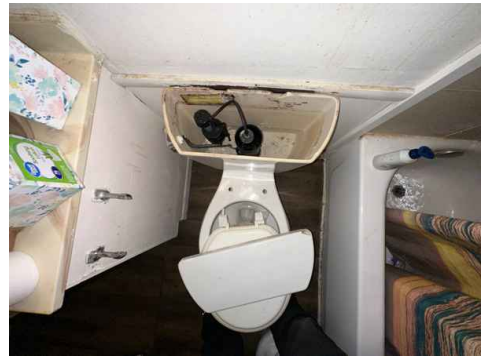
14.8.1 Toilet(s)

TOILET - NOT FLUSHING PROPERLY

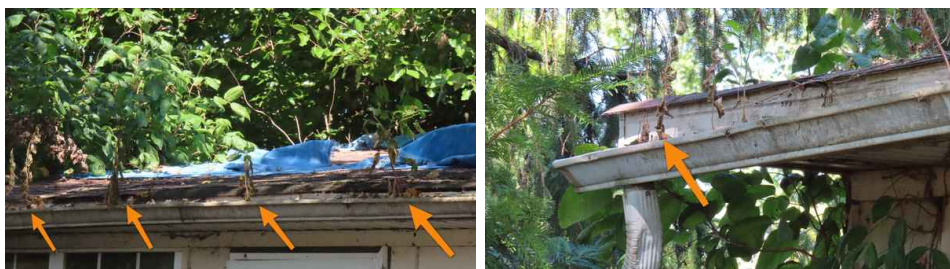
GUTTERS - VEGETATION GROWTH

The gutters were full of organic debris to the point that vegetation was growing out of the gutters. Typically when this amount of debris is present the total system is clogged including downspouts and any applicable drain tubes.

Weight of vegetation pulling gutter down

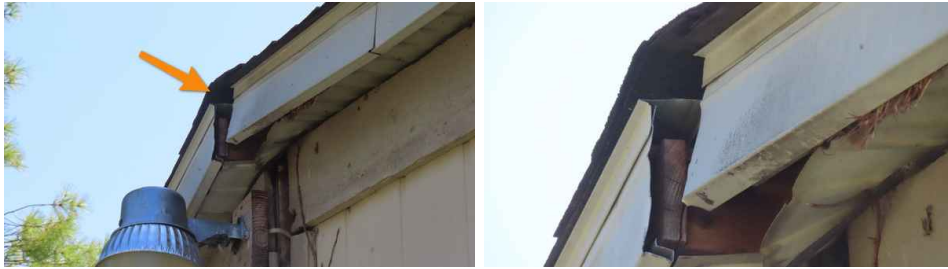
17.6.3 Roof Structure/Framing

RAFTERS AT RAKE END OF GABLE - SEPARATED FROM RIDGE

The rafters at the opposing slopes of the roof appeared to be separated from each other at their connection point at the ridge beam.

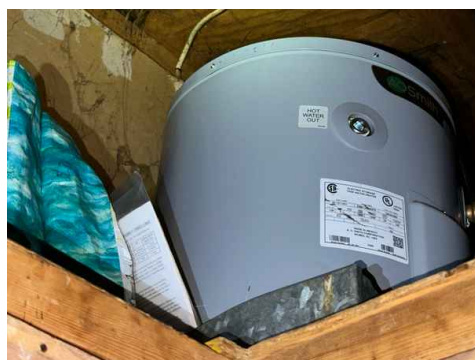
This water heater may not be large enough to supply adequate hot water..

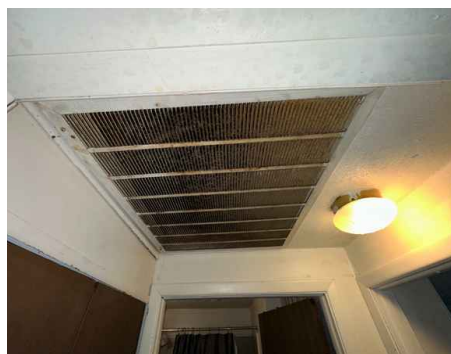
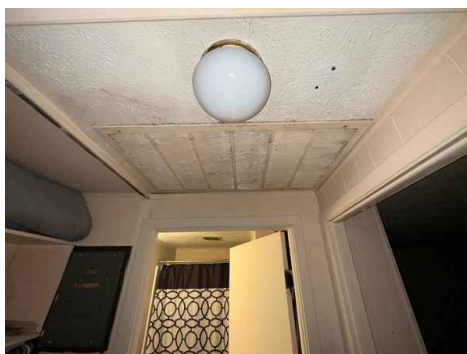
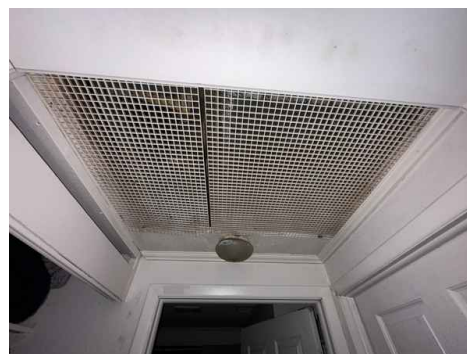
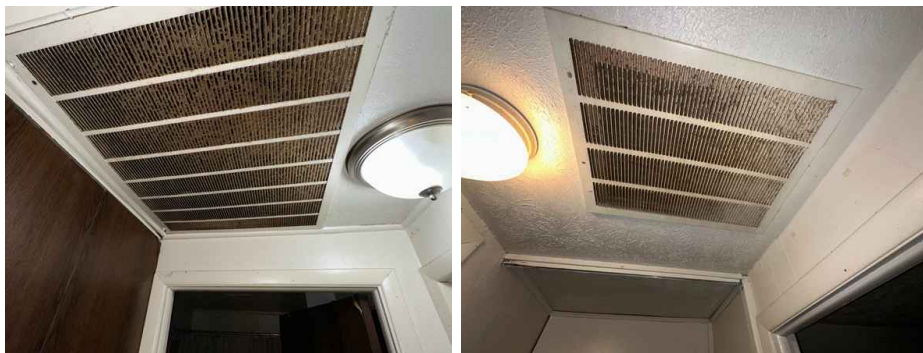
Hallway Ceiling

Two units had leaks through the return air grate from the attic. This appeared likely due to a leaky condensate line in the attic. Most AC units did not operate, so there was no evidence of faulty condensate lines in other units.
