The Nanni Corporation DBA
National Property Inspections

AMI INC, 6678 River Road, Fuquay Varina, NC, 27526

Wednesday, December 13, 2023

Property Location : **6678 RIVER ROAD
FUQUAY VARINA NC 27526**

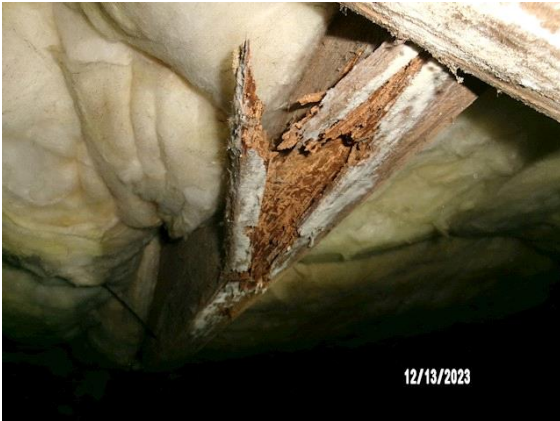
STRUCTURAL FRAME AND BUILDING ENVELOPE:
probing a mold covered floor joist

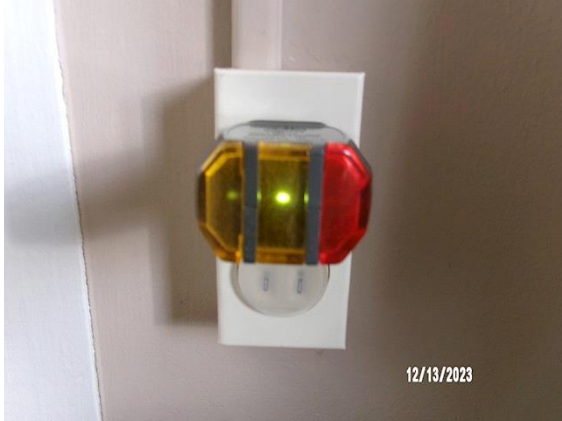
CHAPEL OFFICES: open/no ground

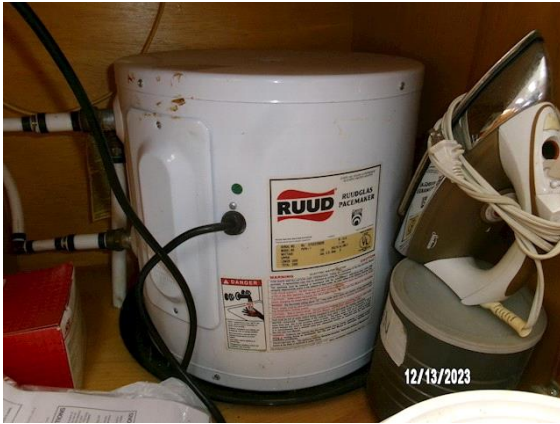
Water Heater:

Based on the date code in the s/n the approximate age of this water heater is 21 years. Recommend budgeting for a new water heater in the new future as age indicates water is past normal life expectancy
